Pilot Study on Quality Aspects of PV Power Plants in India

Conducted in the framework of the Indo-German cooperation project
“Strengthening Quality Infrastructure for the Solar Industry”

by PI Photovoltaik-Institut Berlin AG

First published: September 2017

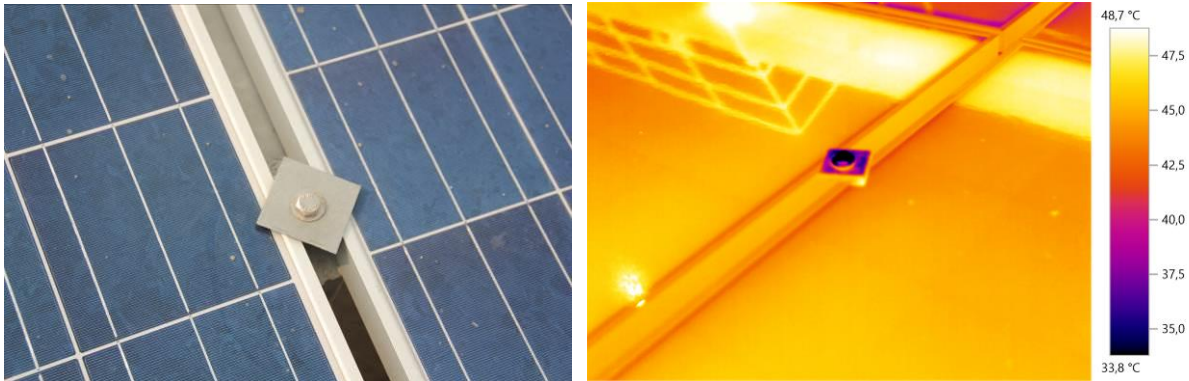
Figure 21: Improper module fixing and associated hot spots due to microshading effects

3.1	Mounting structure	
3.1.1	Poor module fixation	The module clamps are unsuitable for PV applications and do not ensure the proper fixation of the modules to the mounting structure. In case of strong wind, the modules might suffer severe damages. Apart from this, the micro-shadings caused by the clamps have an influence on the module performance.

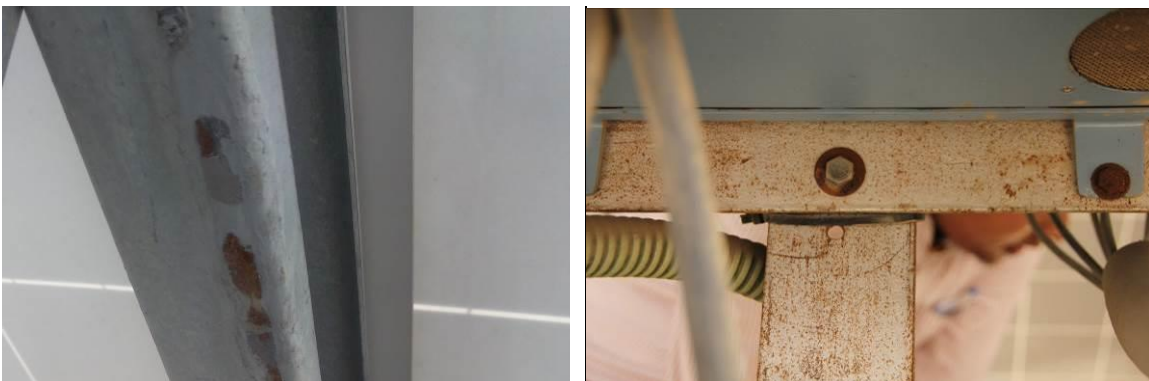
- iii. Rust on the mounting structure surface: Rust is present in many parts of the mounting structure after 18 months of outdoor exposure. Some areas of the plant show advanced levels of rust. No aluminium has been used, all parts are made of steel.

Figure 23: Presence of rust in the mounting structure

3.1.3	Rust on the mounting structure components	The rust can lead to a reduction of the structural strength of the mounting structure, especially in combination with strong wind.

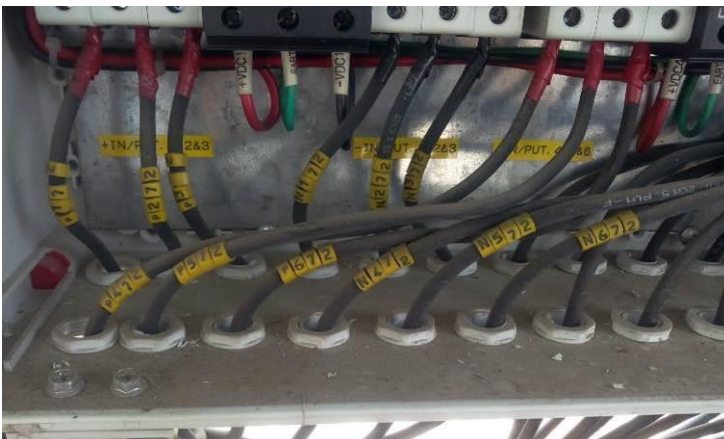
- ii. Cleanliness of the CB: The DC combiner boxes have a significant amount of dust and dirt inside. Signs of rust could also be detected. The AC combiner boxes couldn't be opened.

Figure 25: Presence of dust inside the combiner box

3.2	Combiner boxes	
3.2.1	Dust and dirt inside the housing	The presence of dust and dirt inside the combiner boxes can lead to the development of micro-organisms and possible corrosion and chemical reactions that damage the electrical components inside the housing. Additionally, the dust tends to grip the electrical protections such as fuse holders and breakers limiting their functionality.

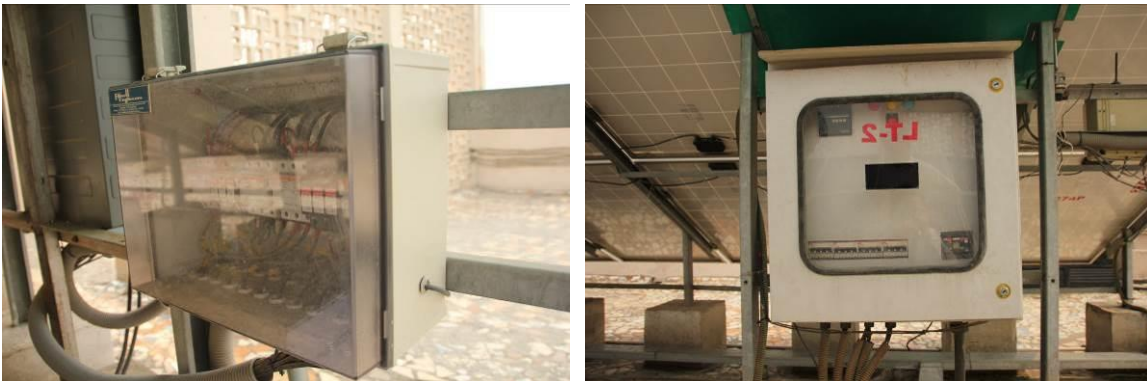
- iv. Labelling of the CB: A durable and clearly visible labelling of the DC combiner boxes is missing. The AC combiner boxes are labelled.

Figure 27: (left) Missing labelling of the DC combiner box; (right) Labelled AC combiner boxes

3.2.2	No labelling of the boxes.	The missing combiner box labelling makes the correct identification of the various areas of the plant more difficult leading to increased reaction times during corrective maintenance. Additionally, electrical parts that aren't properly labelled may hide safety risks when manipulated by O&M members.

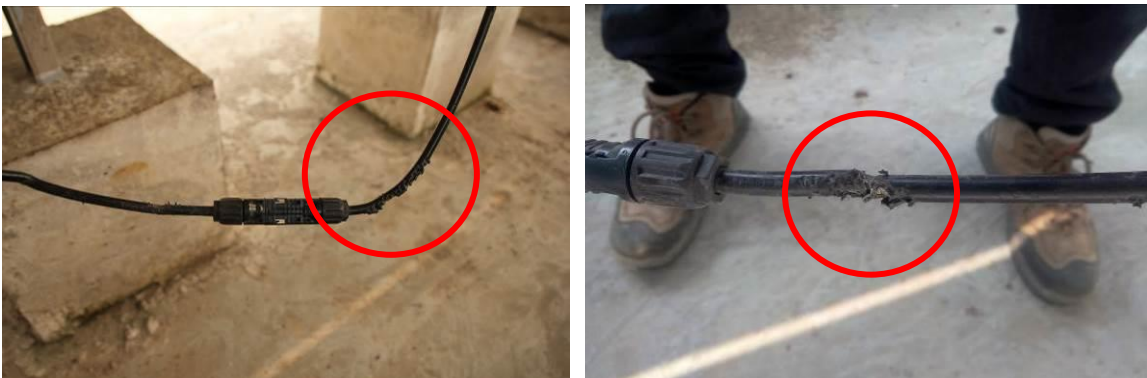
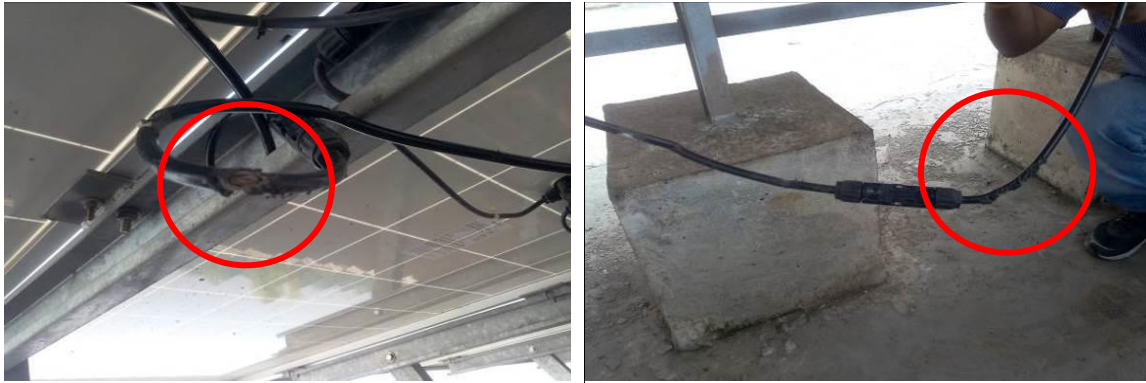
- i. Cable damage: Some cables show mechanical damages caused by monkey bites. Additionally, some cables are in contact with sharp edges of the mounting structure components leading to abrasion of the cable shield.

Figure 28: String cables damaged by monkey bites

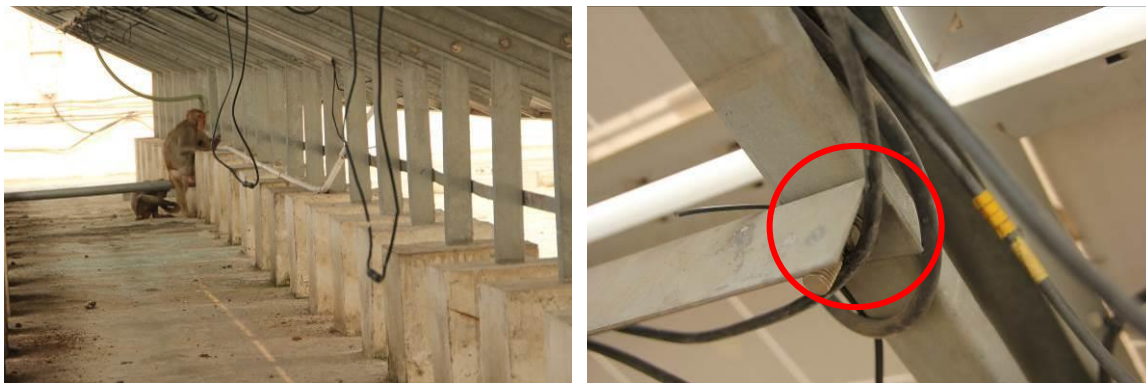
Figure 29: (left) Monkeys present on site; (right) String cables in contact with sharp edges

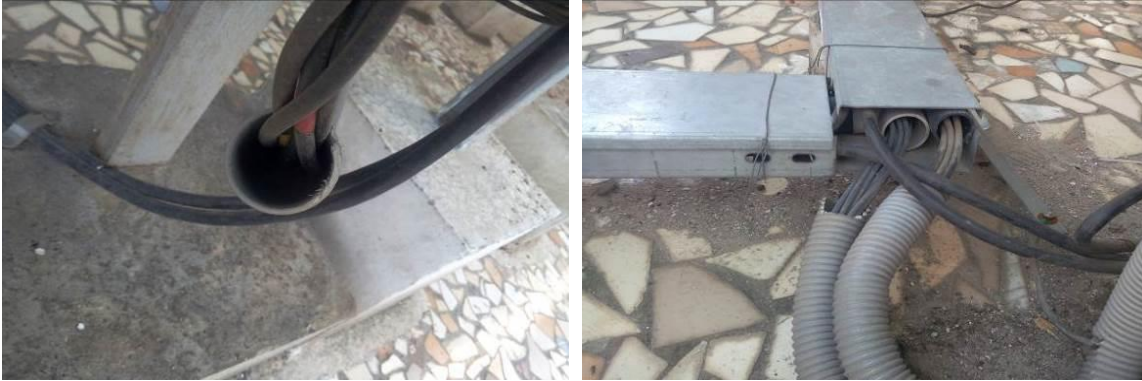
- vi. Sealing of tubes: The tubes are not sealed.

Figure 34: Non sealed cable tubes

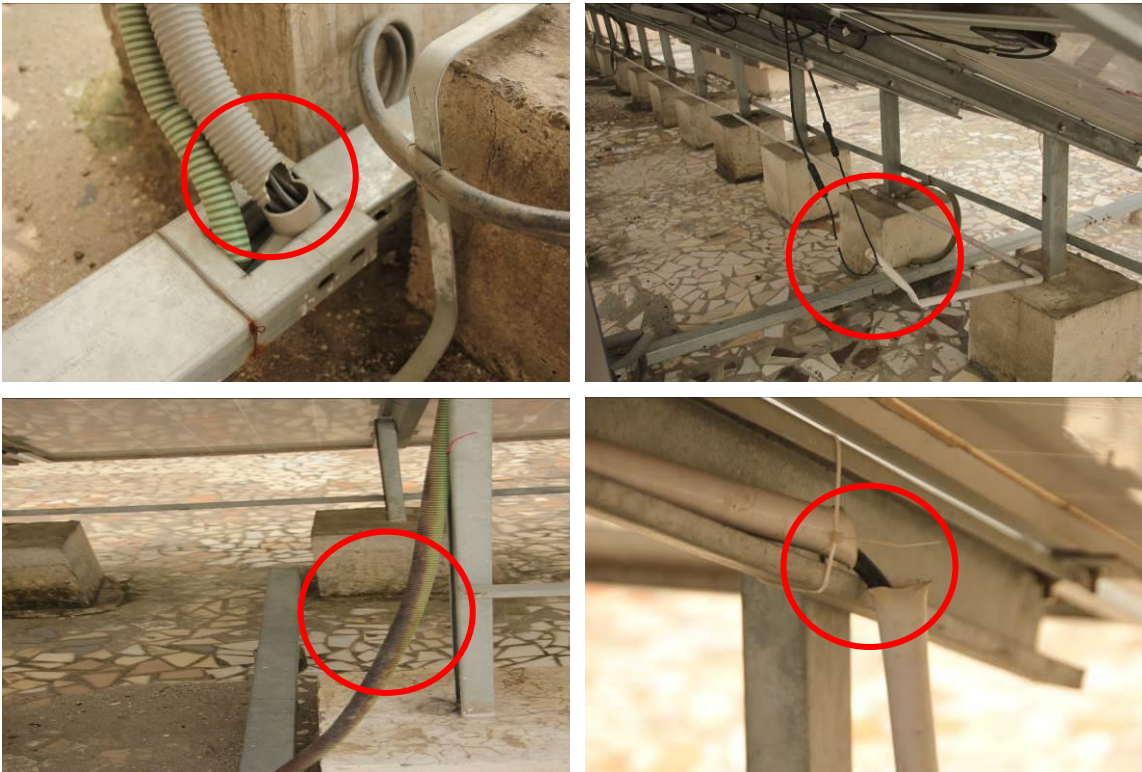
- vii. Cable pipes: The tubes where the cables are routed show degradation due to outdoor exposure. That leads to a lack of UV protection of the cables in some areas of the plant.

Figure 35: Degraded cable pipes

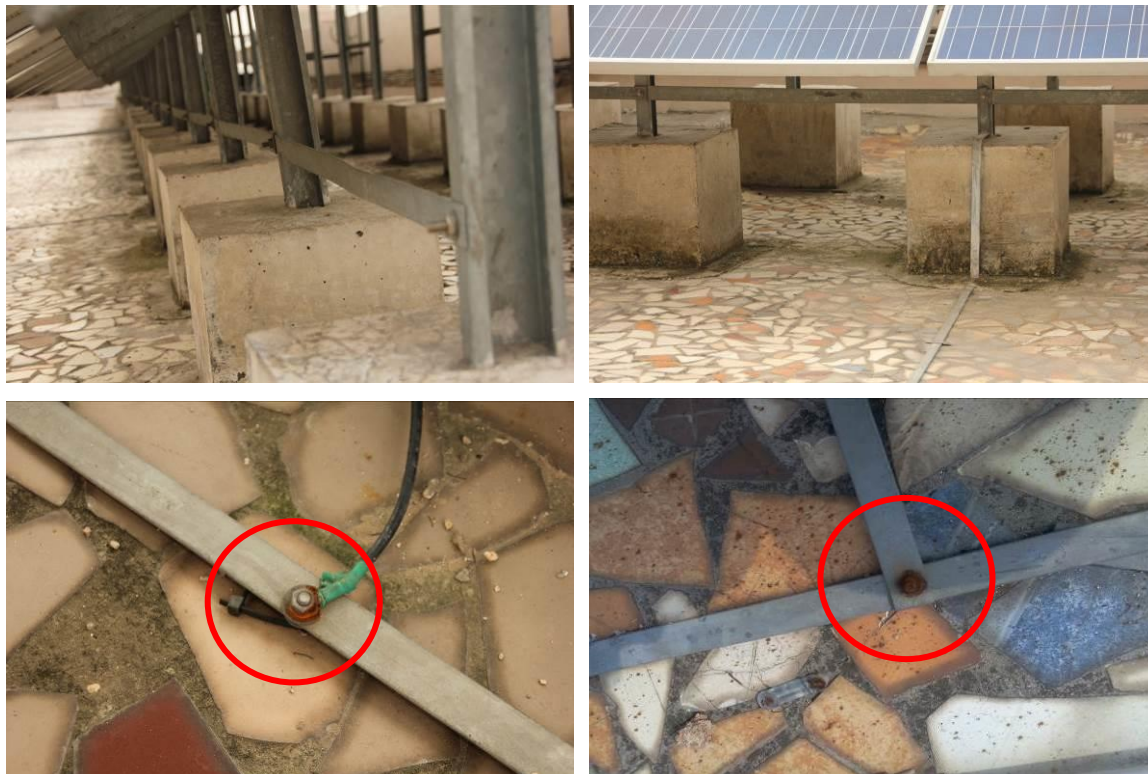
Figure 37: (Top) Equipotential bonding system installed onsite; (bottom) Rust in the equipotential bonding system

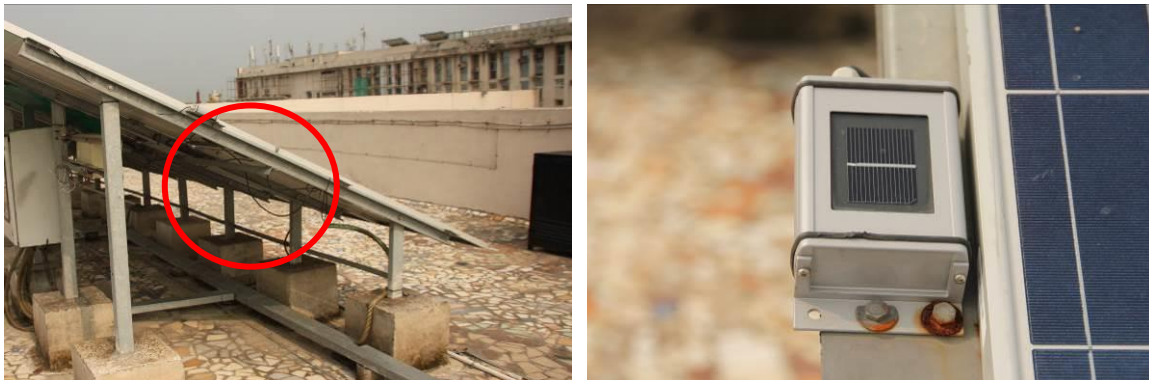
Figure 38: (left) Not protected communication cable; (right) Irradiation sensor installed onsite

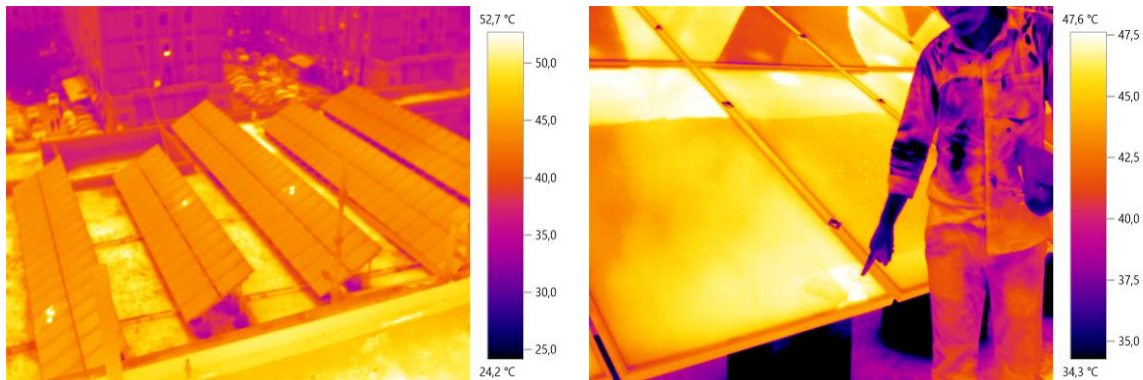
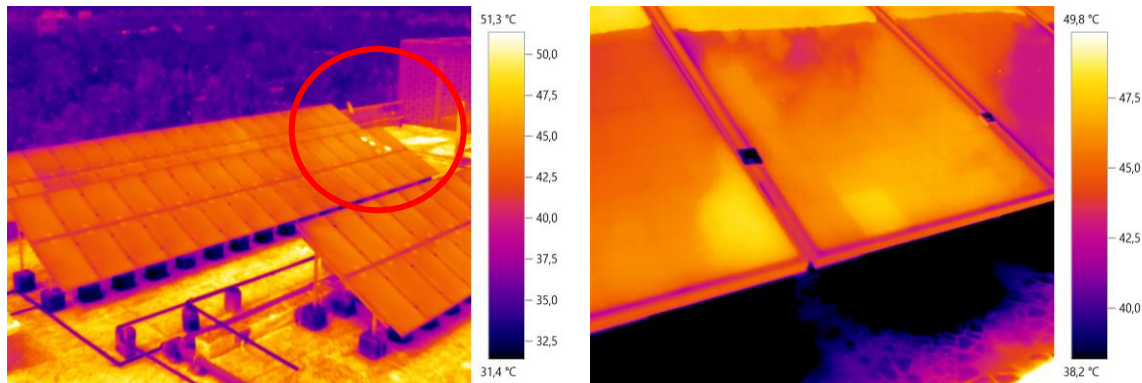
The infrared inspection did not show major defects apart from a few hot spots.

Figure 40: Modules affected by hot spots

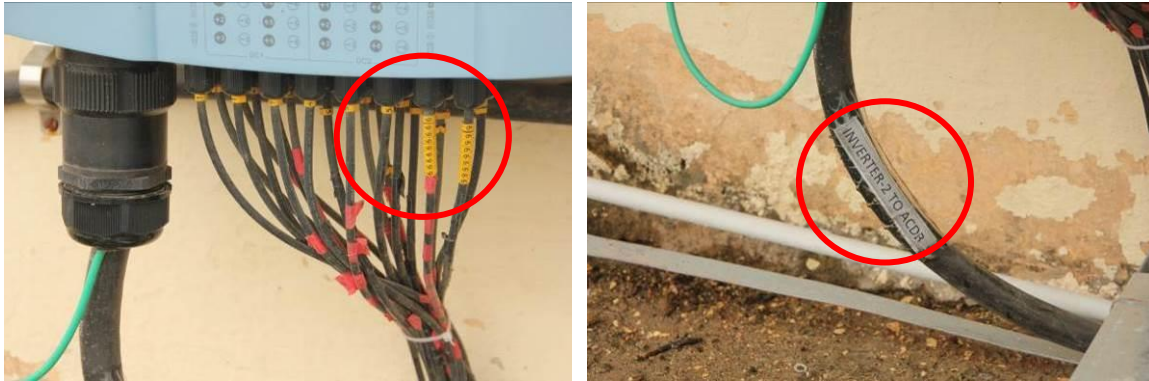
Figure 45: (left) Inconsistent labelling of the string cables; (right) Non-durable tags of the AC cables

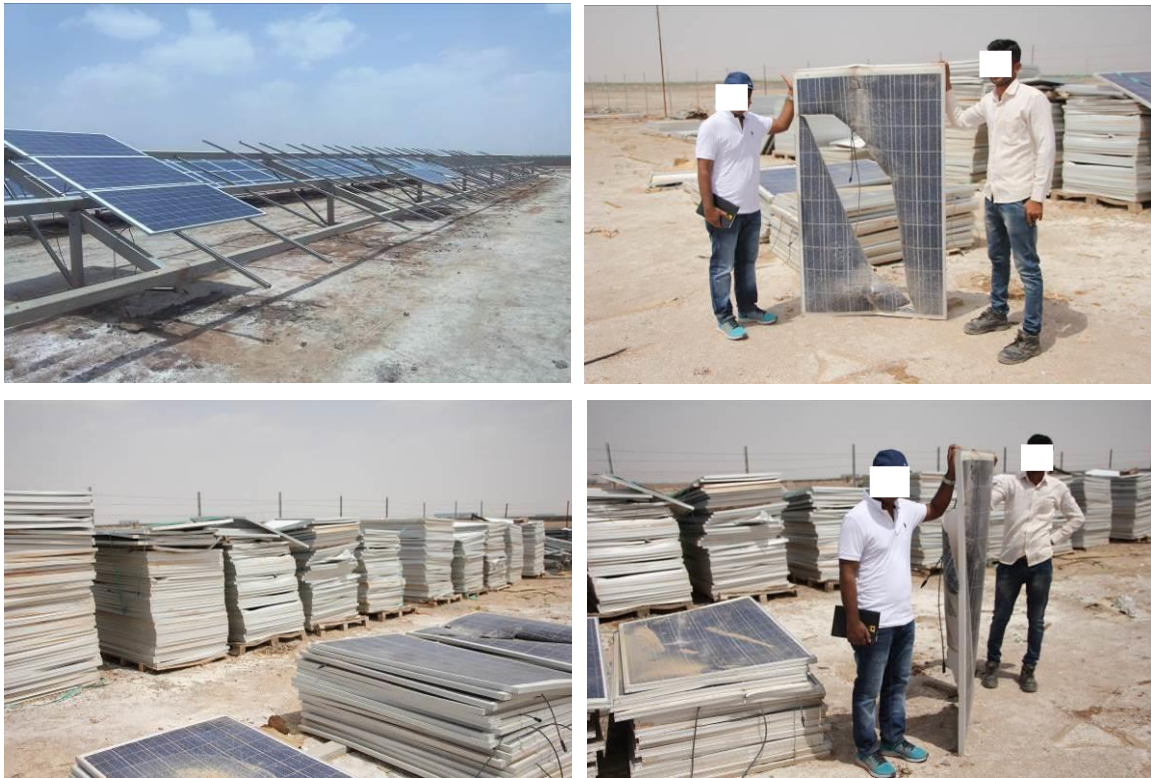
No static calculations were shared with PI Berlin, hence the structural integrity of the mounting structure couldn't be proven. However, the module fixation doesn't withstand the wind loads registered onsite.

Figure 56: Damaged modules due to strong winds

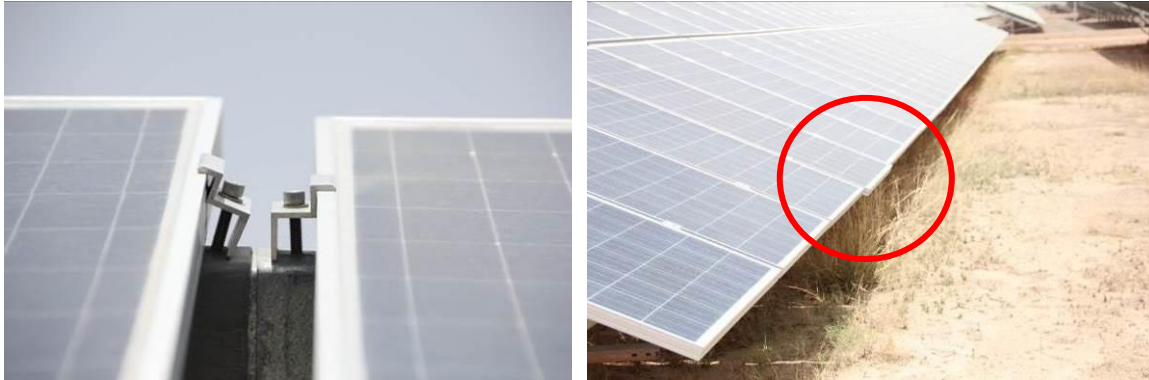
- Module fixation:** The modules are not always properly fixed to the cross beams which leads to a misalignment along the mounting tables.

Figure 58: Improper module fixation

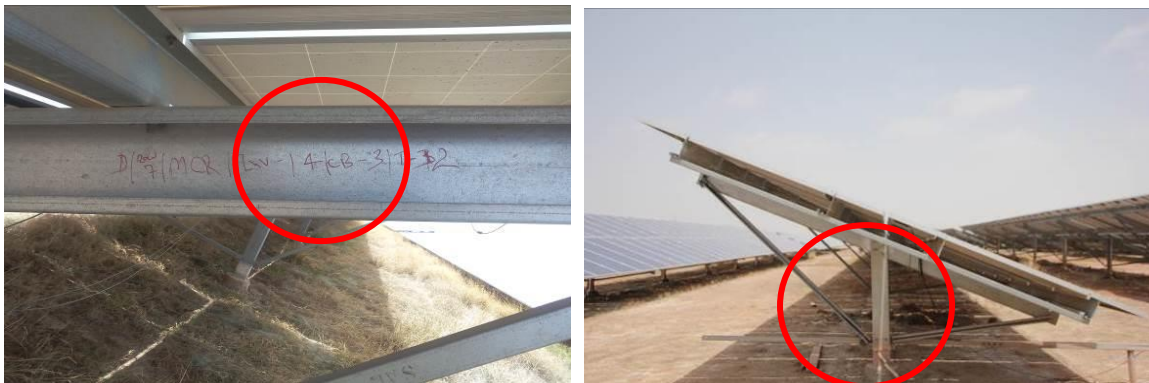
- Labelling of rows:** The labelling of the mounting structure hasn't been conducted in all areas of the PV plant. Besides, the labels are not durable for the entire lifetime of the project.

Figure 59: Improper row labelling

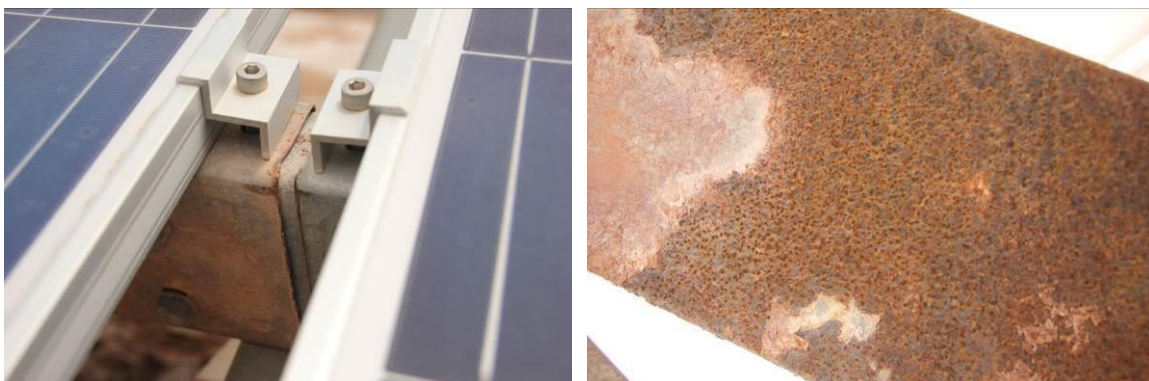
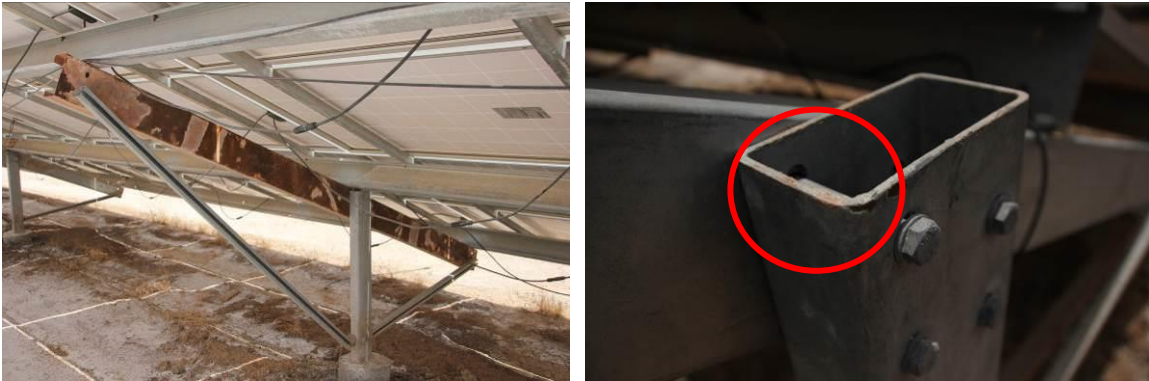
- Rust on the mounting structure surface:** The mounting structure shows advanced levels of rust due to the salty environment.

Figure 60: Mounting structure affected by rust due to the salty environment

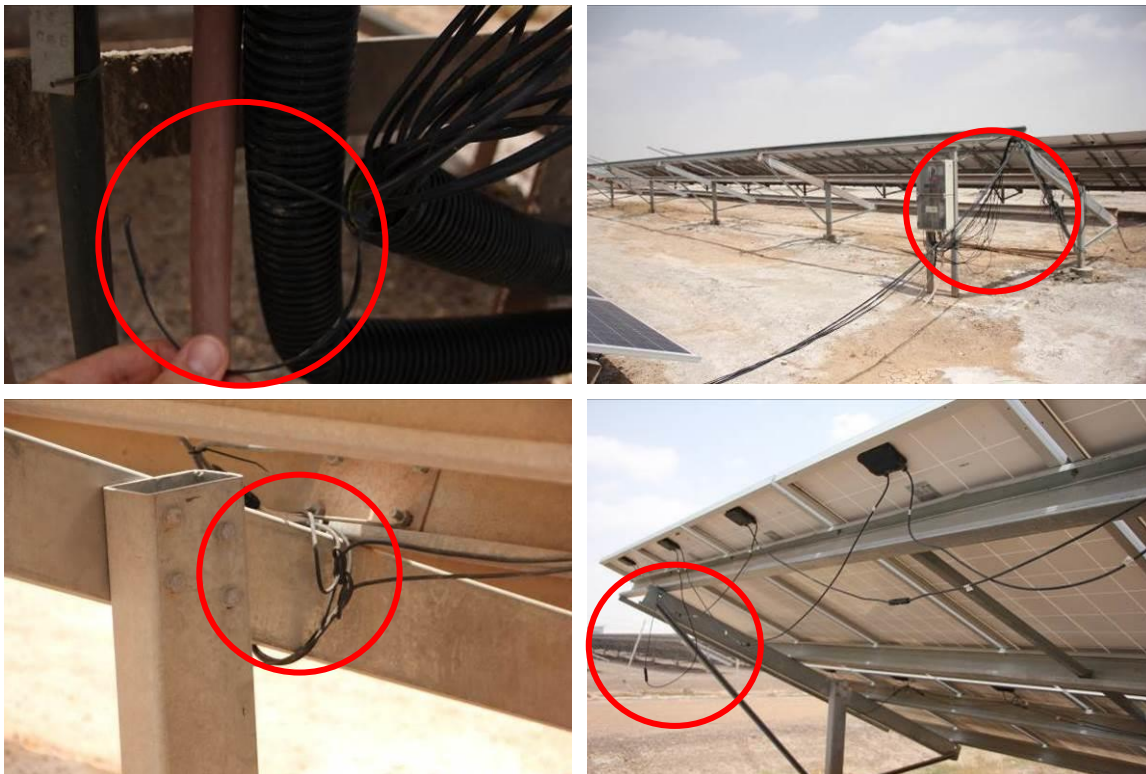
- iv. Cable fixation: The cables ties used for the cable fixation are not suitable for outdoor exposure and start falling apart.

Figure 67: Improper cable fixation of the string cables

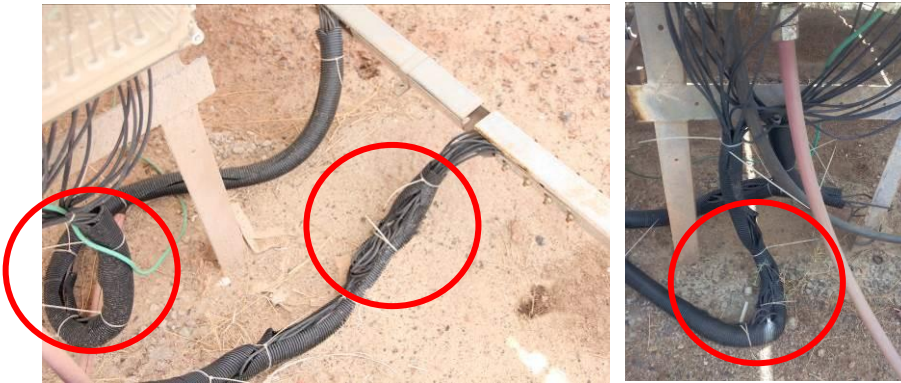
- viii. Cable pipes: The tubes where the cables are routed show degradation due to outdoor exposure.

Figure 71: Degraded cable pipes due to outdoor exposure

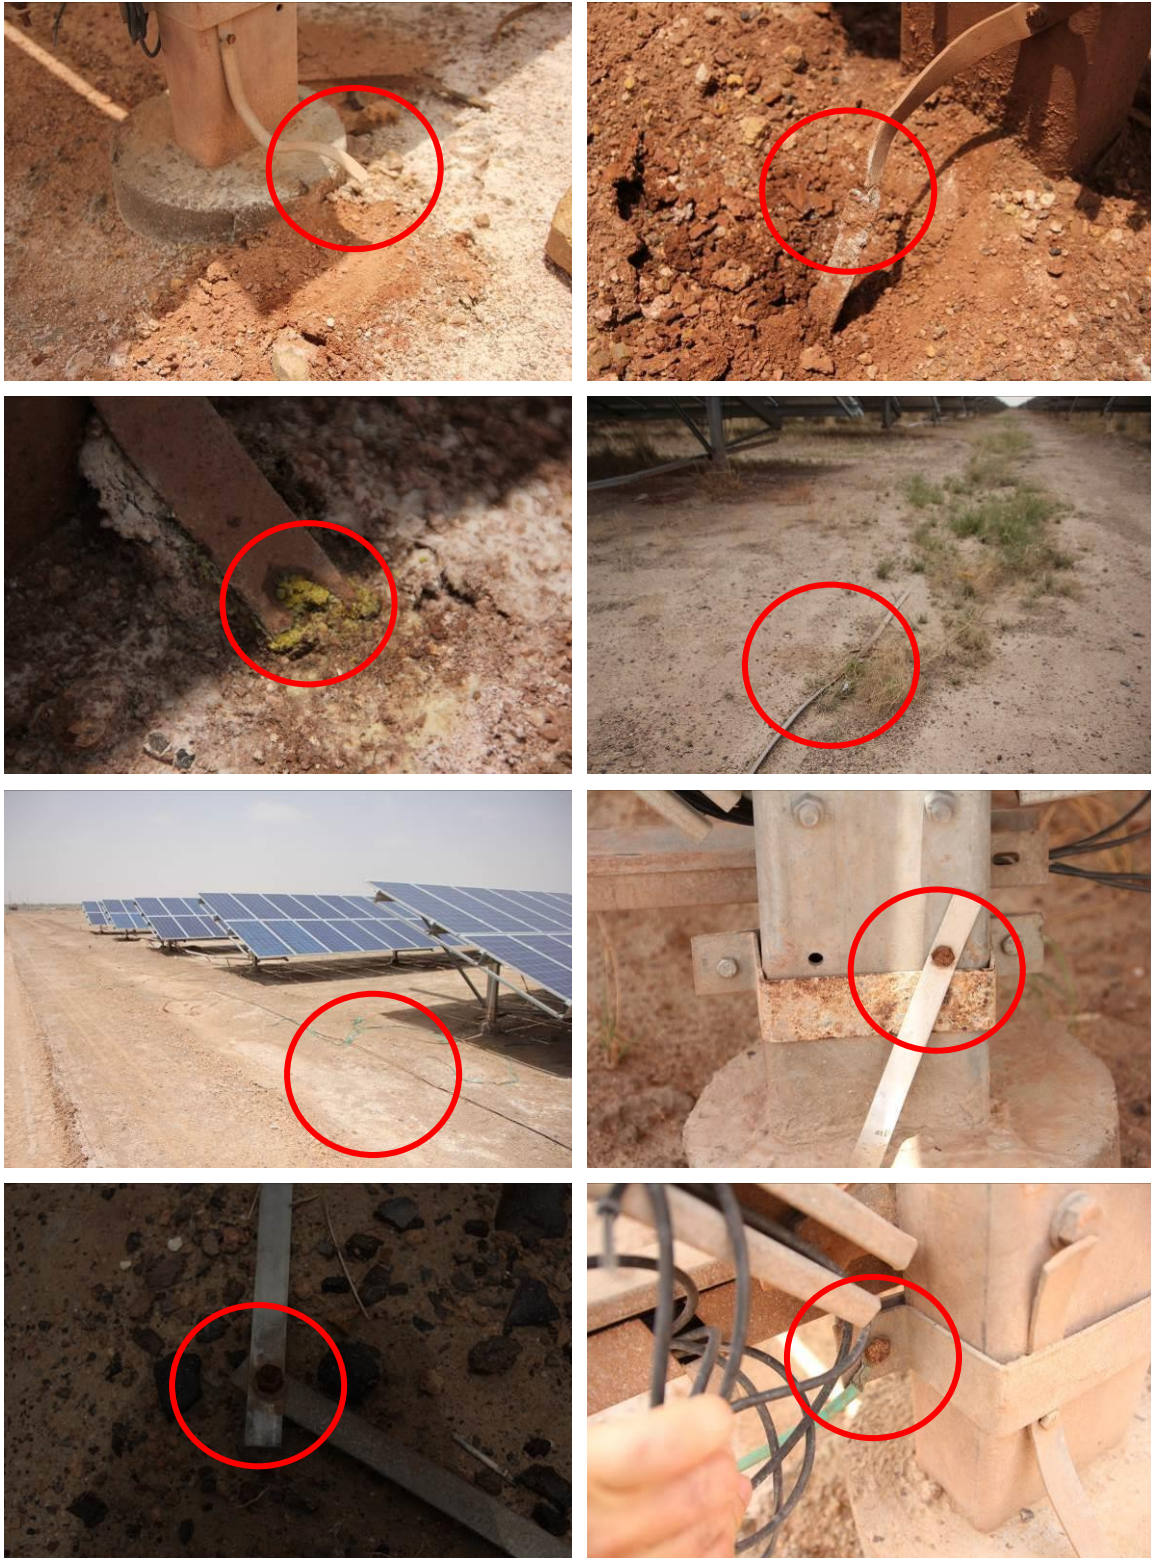
The equipotential bonding system connects all conductive parts of the PV plant as the mounting structure, module frames or housings. The equipotential bonding conductor is heavily damaged by the corrosion of the ground and is not properly buried. In terms of Potential Induced Degradation (PID) avoidance, no measures have been taken, such as functional grounding of the negative pole. The PV plant does not show signs of PID.

Figure 73: Heavily damaged equipotential bonding system due to corrosion

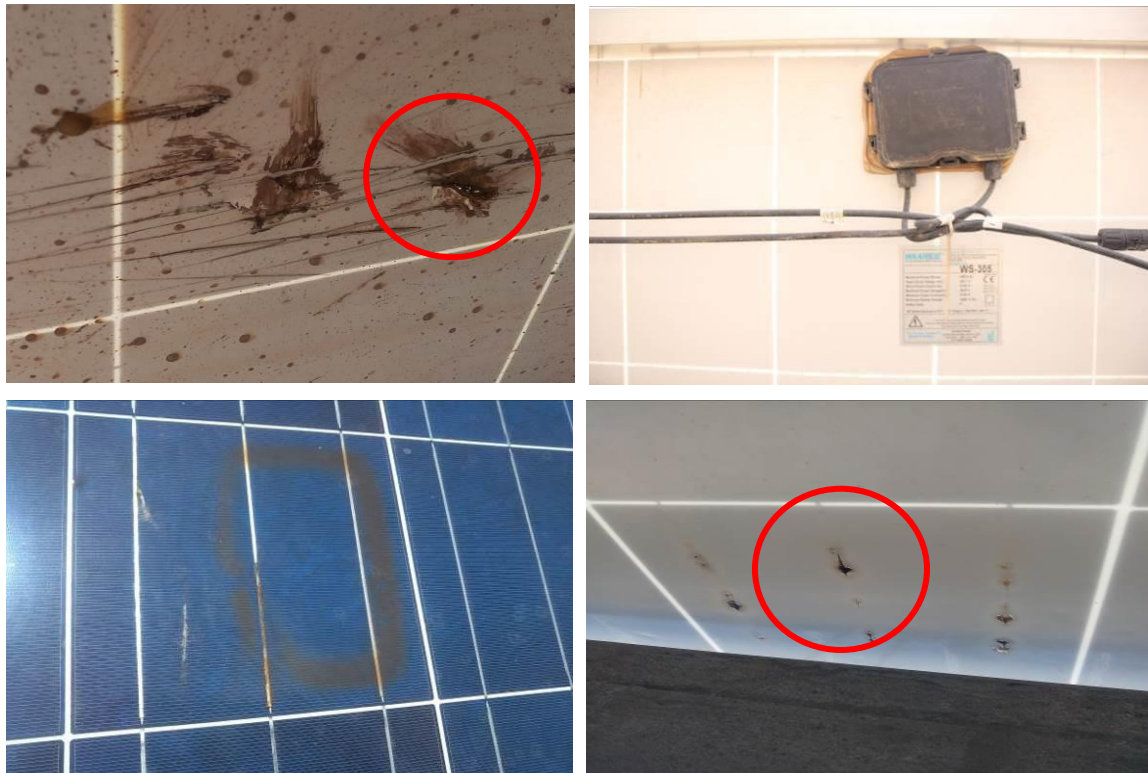
The visual inspection on the modules showed clear signs of snail trails and evidences of burned cells. Some modules showed backsheet fully covered with mud while others were scratched pointing towards an improper module handling. In some sporadic cases, the junction box is not properly aligned with the module frame. Footprints were detected on the module surface in some areas of the plant. According to the Owner the flash lists of the PV modules are available, however these were not shared with PI Berlin.

Figure 75: (top left) Scratched module backsheet; (top right) J-box misaligned; (bottom left) Burned cell front; (bottom right) Burned cell

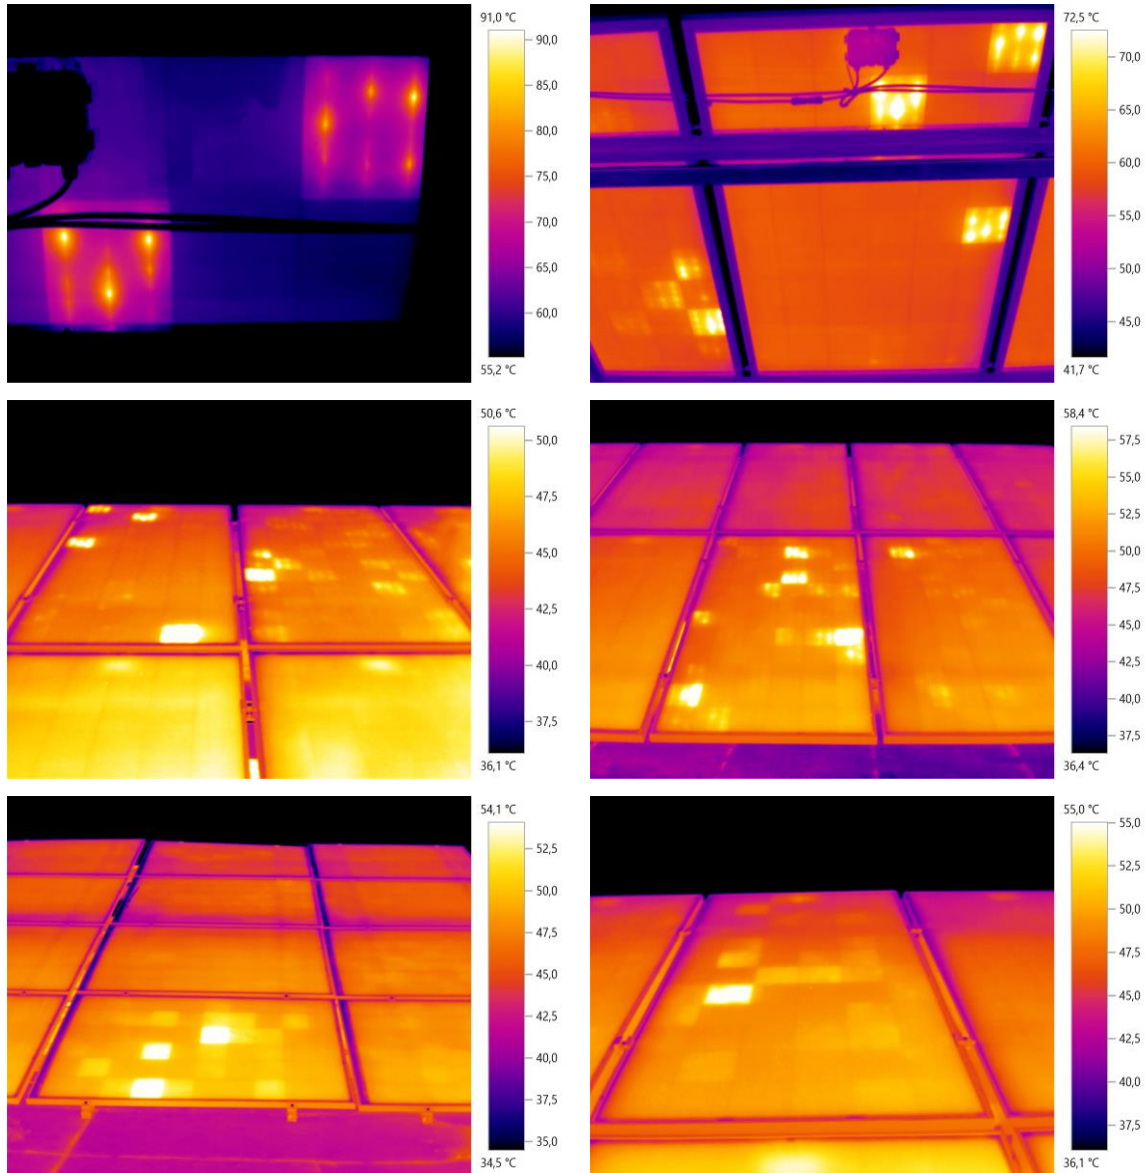
The infrared inspection showed clear evidences of soldering problems. Additionally, the cell and module cracks evidenced by the snail trails, are also visible on infrared basis as hot spots.

Figure 78: PV modules affected by bad soldering

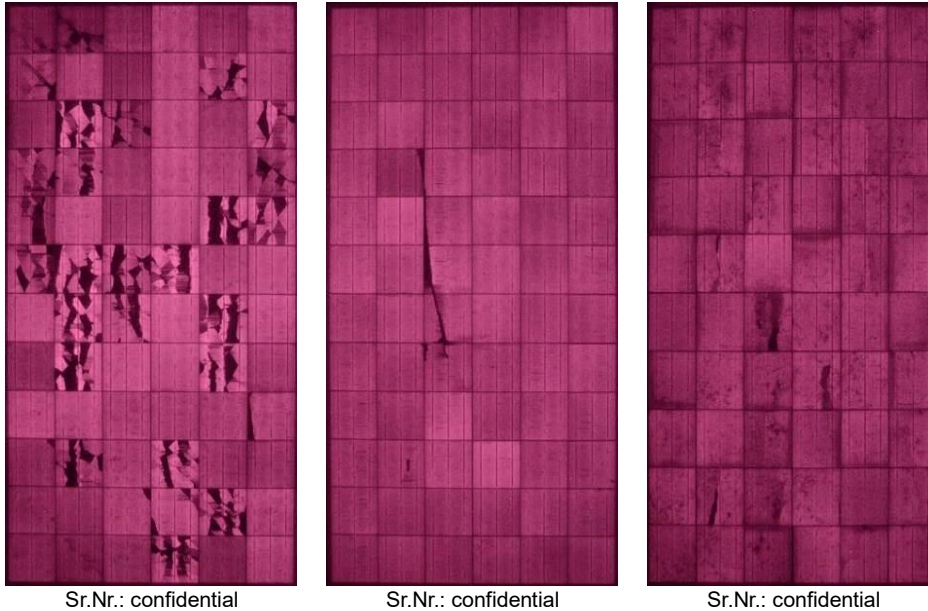
The electroluminescence analysis on a selected amount of PV modules confirmed the presence of cell cracks and shunts caused by an inaccurate soldering process of the ribbon to the busbars¹⁸.

Figure 79: PV Modules affected by cracks

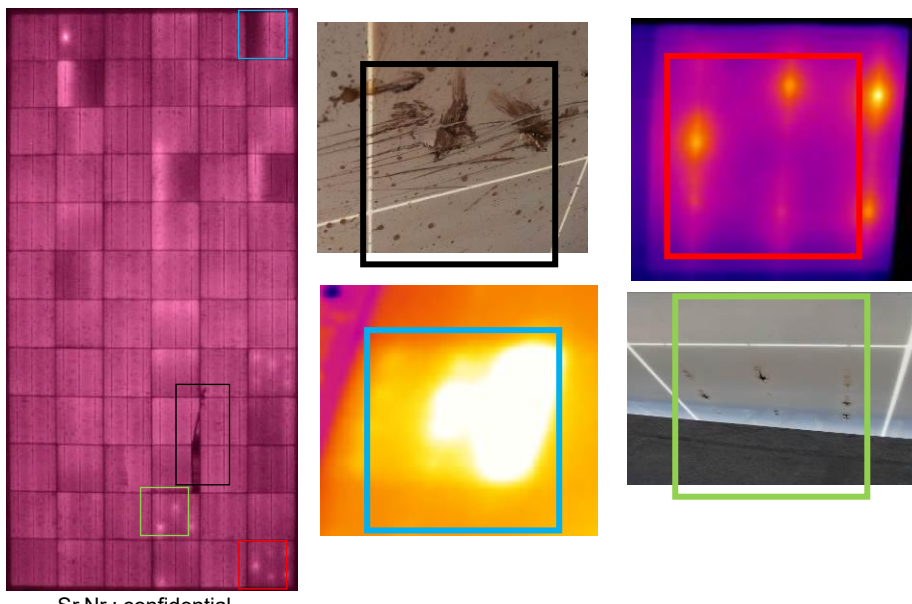
Figure 80: (Black) Damaged cells due to backsheet scratches; (blue) Inhomogeneous current flow due to bad soldering; (red) Shunts due to bad soldering; (green) Hotspots due to bad soldering

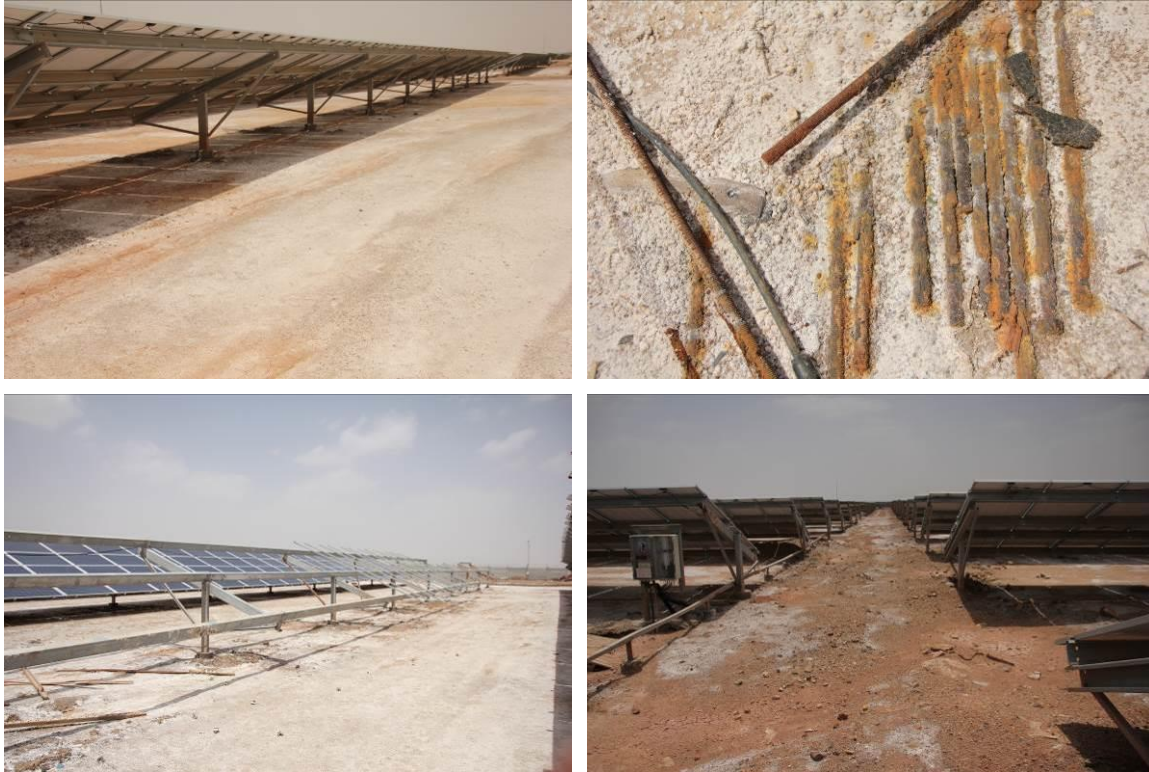
The most relevant environmental phenomena reported onsite are: sandstorms, highly corrosive environment due to salt presence, strong winds and difficulties with water drainage. The O&M plan does not include specific actions to mitigate the effects of the abovementioned phenomena.

Figure 81: (top and bottom right) Salt presence onsite; (bottom left) Removed modules due to strong winds

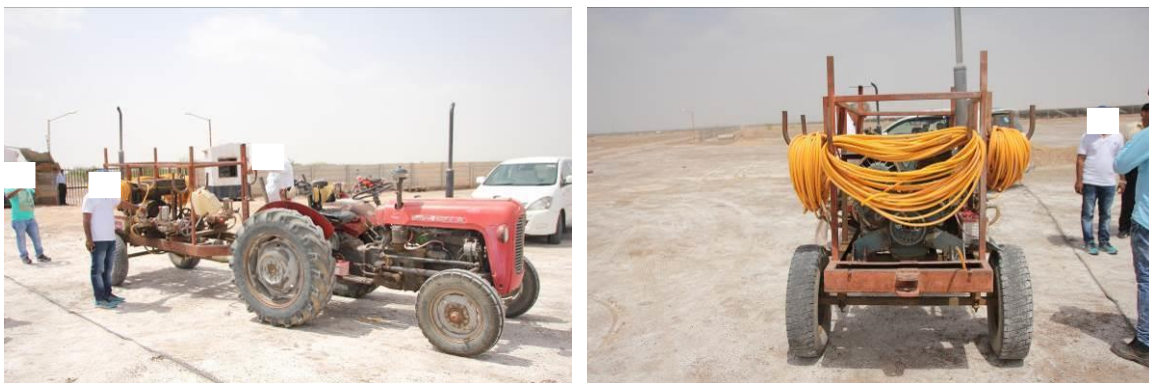
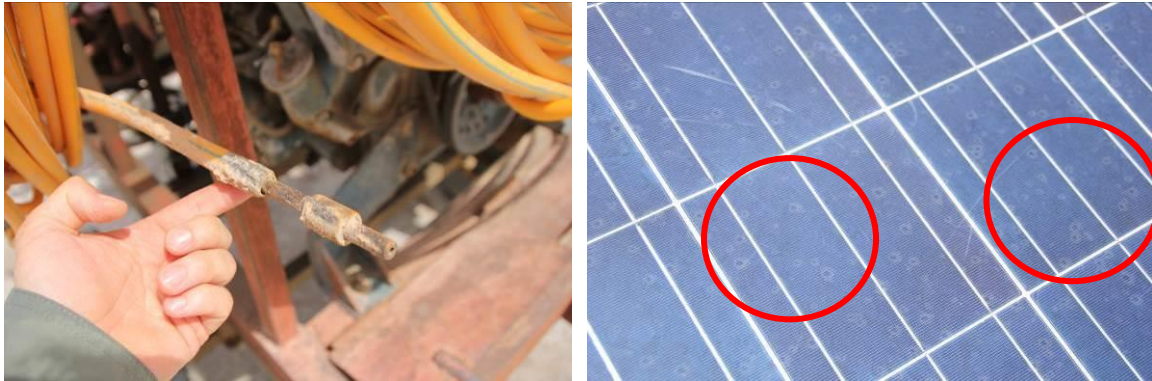
According to the Owner and Operator, the module cleaning is performed 2 times a month using cotton wipers and underground water stored at 5kg/cm². The impact of the selected cleaning methodology on the module warranty was not analysed by the Owner and Operator. 2 persons are involved in the cleaning. No soiling losses are measured onsite and the cleaning campaign is started after conducting only a visual analysis of the PV module surface. It could be observed that the remaining water drops on the module surface attract dust and dirt particles.

Figure 82: (top and bottom left) Module cleaning system; (bottom left) Dust and soil attracted by water drops

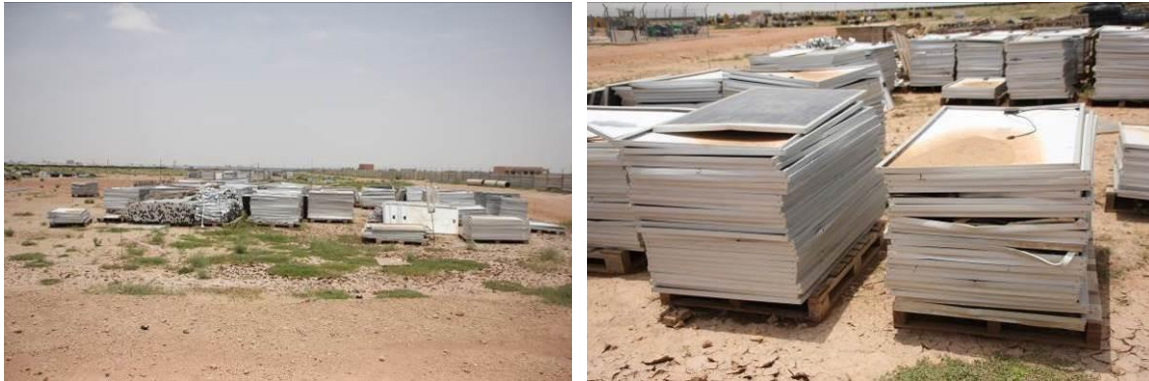
No static calculations were shared with PI Berlin, hence the structural integrity of the mounting structure couldn't be proven. The mounting structures have been designed for a maximum wind speed of 47 m/s. However, the module fixation doesn't withstand the wind loads registered onsite.

Figure 86: PV modules damaged by strong winds

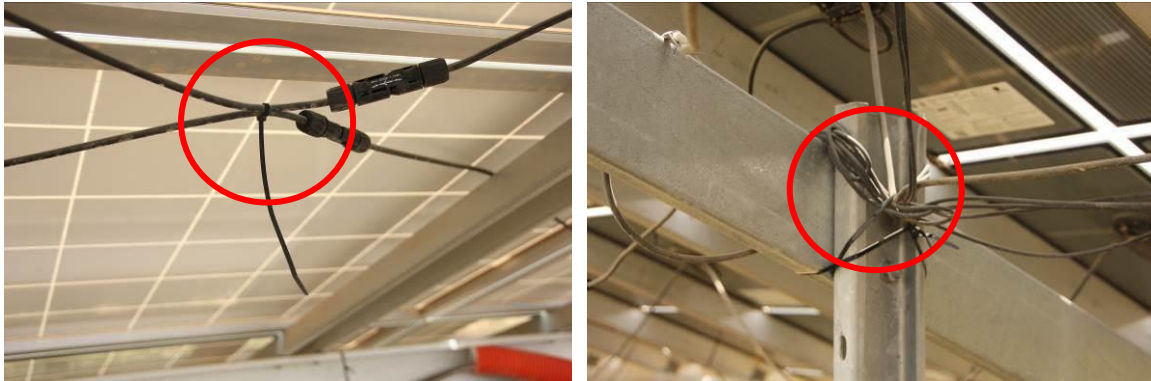
- i. Cable damage: The cables do not show damages caused by external agents. However, some cables are in contact with sharp edges of the metallic cable trays, thus, an erosion of the cable shield can't be excluded in the midterm.

Figure 95: Improper cable fixation

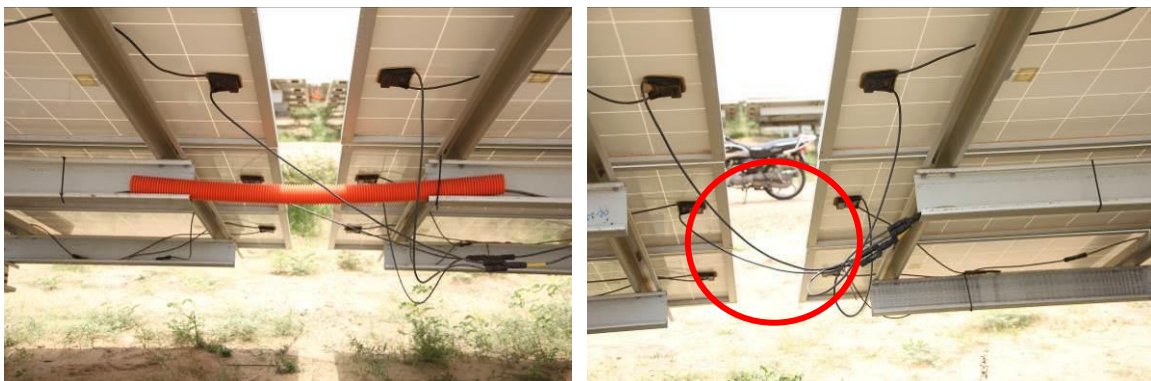
- v. Bending radius: In general, the minimum bending radius of the cables was respected.
- vi. Protection against UV: In general the DC cables are protected from UV exposure by using pipes. In some cases however, the protection between module tables is missing.

Figure 96: (left) String cables protected from UV; (right) Missing UV protection

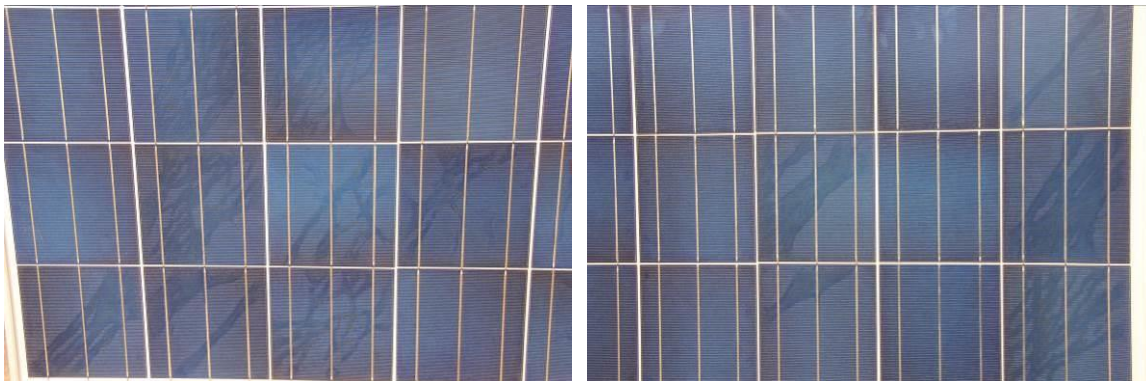
Figure 106: PV modules showing snail trails

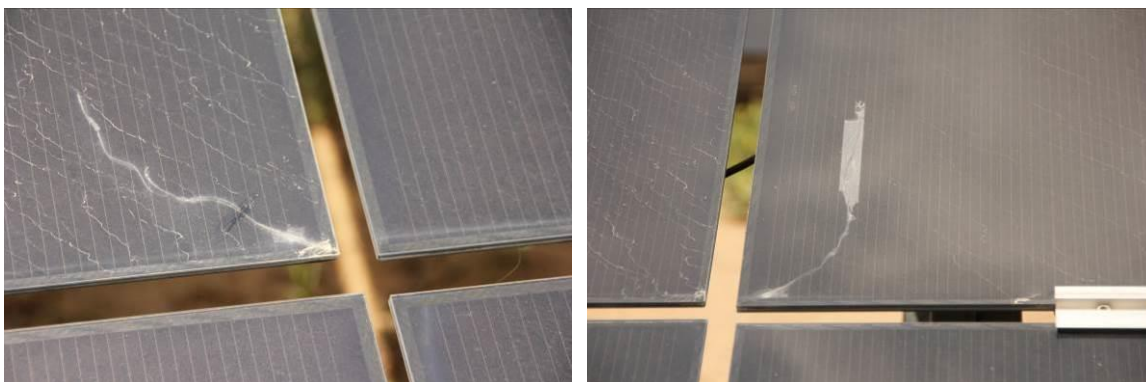
Figure 107: PV modules affected by corrosion

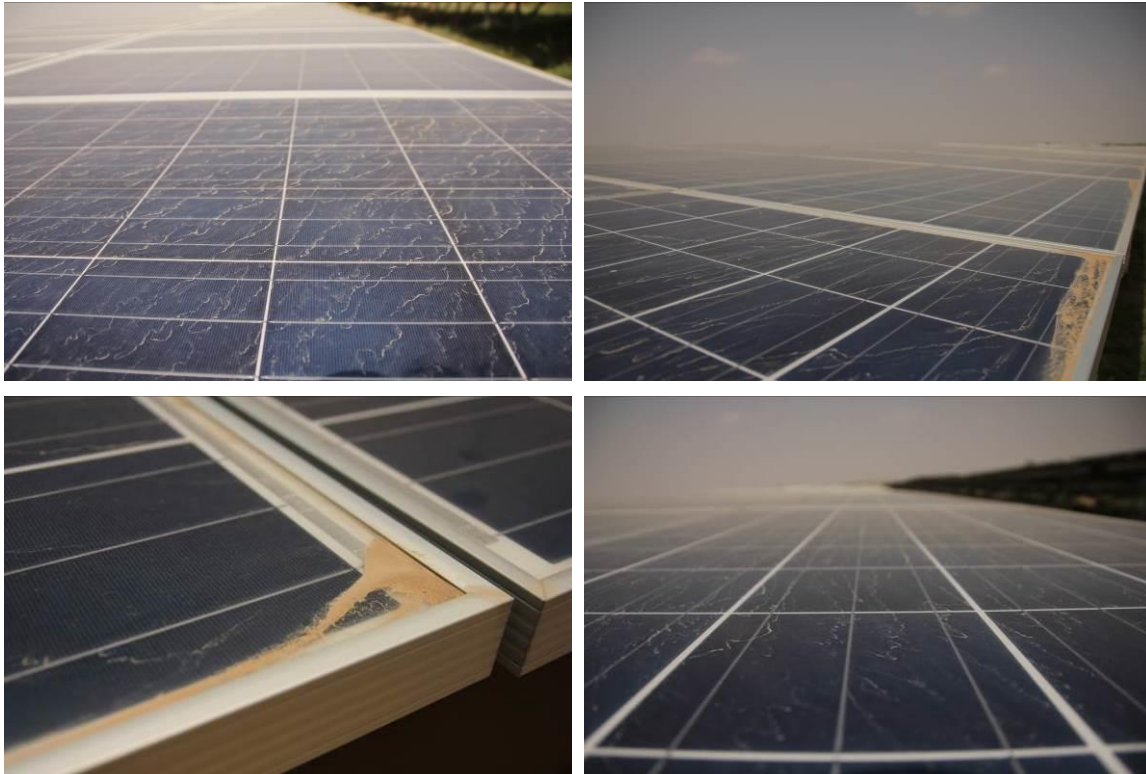
Figure 115: Dust accumulated on the remaining water after the cleaning process
