Pilot Study on Quality Aspects of PV Power Plants in India

Conducted in the framework of the Indo-German cooperation project
“Strengthening Quality Infrastructure for the Solar Industry”

by PI Photovoltaik-Institut Berlin AG

First published: September 2017

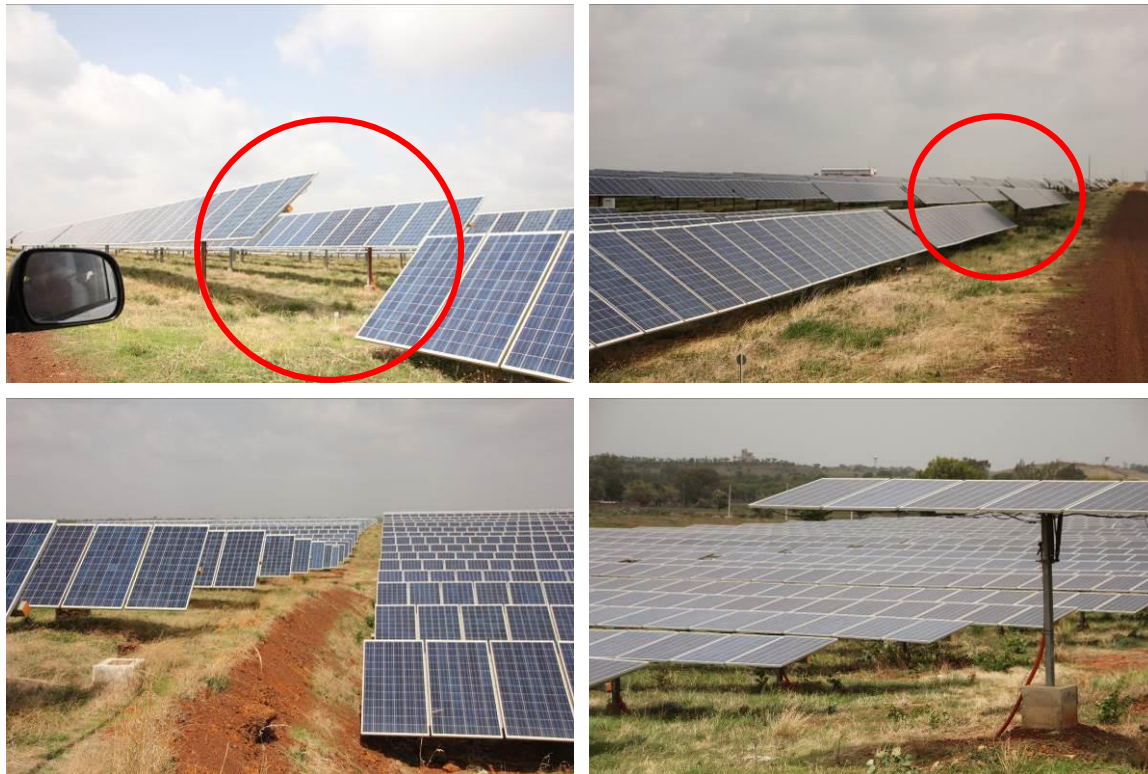
Figure 120: Height difference between the tracker units

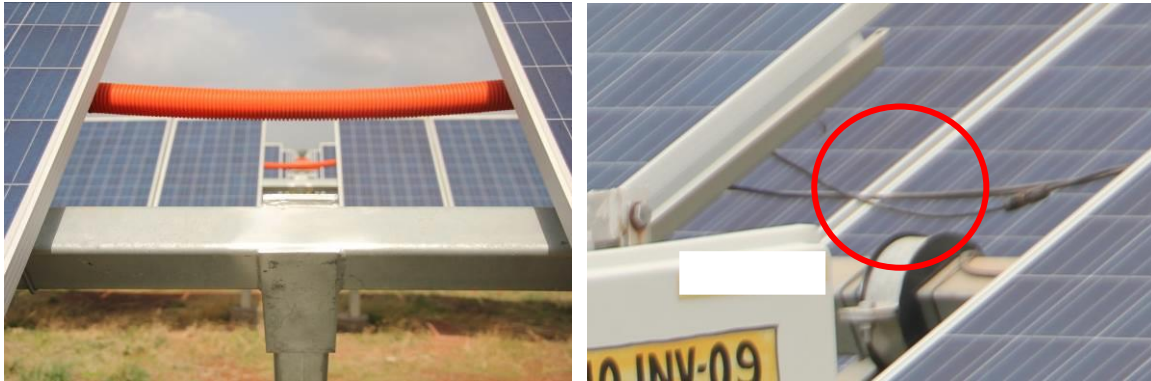
Figure 135: (left) UV protection of the string cables; (right) Missing UV protection of the string cables

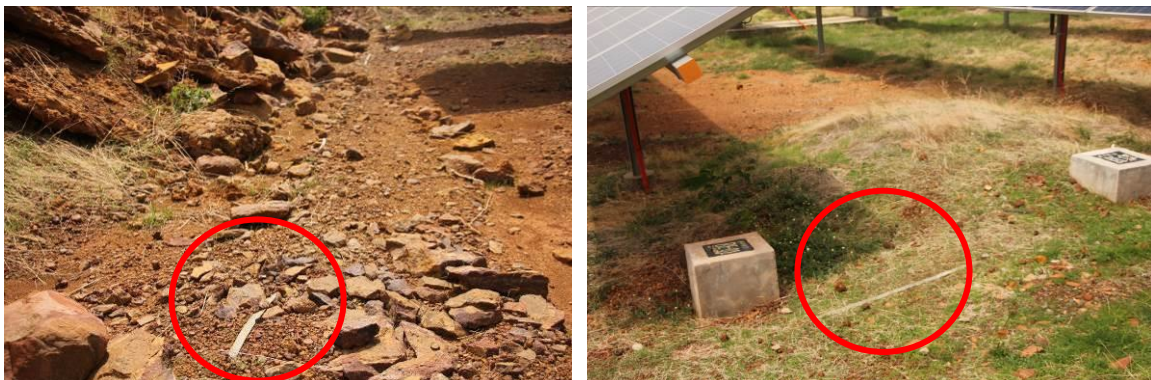
Figure 140: Equipotential bonding conductor not buried

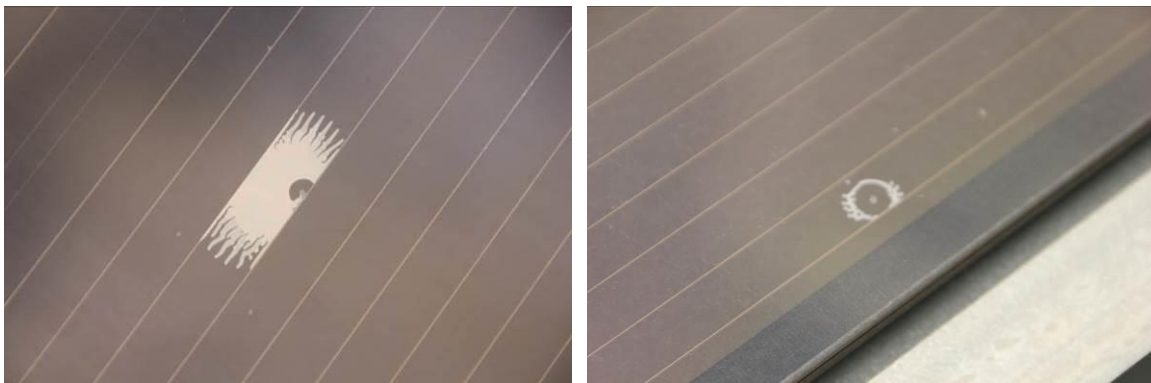
Figure 145: PV modules showing shunts

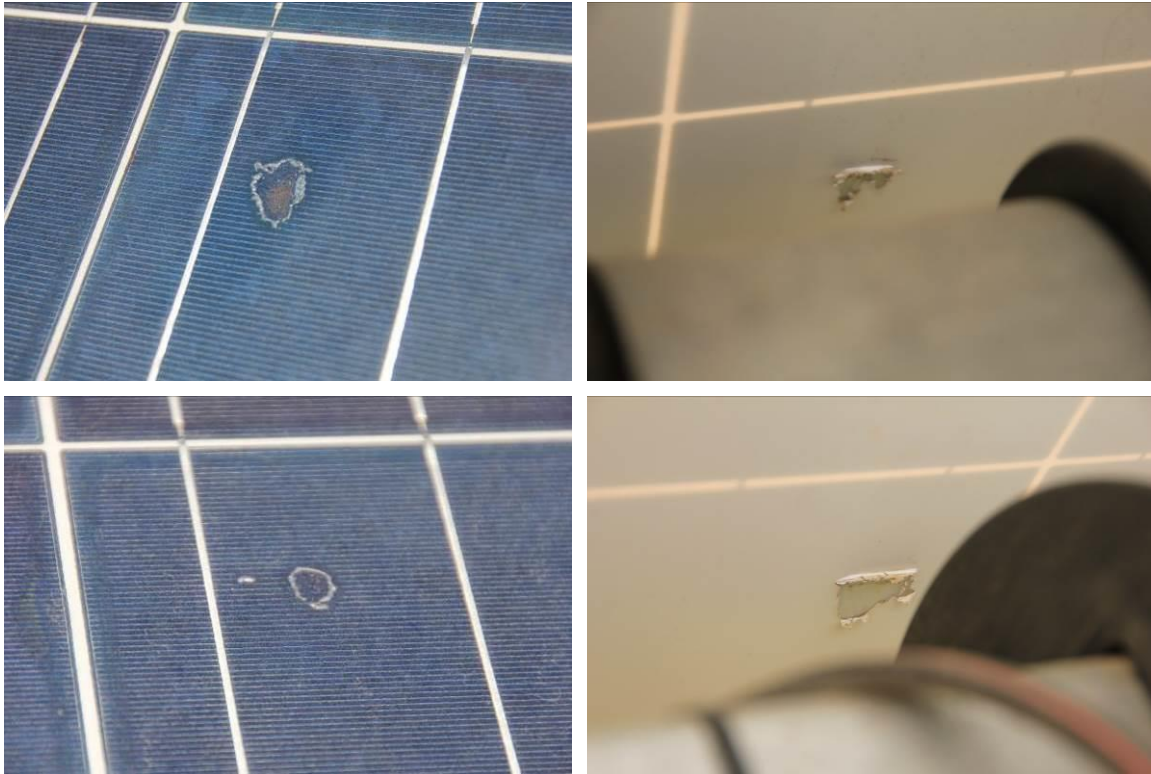
Figure 146: PV modules damaged by the dampers

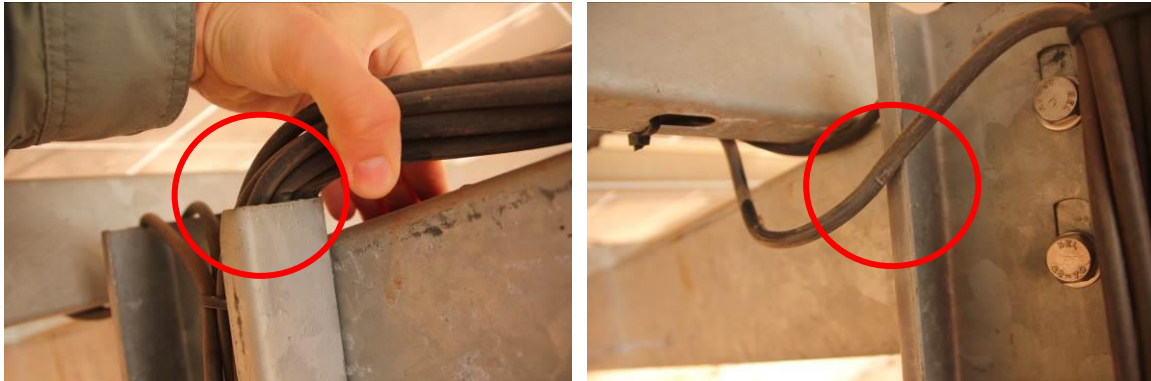
Figure 158: String cables in contact with sharp edges

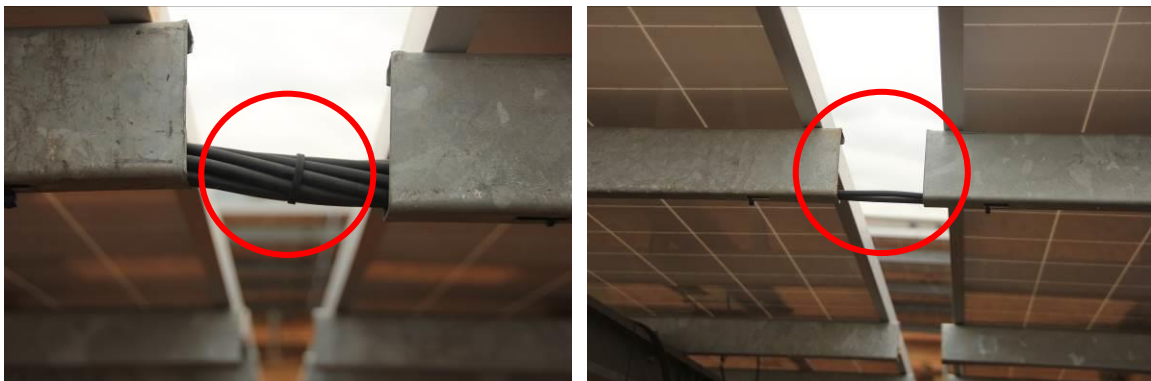
Figure 160: Missing UV protection of the string cables

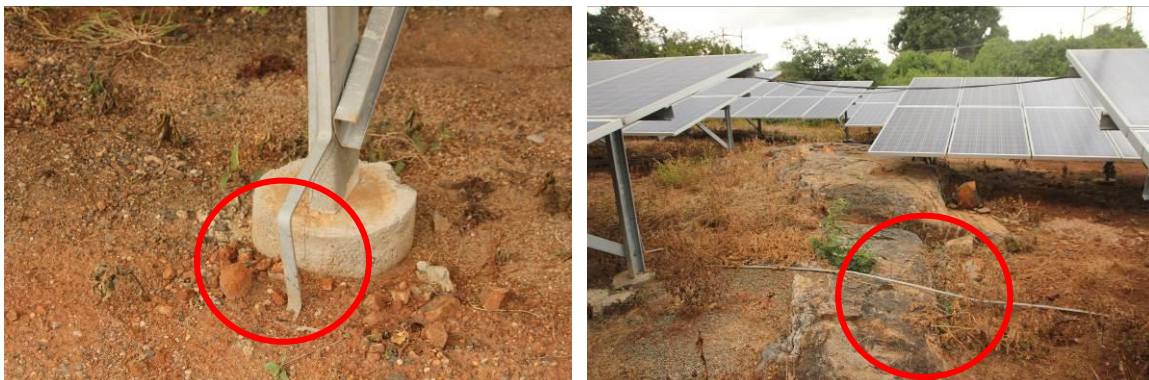
Figure 163: (left) Equipotential bonding conductor; (right) Not buried equipotential bonding conductor

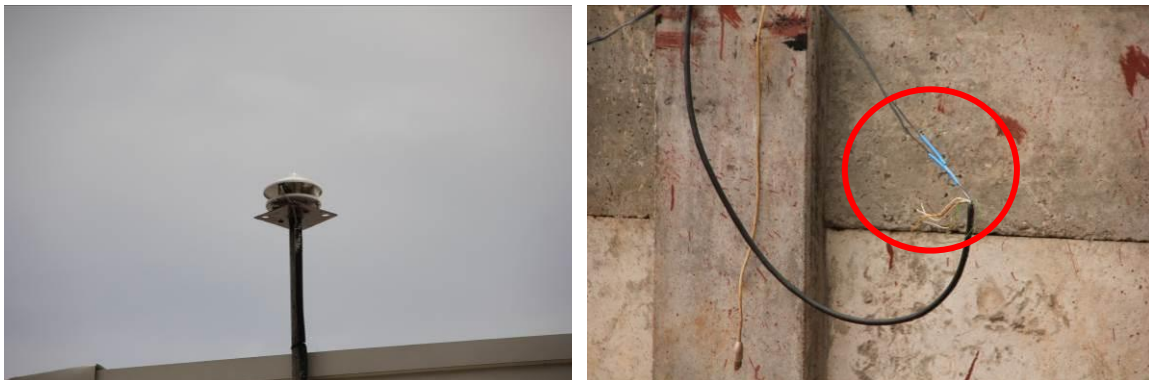
Figure 166: (left) Pyranometer on the horizontal surface; (right) Damaged communication cable

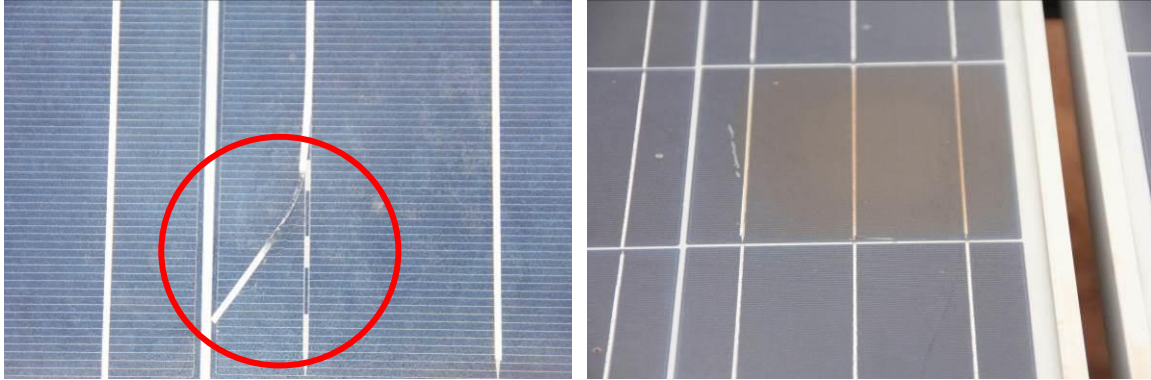
Figure 167: (left) Detached ribbon; (right) Burned cell

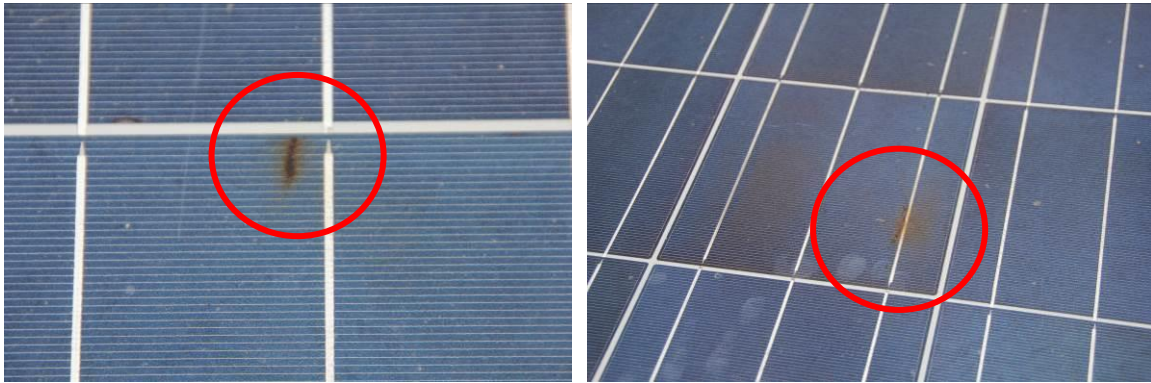
Figure 168: Hot spots
