HOW MICRO HYDRO POWER SYSTEMS IMPLEMENTED DURING ENDEV I ARE PERFORMING

EVALUATION OF A MONITORING SURVEY OF 20 MHP
SYSTEMS.

November 2010

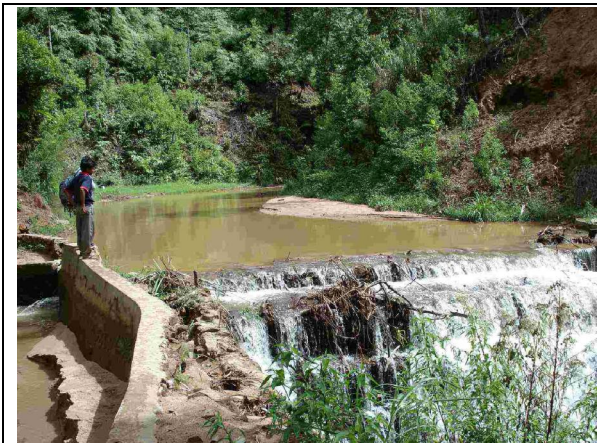
Photo 1: Weir in Minangga in Nov 07

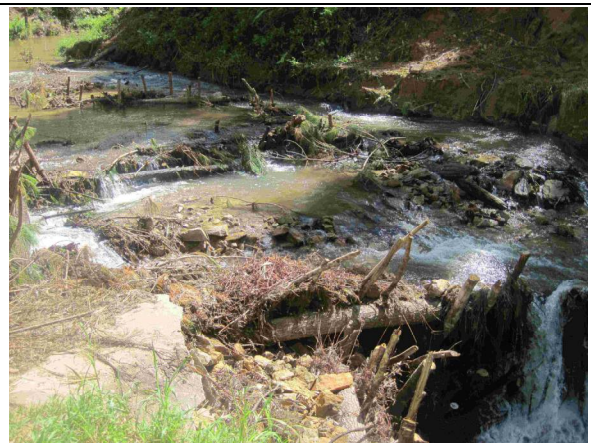
Photo 2: Same weir in Oct 10

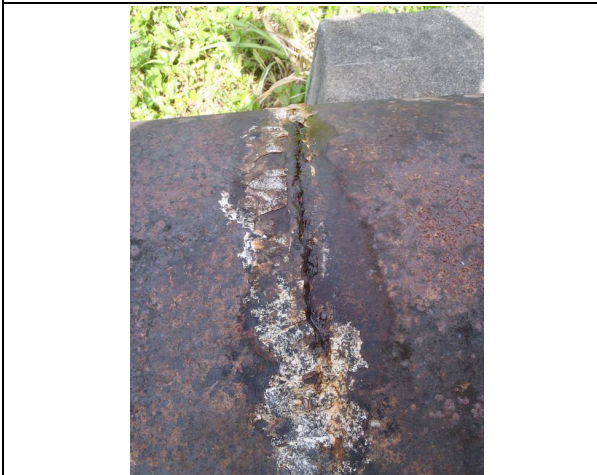
The “bad” scores for penstocks were given in cases where corrosion (see photo 3 below) or even leakages were visible or where the strength of the thrust block was not sufficient. The “bad” score for “turbine & other mechanical equipment” was given for the turbine in Wonorejo, which can not be closed anymore (problem with guide vane, see photo 4 below).

Photo 3: Corrosion at penstock in Wonorejo, Oct 10

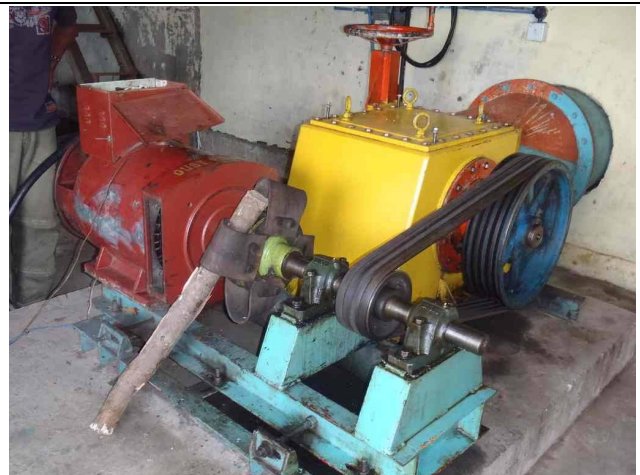
Photo 4: Turbine Wonorejo, wooden stick to keep system stopped, Oct 10

“Bad” score for electrical components was awarded for Satanetean were the electric load control is not functioning, for Wonorejo where no ELC is installed and high frequency fluctuations happen and in Sungai Kalu where the voltage is as low as 160 V (frequency meter not working, manual control). Several smaller MHP systems in Sulawesi work properly with **manual control**, however bigger systems with more consumers, who often switch on

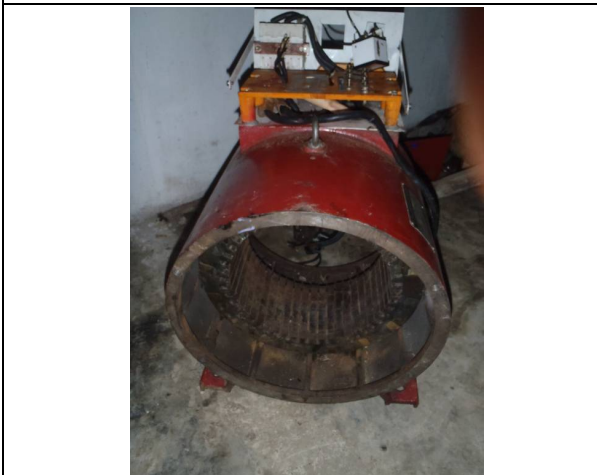
Photo 5: Old broken generator in Jorong Karang Putih, Oct 10

and off their appliances, experience difficulties when being controlled manually. This might also be the reason for the fact that in some cases generators had to be replaced even before reaching the end of their service life (see photo 5 above, Jorong Karang Putih).

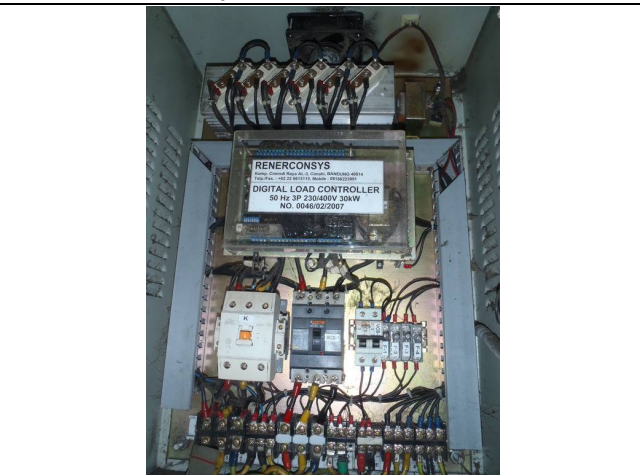
Photo 6: Properly operating ELC in Sapan Salak, Oct 10

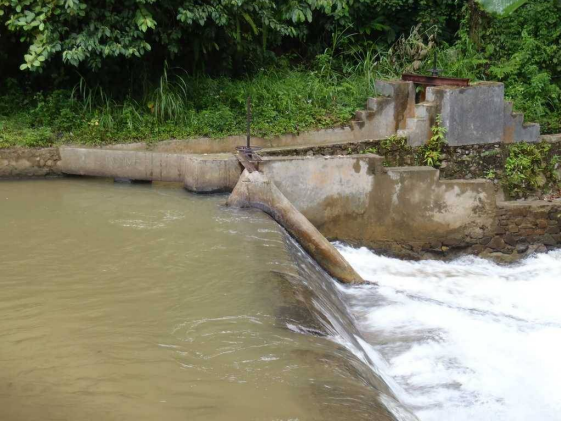
<p>Photo 11: Weir with intake in Sapan Salak, Oct 10</p>	<p>Photo 12: Temporary, instable weir in Wonorejo, Oct 10</p>

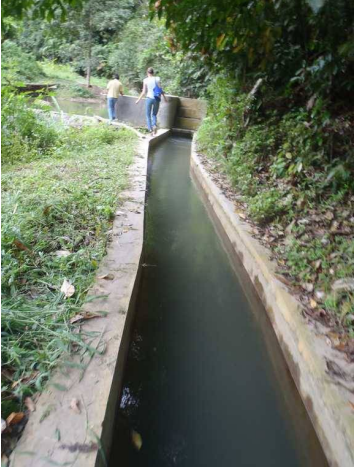
<p>Photo 13: Channel in Sapan Salak, Oct 10</p>	<p>Photo 14: Instable earth channel in Satanetean, Oct 10</p>

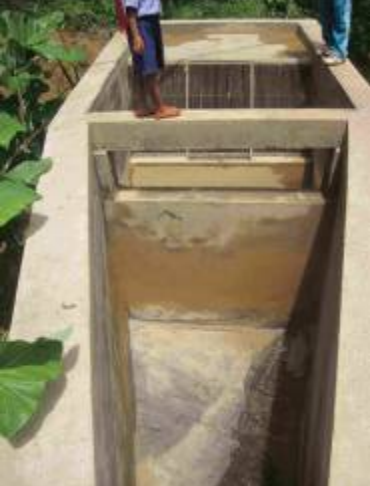
<p>Photo 15: Clean forebay in Rante Puang, Oct 10</p>	<p>Photo 16: Forebay with inappropriate trashrack in Kampung nan Limo, Oct 10</p>

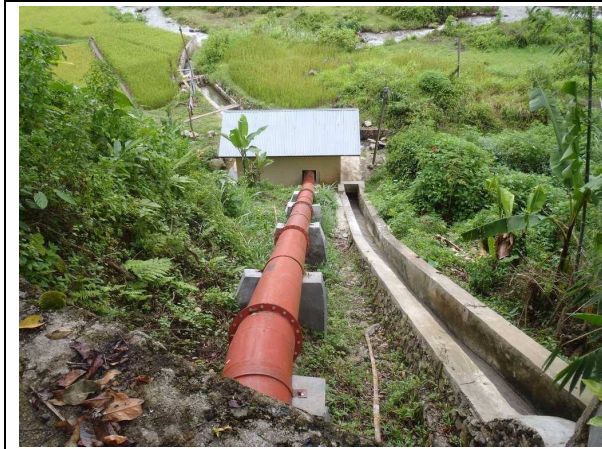
Photo 17: Penstock in Limau Limau, Oct 10

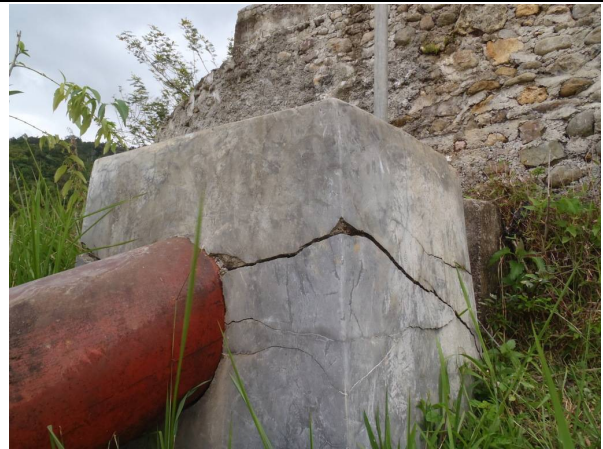
Photo 18: Anchor block broken due to earthquake, Sungai Kalu Oct 10

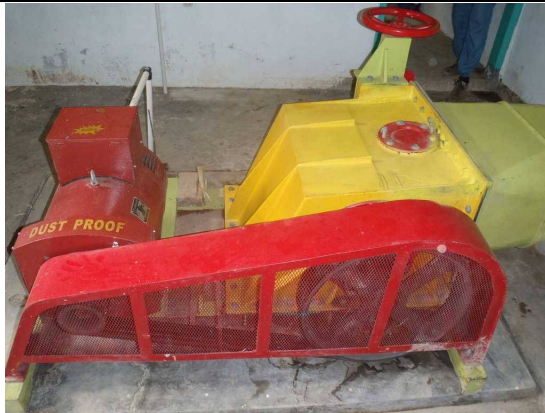
Photo 19: Properly operating turbine with generator and protection on belt, Oct 20

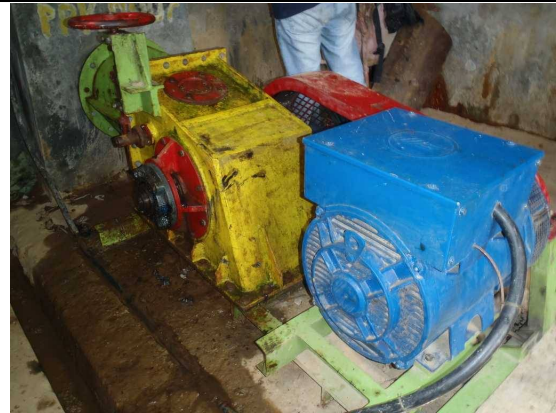
Photo 20: Turbine with leakage and too much grease in Sungai Kalu, Oct 10

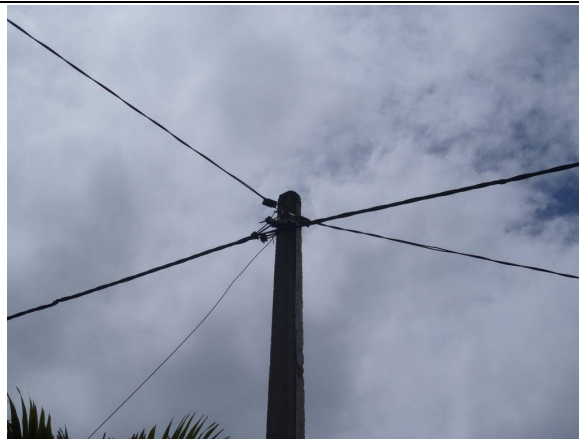
Photo 21: Concrete pole with well fixed cables in Sungai Kalu, Oct 10

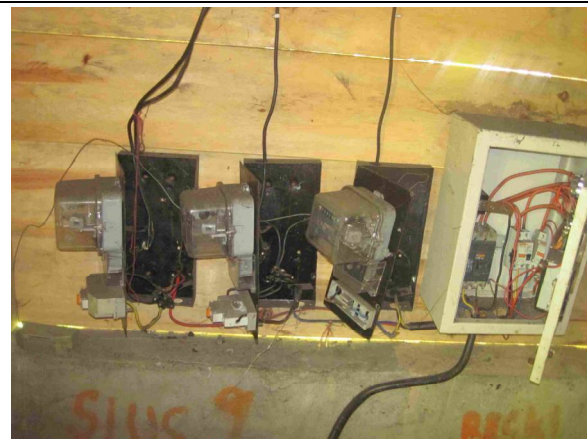
Photo 22: Not well maintained electrical installations in powerhouse in Minangga, Oct 10

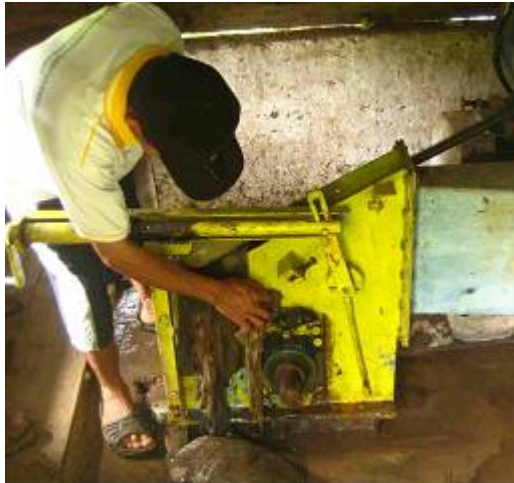
turbine from Endev I phase

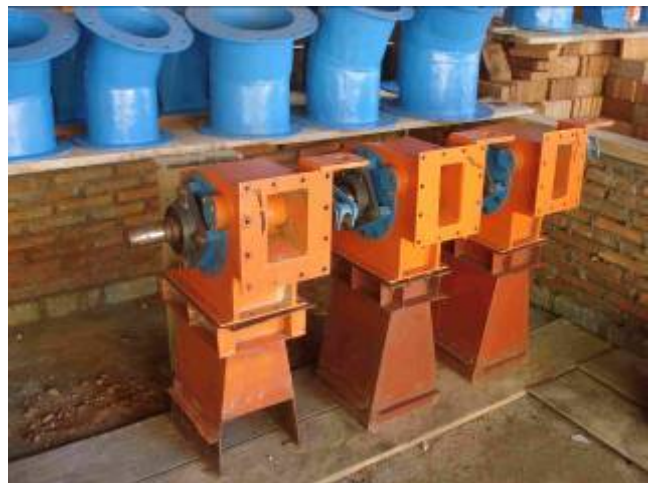
turbines of the same manufacturer, today

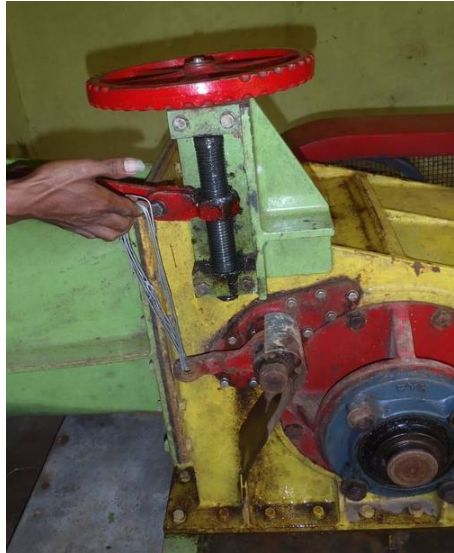
Turbine manufacturers in Sumatra would definitely also benefit from trainings on certain technical details:
