Pilot Study on Quality Aspects of PV Power Plants in India

Conducted in the framework of the Indo-German cooperation project
“Strengthening Quality Infrastructure for the Solar Industry”

by PI Photovoltaik-Institut Berlin AG

First published: September 2017

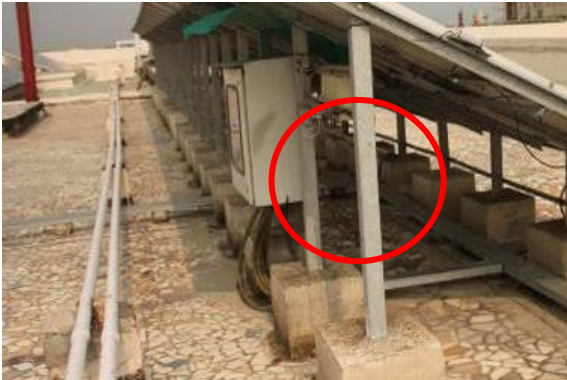
- ii. Labelling of rows: No labelling of module rows could be observed.

Figure 22: Missing labelling of the module rows

3.1.2	No row labelling	The missing row labelling makes the correct identification of the various areas of the plant more difficult leading to increased reaction times during corrective maintenance.

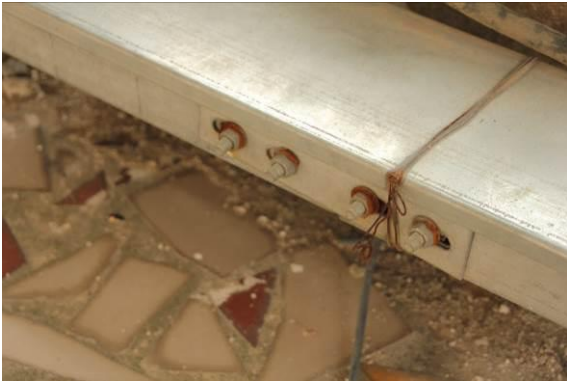
- iii. Rust on the mounting structure surface: Rust is present in many parts of the mounting structure after 18 months of outdoor exposure. Some areas of the plant show advanced levels of rust. No aluminium has been used, all parts are made of steel.

Figure 23: Presence of rust in the mounting structure

3.1.3	Rust on the mounting structure components	The rust can lead to a reduction of the structural strength of the mounting structure, especially in combination with strong wind.

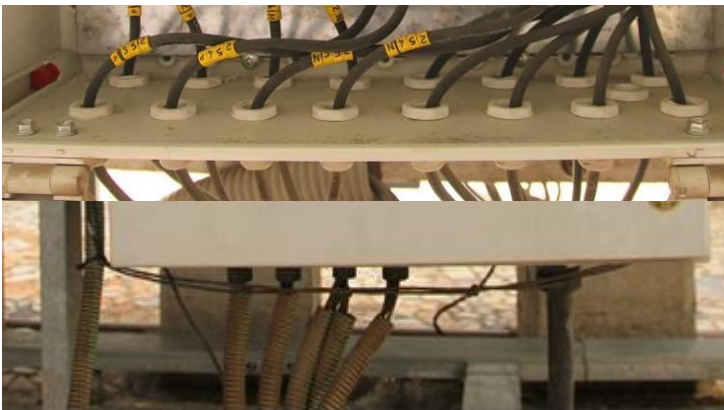
- i. Sealing of the cable glands: The cable glands are properly sealed both in the DC and AC combiner boxes.

Figure 24: Cable glands of the combiner box

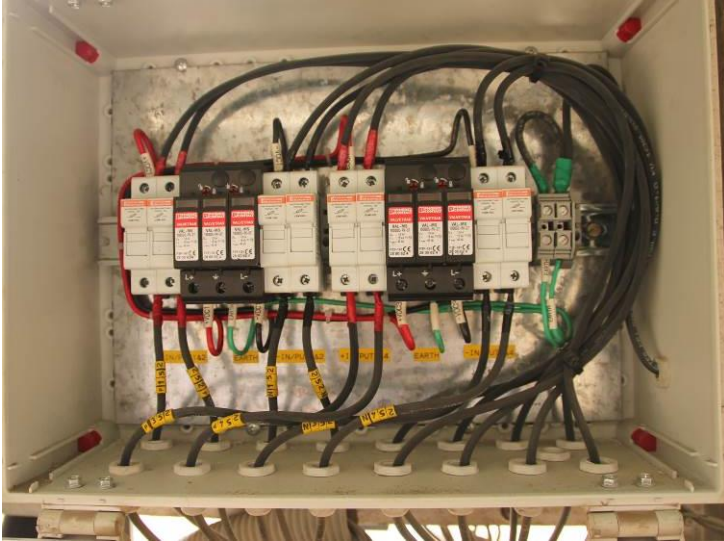
- iii. Overvoltage in the CB: An overvoltage protection is present in the DC combiner boxes.

Figure 26: View of the combiner box hardware

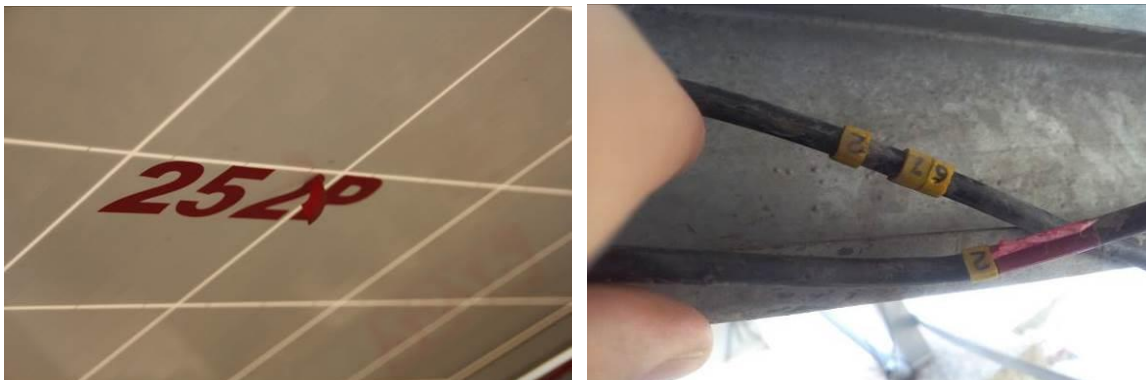
- ii. Labelling of cables: Each module string is labelled. The positive and negative poles are also labelled. In both cases the used tags do not seem to be durable for the whole lifetime of the project.

Figure 30: Non-durable string cable labelling

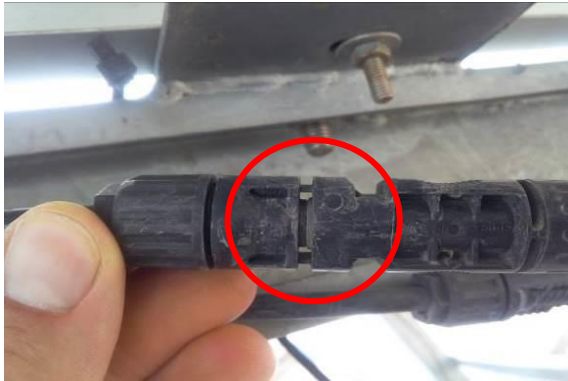
- iii. Connectors: The connectors are in general in a good shape. Some of them were not properly closed and screwed.

Figure 31: PV module connectors not properly closed

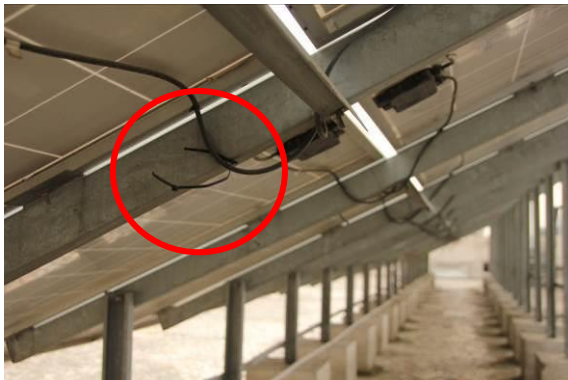
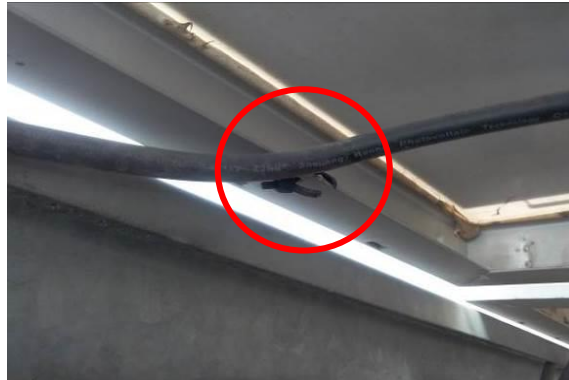
- iv. Cable fixation: The cables ties used for the cable fixation are not suitable for outdoor exposure and start falling apart.

Figure 32: String cables not properly fixed due to degraded cable ties

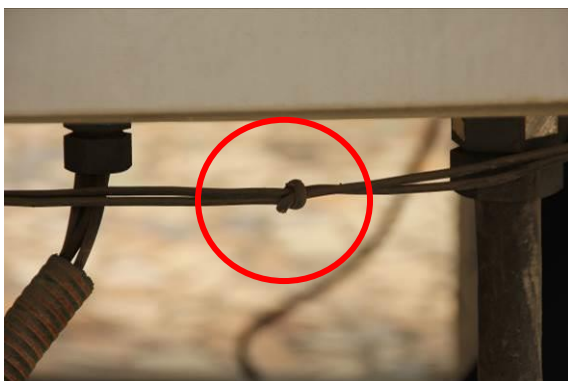
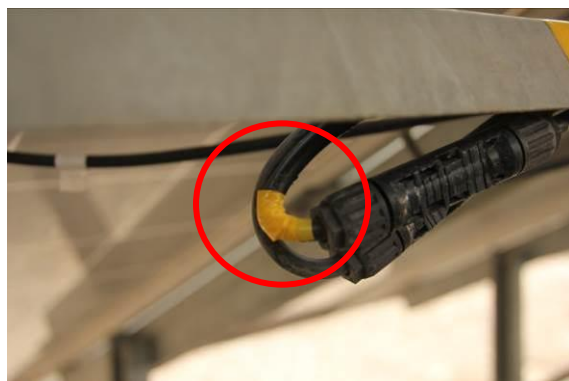
- v. Bending radius: In general, the minimum bending radius has been respected. In some sporadic cases the manufacturer's requirements are not fulfilled.

Figure 33: Low bending radius in the string cables

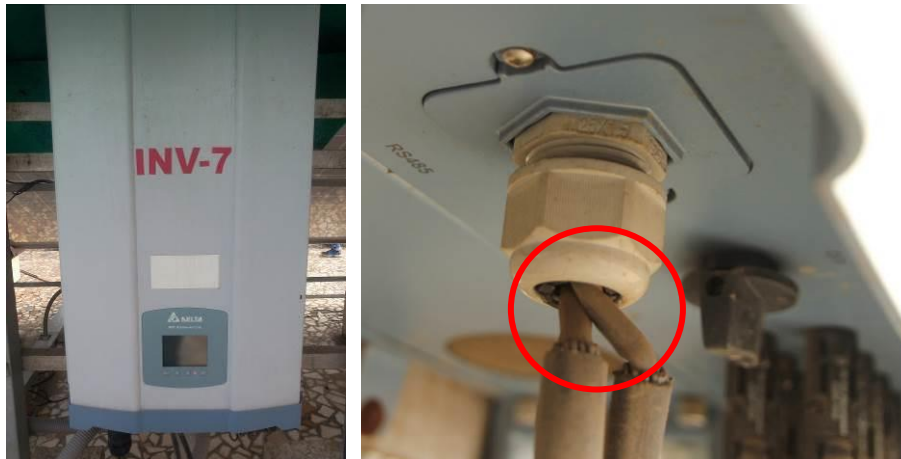
The inverters have an overvoltage protection both on the DC and AC side as well as a DC switch. The cooling of the inverter is ensured with active fans and the inverter filters are clean. The housing is grounded and the IP 65 is ensured. The inverters could not be opened due to warranty aspects, hence no information about the cleanliness of the inverter inside can be provided. The cable size of the RS 485 communication cable exceeds the maximum size of the gland diameter. This has led to an improvised solution where the shield had to be removed letting the interface between cable and gland unprotected. All inverters are protected from the sun.

Figure 36: (left) String inverter; (right) Unprotected interface between communication cables and inverter housing

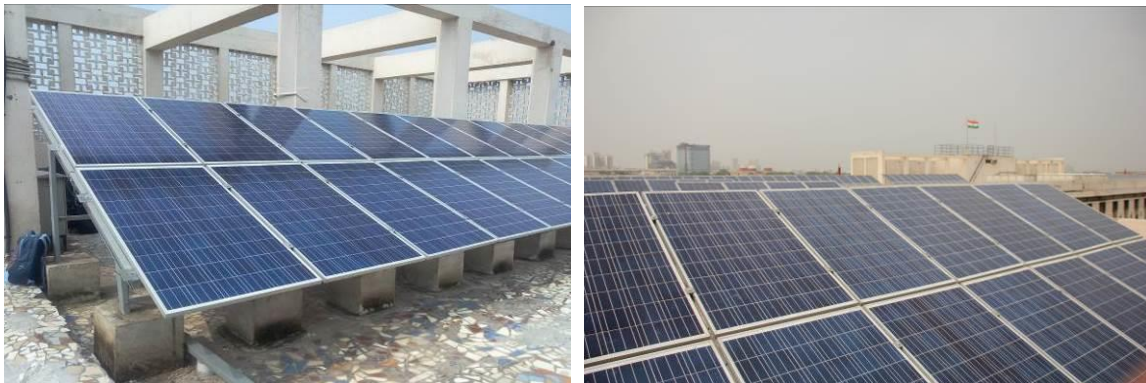
The visual inspection on the modules did not show major defects affecting the quality of the BOM, the system performance or the safety of persons, animals and goods. No scratches of the backsheet were detected. No snail trails were detected on site.

Figure 39: PV modules installed onsite

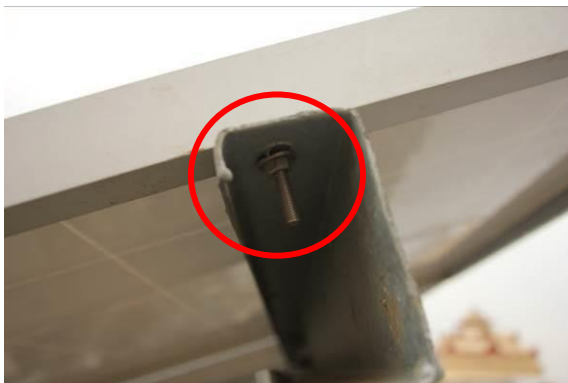
- Module fixation: The modules are fixed to galvanize steel U-profiles using screws and nuts. This system does not always ensure a proper fixation.

Figure 41: Loose fixation of the PV modules to the cross beam

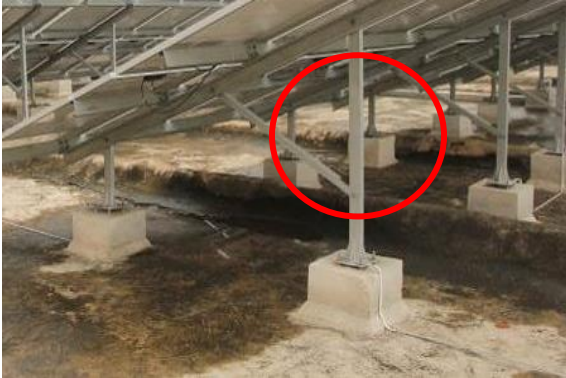
- ii. Labelling of rows: No labelling of module rows could be observed.

Figure 42: Missing labelling of the module rows

3.1.2	No row labelling	The missing row labelling makes the correct identification of the various areas of the plant more difficult leading to increased reaction times during corrective maintenance.

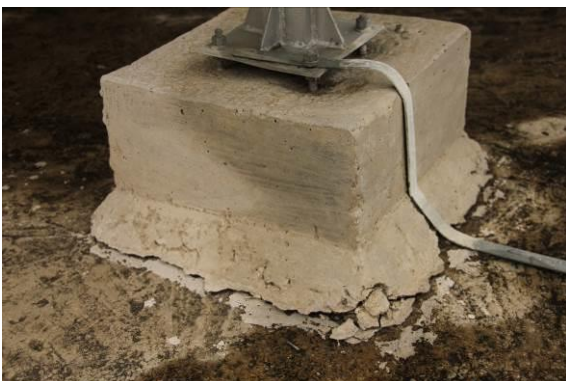
- iv. Foundation: The foundation of the mounting structure does not seem to be durable for the whole lifetime of the project.

Figure 44: Improper anchorage of the mounting structure foundation to the roof top surface

3.1.3	Weak foundation, no solid anchorage	The foundation loses adherence to the roof top surface which affects the structural strength of the mounting structure.

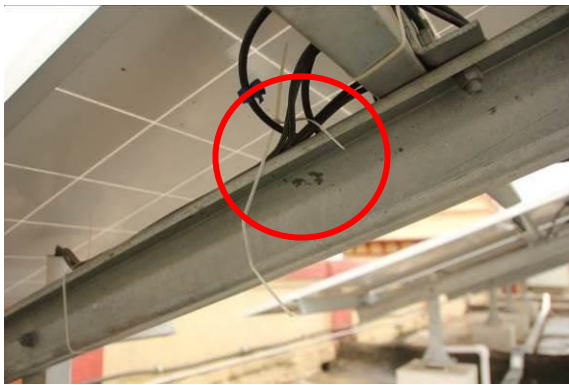
- iii. Connectors: The connectors are in general in a good shape.
- iv. Cable fixation: The cables ties used for the cable fixation are not suitable for outdoor exposure and start falling apart.

Figure 46: Improper fixing of the string cables to the mounting structure

3.3.2	Poor cable fixation	Hanging cables due to non-durable cable ties are more exposed to mechanical damage caused by the wind and the friction against other components such as the mounting structure or the module frames.

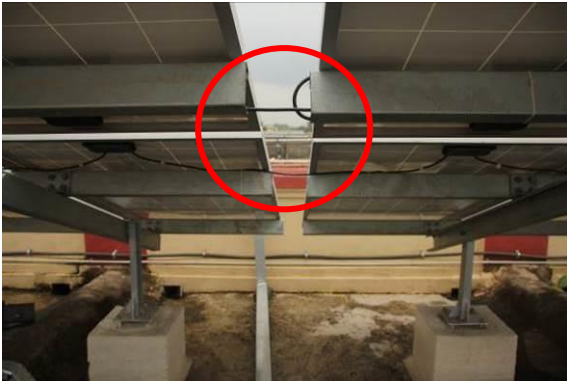
- v. Bending radius: In general, the minimum bending radius of the cables has been respected.
- vi. Protection against UV: A lack of UV protection of the cables has been detected in the gaps between module tables.

Figure 47: Missing UV protection of the string cables

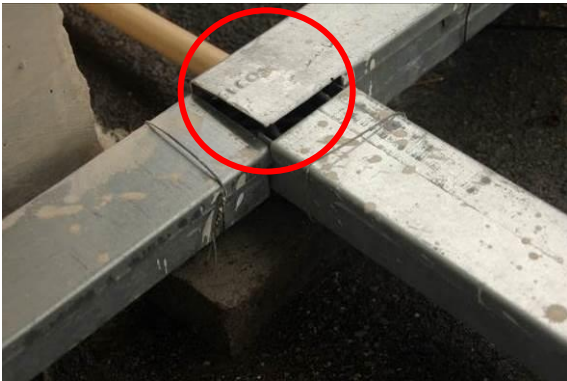
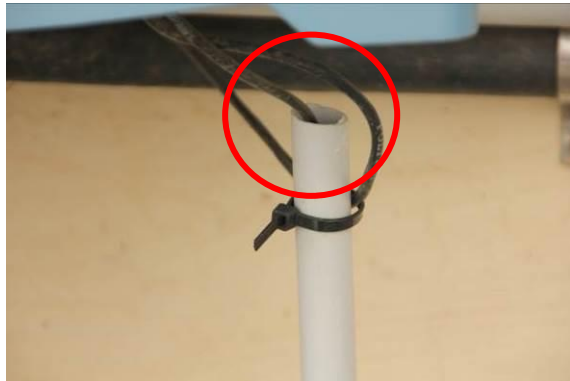
- vii. Sealing of tubes: The tubes conducting the DC cables to the inverter are not sealed.

Figure 48: Non sealed cable conduits

3.3.4	No sealing of pipes	Sealing the pipes and tubes helps protecting the cables from water and dirt accumulation as well as mechanical damage caused by animals. No foam was used to seal the pipes.

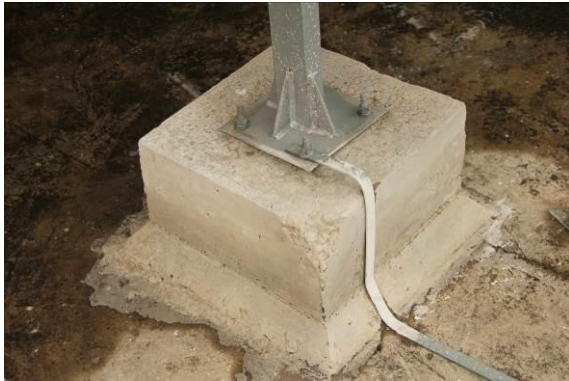
The equipotential bonding system connects all conductive parts of the PV plant as the mounting structure, module frames or housings. The equipotential bonding system of the PV plant is not integrated in the equipotential bonding system of the building which violates the requirements specified in the IEC 62305-3. The equipotential bonding belt does not show signs of corrosion. In terms of Potential Induced Degradation (PID) avoidance, no measures have been taken, such as functional grounding of the negative pole. The presence of PID could be confirmed on site as shown in chapter 5.2.6.

Figure 50: Equipotential bonding system conductor

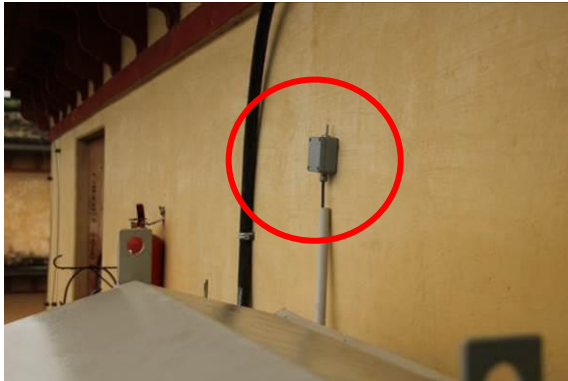
Figure 51: Ambient temperature sensor

The weather station is constituted by a c-Si sensor which is measuring both the irradiation on the tilted plane and the ambient temperature. A Pt sensor adhered to the backsheet of the modules for measuring the module temperature is missing. The global horizontal irradiation (GHI) is not measured either.

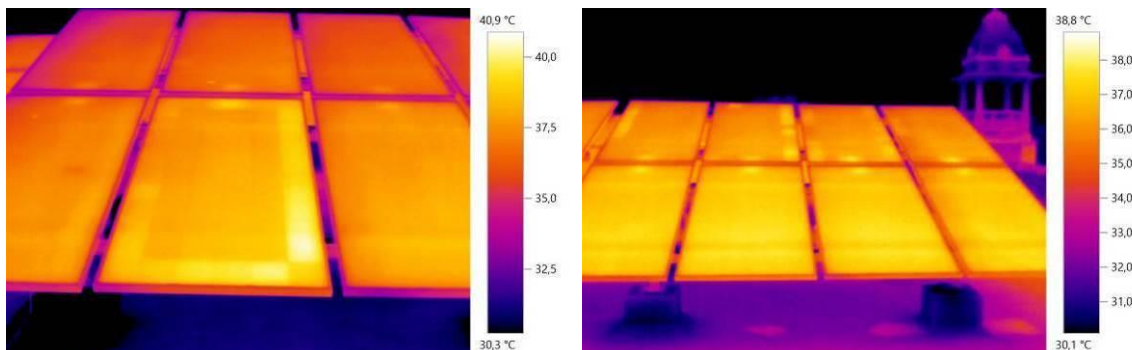
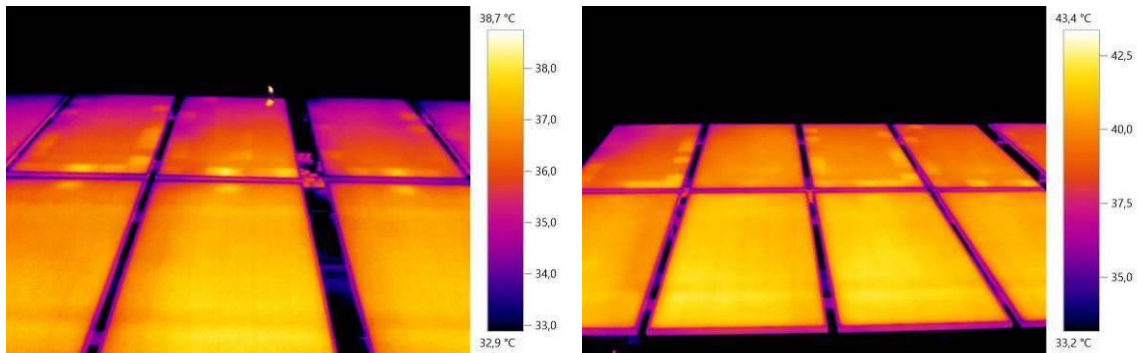
The infrared inspection showed clear evidences of PID.

Figure 52: PV modules affected by PID

3.4.2	No functional grounding against PID	No anti-PID measures were taken in order to avoid the appearance and development of PID. The region around Plant 2 is a PID risk area due to high temperatures and humidity. The presence of PID was confirmed onsite.

6.3	Presence of PID	The PID effect can be responsible in the short term, for a significant reduction of the PV power output of the modules located on the negative side of the string, and should be stopped immediately. The development of PID is accelerated with high temperatures and humidity rates, both present at the PV plant location.
7	Operation and Maintenance

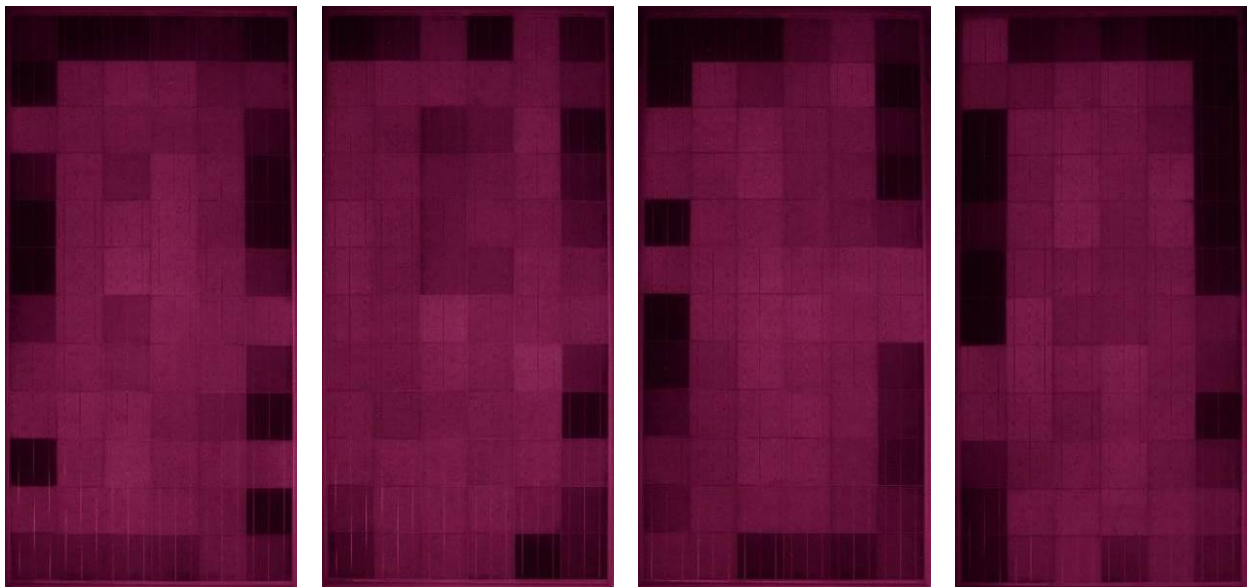
The electroluminescence analysis on a selected amount of PV modules confirmed the presence of PID.

Figure 53: PV modules affected by PID

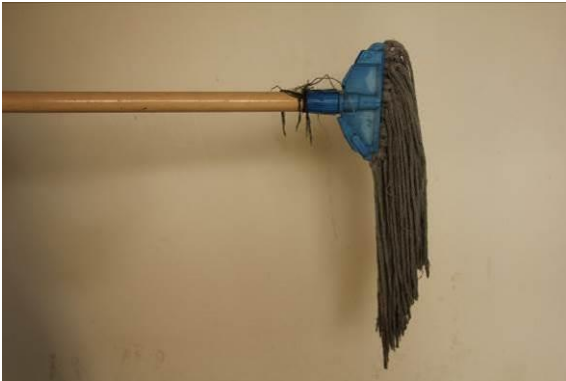
The module cleaning is performed 2 times a month using cotton wipers and tap water. The impact of the selected cleaning methodology on the module warranty hasn't been analysed by the Owner and Operator. 2 persons are involved in the cleaning. The impact of the selected cleaning methodology on the module warranty hasn't been analysed. No soiling losses are measured onsite.

Figure 54: Wipers used for the module cleaning

7.3	No evaluation of the impact of the cleaning concept on the module warranty	The impact of the selected cleaning methodology on the module warranty hasn't been analyzed. Several factors such as the material used for the wipers, the type of water, the cleaning methodology, the water pressure and the physical and chemical properties of the soil, might have an influence on the glass and the anti-reflective coating of the modules. Product damages or performance losses of any kind originated by the cleaning process are not covered by the product warranty unless the cleaning concept has been approved previously by the module manufacturer. This step was not given before starting the operational phase.

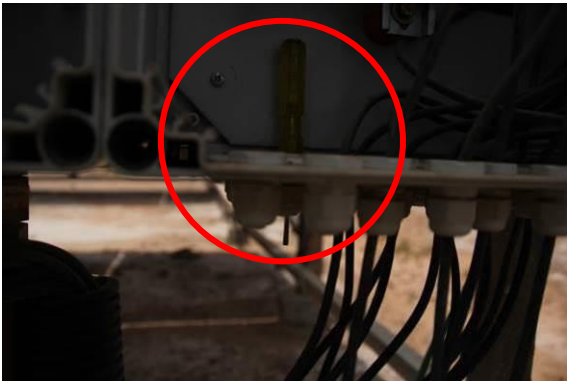
- i. Sealing of the cable glands: The cable glands of the combiner boxes are not properly sealed.

Figure 61: Not sealed cable glands (a screwdriver has been passed through the cable gland to show that it is not properly sealed)

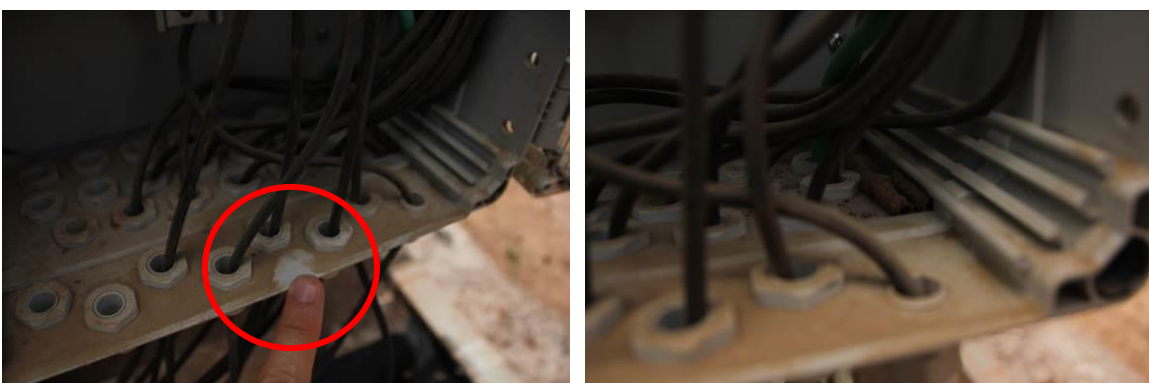
- ii. Cleanliness of the combiner box: The dust accumulation inside the combiner boxes is significant.

Figure 62: Dust presence inside the combiner boxes

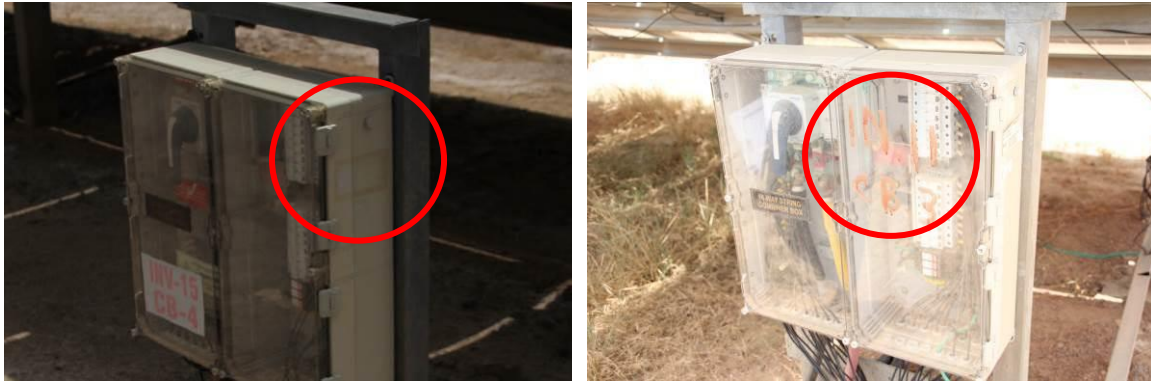
- iii. Labelling of the combiner box: The DC combiner boxes aren't labelled with durable tags.

Figure 63: Non-durable labelling of the DC combiner boxes

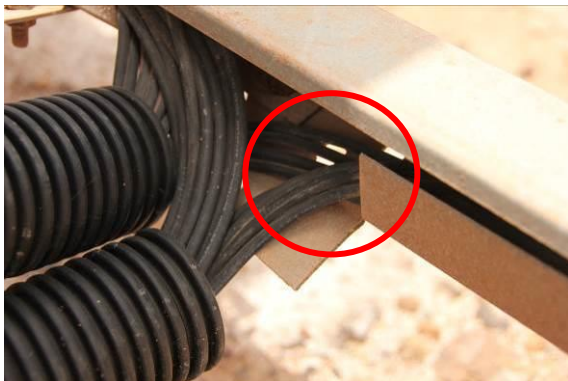
- i. **Cable damage**: The cables do not show damages caused by external agents. However, many cables are in contact with sharp edges of the metallic cable trays, thus, an erosion of the cable shield can't be excluded in the midterm.

Figure 64: String cables in contact with sharp edges

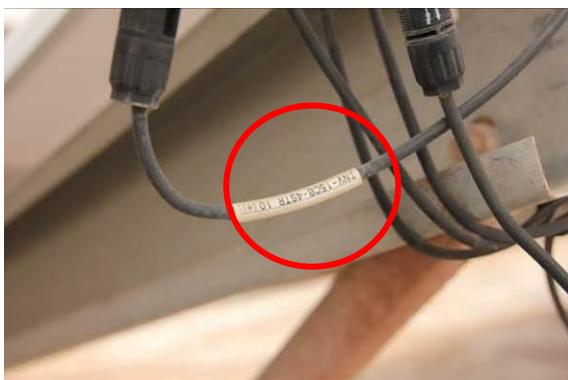
- ii. **Labelling of cables**: Both the strings cables entering the combiner box and the main DC cables connecting the combiner box with the inverter aren't properly labelled. In both cases the used tags are either not durable or do not exist at all.

Figure 65: Non-durable string cable labelling

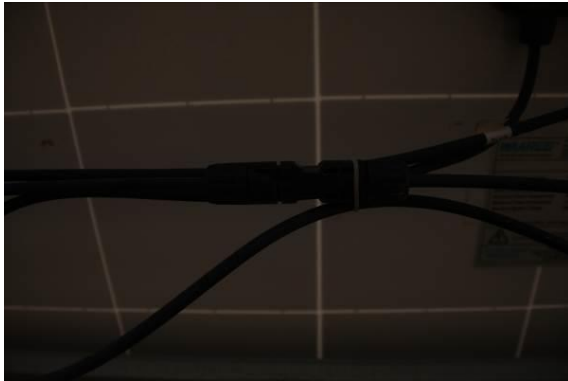
- iii. **Connectors**: The connectors are in general in a good shape. In some cases the connectors are not properly closed.

Figure 66: MC connectors

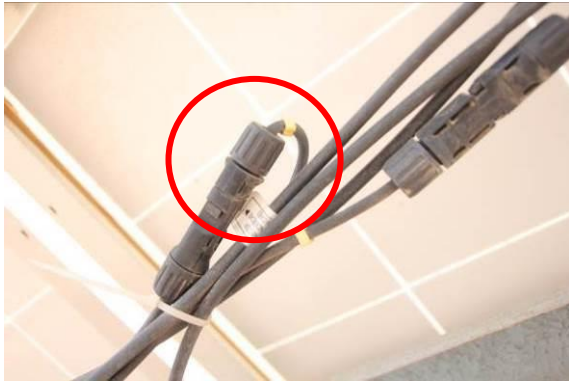
- v. Bending radius: In general, the minimum bending radius of the cables has been respected. In some cases the manufacturer requirements are not fulfilled.

Figure 68: Low bending radius of the string cables

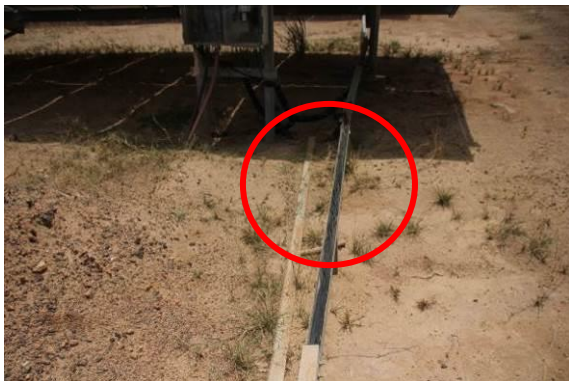
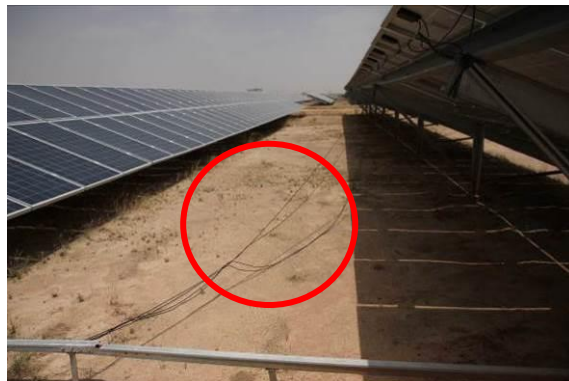
- vi. Protection against UV: A lack of UV protection of the cables has been detected in many areas of the plant. This affects mainly hanging cables between module rows and open cable trays.

Figure 69: String cables not protected against UV radiation

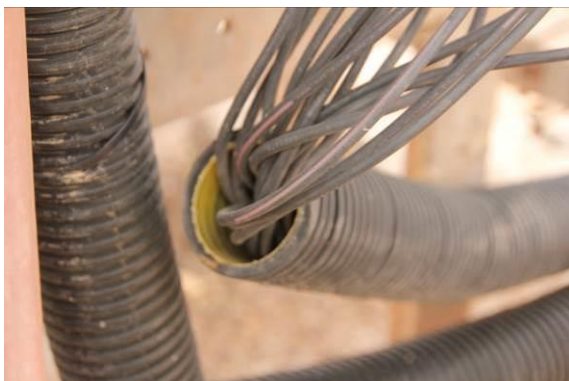
- vii. Sealing of tubes: The tubes conducting the DC cables to the inverter are not sealed.

Figure 70: Tubes used for the string cable routing not sealed

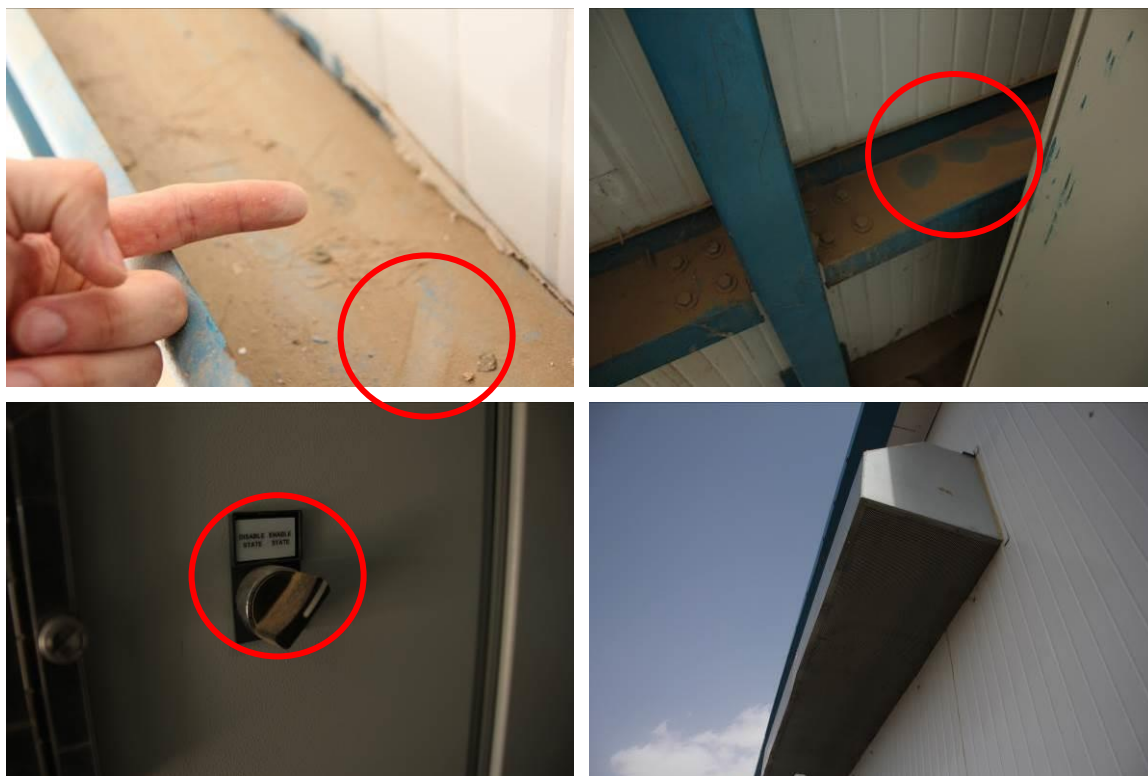
The inverter has an overvoltage protection on the AC side as well as a DC switch. The inverter room shows a significant amount of dust. During the site visit a dust cloud was created when the air ventilation fan was switched on showing that the dust accumulates fast. The inverter has a default ventilation system. The inverter room does not have a thermostat that regulates the temperature inside the housing, so the cooling is conducted when the air ventilation fan is connected manually which happens only during selected months of the year. The inverter filters and air inlets are clean.

Figure 72: (top and bottom left) Presence of dust inside the PCU; (right) Air inlets of the PCU

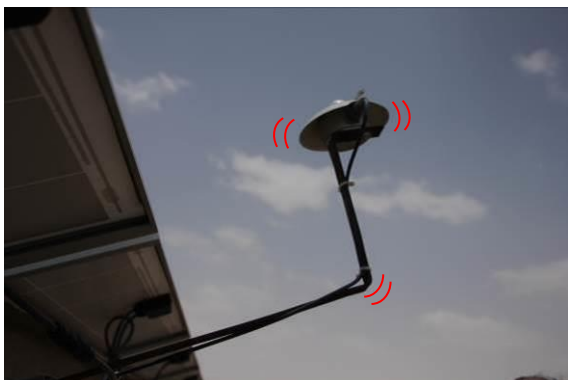
PI Berlin had no access to the readings of the irradiation and temperature data of the installed sensors. According to the Owner, the sensors are calibrated each 6 months. No calibration certificates were provided to PI Berlin. The weather station is constituted by a pyranometer on the tilted plane, an ambient temperature sensor and an anemometer. A Pt sensor adhered to the backsheet of the modules for measuring the module temperature is missing. The global horizontal irradiation (GHI) is not measured. The metal arm fixing the pyranometer to the mounting structure is too long leading to an oscillation of the sensor when the wind blows.

Figure 74: Pyranometer installed onsite

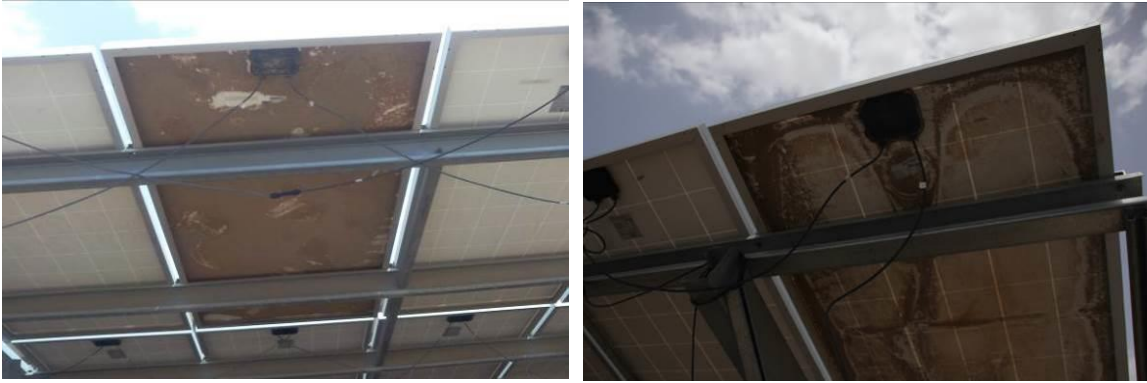
The visual inspection on the modules showed clear signs of snail trails and evidences of burned cells. Some modules showed backsheet fully covered with mud while others were scratched pointing towards an improper module handling. In some sporadic cases, the junction box is not properly aligned with the module frame. Footprints were detected on the module surface in some areas of the plant. According to the Owner the flash lists of the PV modules are available, however these were not shared with PI Berlin.

Figure 76: Module backsheet covered with mud

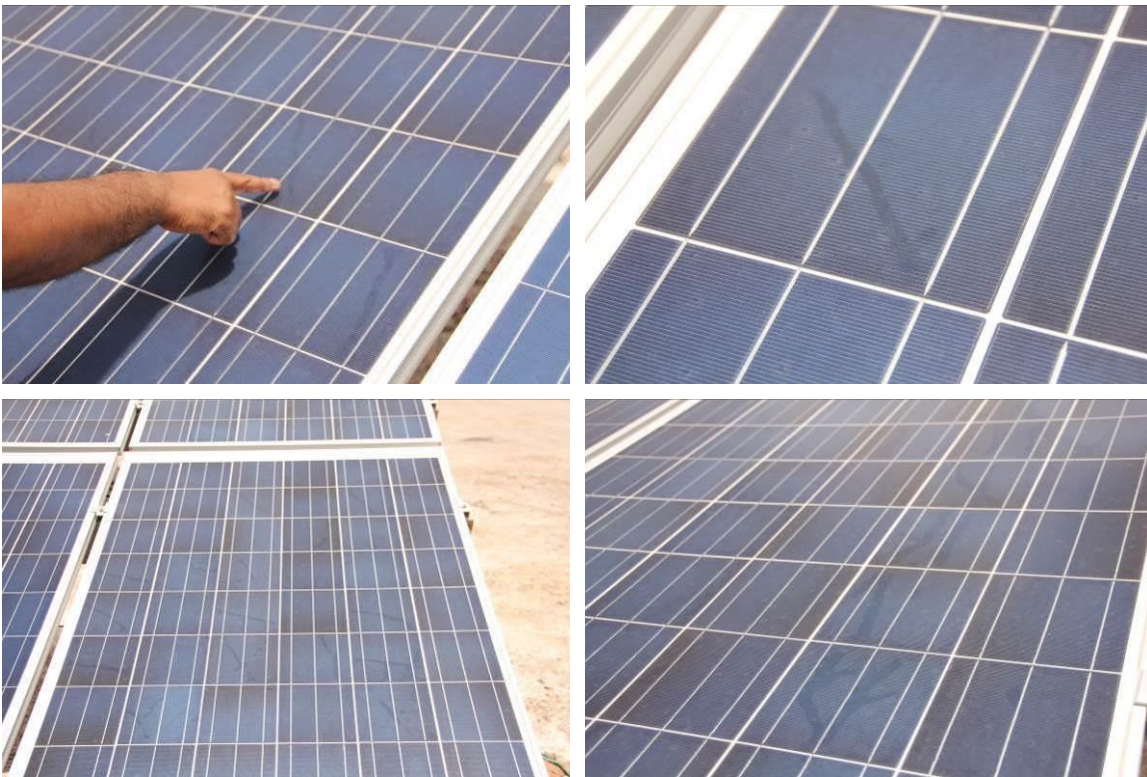
Figure 77: PV modules showing snail trails

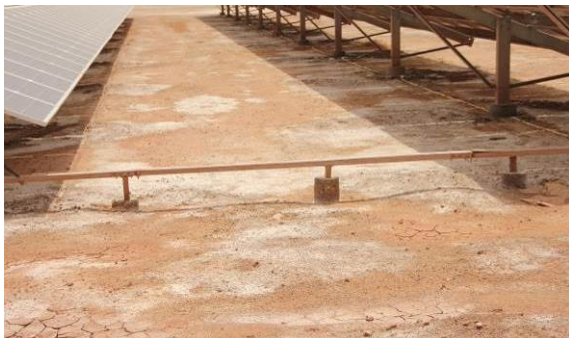
Daily O&M reports are issued registering only the PV plant output generation. According to the Operator, the reaction time is kept below 24h for all failures. PI Berlin could not prove this statement. An increase of the reaction times is caused by the cable trays blocking the access by car to the interrow space.

Figure 83: Cable routing system disturbing the access by car to the interrow space

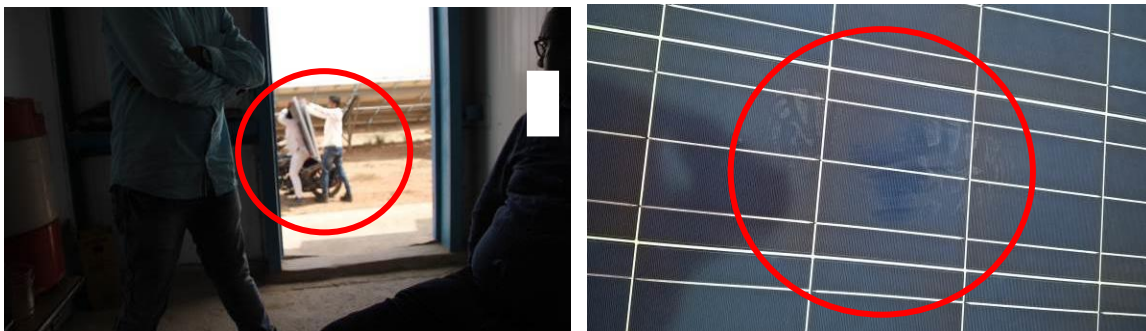
The preventive maintenance program focuses mainly on the switchyard, inverters, combiner boxes, LV DC module, HV and MV transformers and weather station. No preventive actions are conducted on PV modules and DC cables. No corrective maintenance program has been shared with PI Berlin. PI Berlin could identify signs of bad module handling onsite

Figure 84: (left) Inaccurate module transport; (right) Footprints on the module surface

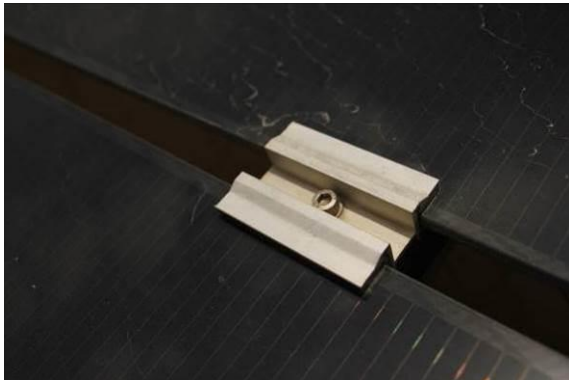
- i. **Module fixation:** The modules are properly fixed to the cross beams. The thin film modules installed in two 20MW blocks show occasionally micro-shading effects due to cell coverage through the clamps.

Figure 87: Module clamps shading the cells

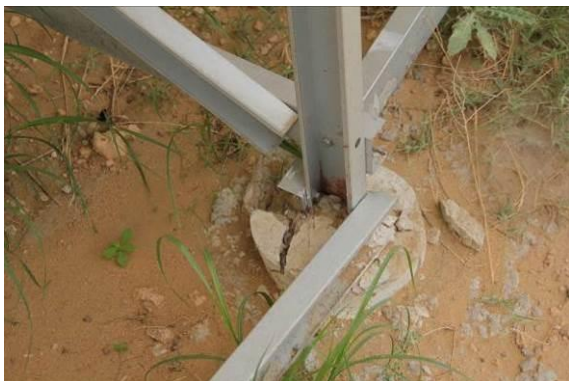
- iii. **Foundation:** Sporadically, damages in the foundation were observed.

Figure 89: Sporadic damages in the foundation

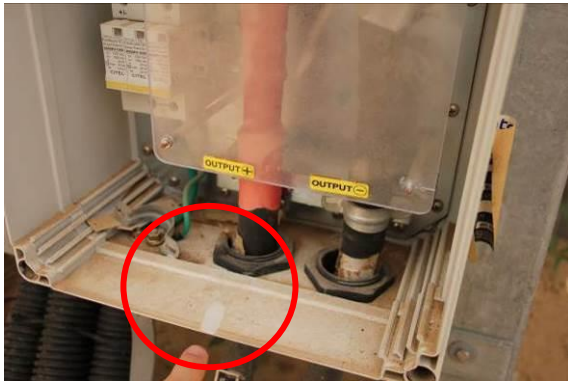
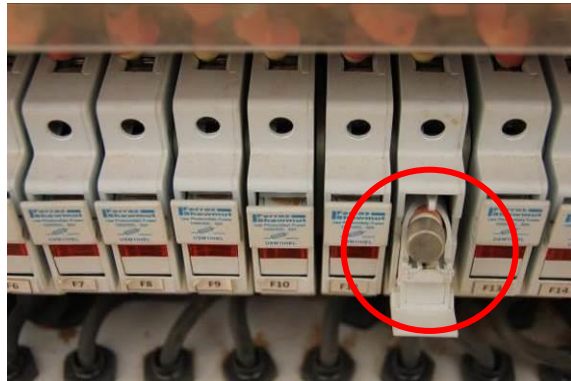
- ii. Cleanliness of the combiner box: The dust accumulation inside the combiner boxes is significant.

Figure 91: Dust inside the combiner boxes

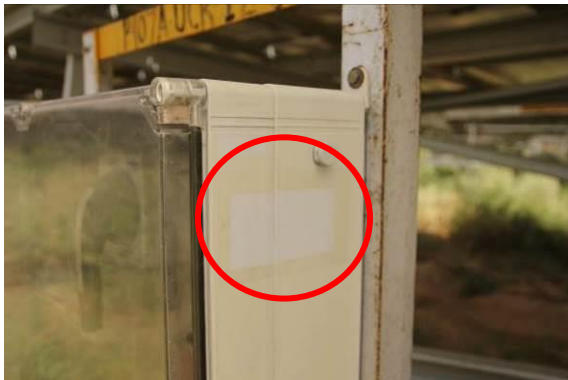
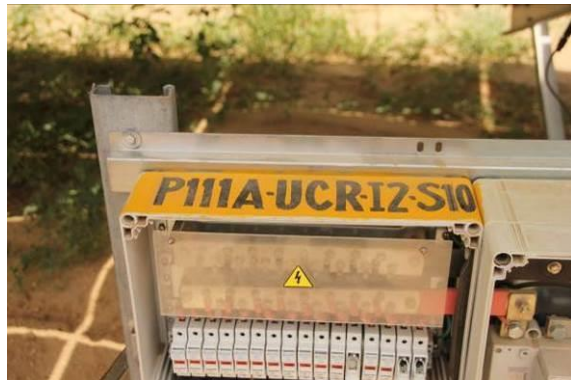
- iii. Labelling of the combiner box: The DC combiner boxes are labelled with durable tags. The datasheets adhered to the combiner box enclosure do not withstand an outdoor exposure.

Figure 92: (left) Missing datasheet; (right) Combiner box labelling

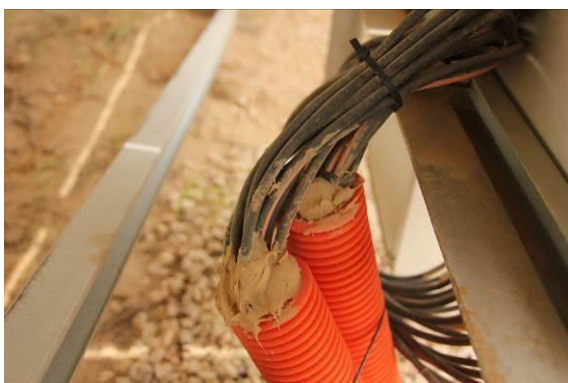
- vii. Sealing of tubes: The tubes conducting the DC cables to the inverter are sealed.

Figure 97: Accurate sealing of cable tubes

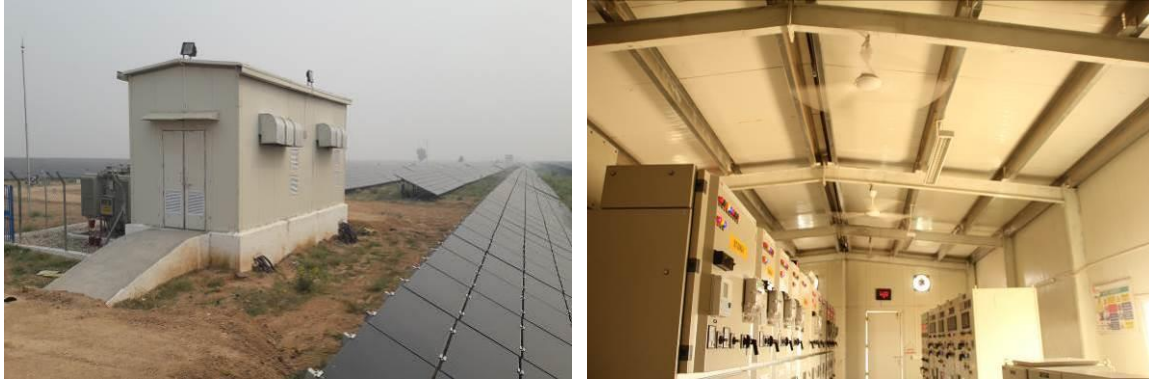
The inverter has an overvoltage protection on the AC side as well as a DC switch. The inverter room shows a significant amount of dust, especially in the filters. The inverter has a default ventilation system. The inverter room does not have a thermostat that regulates the temperature inside the housing. A forced ventilation system was installed inside the PCUs. The door is kept open to ensure natural convection. The inverter filters and air inlets are clean.

Figure 98: Inverter room

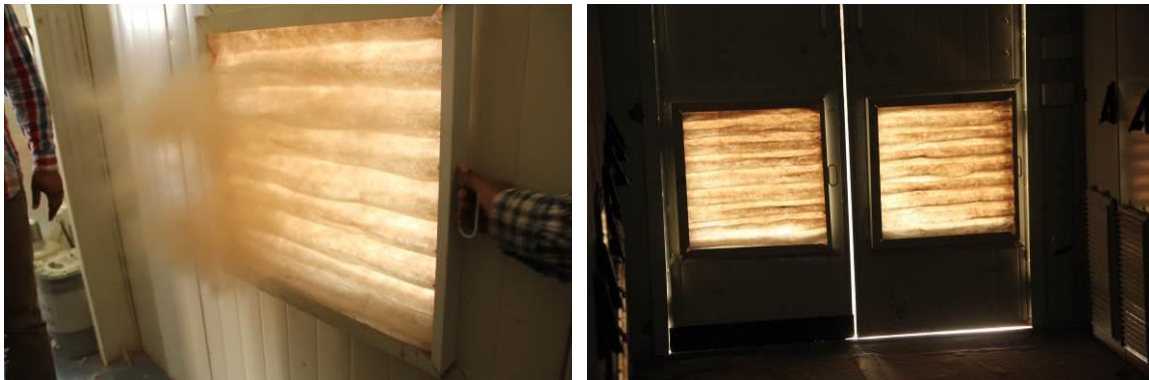
Figure 99: Dirty filters due to dust accumulation

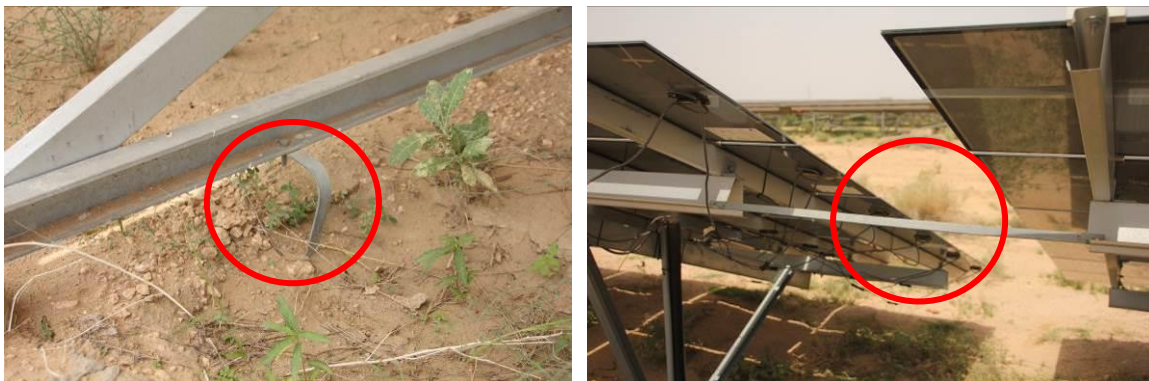
The equipotential bonding system connects all conductive parts of the PV plant as the mounting structure, module frames or housings. The equipotential bonding system is undamaged and doesn't show any signs of corrosion or rust. The equipotential bonding conductor is not properly buried. In some junctions, the continuity is not ensured in the long-term. In terms of Potential Induced Degradation (PID) avoidance, no measures have been taken, such as functional grounding of the negative pole. The PV plant does not show signs of PID.

Figure 100: Equipotential bonding system

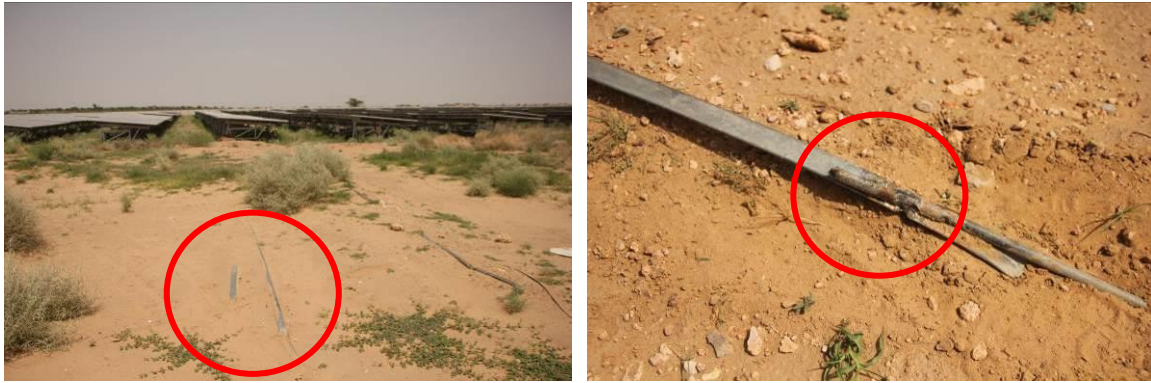
Figure 101: Not buried equipotential bonding conductor

3.5.2	Belt not buried	The equipotential bonding conductor (belt) should be buried at a depth according to the applicable norms (typically around 60cm) in order to avoid safety issues due to possible interactions between personnel and fault currents flowing through the conductor. Additionally, the conductor should be buried in order to avoid mechanical damages caused by vehicles and machinery.

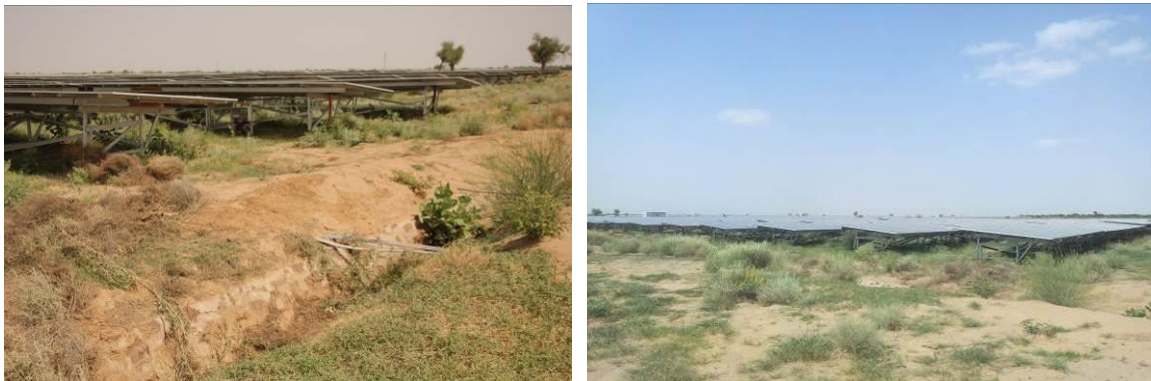
The status of the internal roads is good. A drainage system was implemented on site. The drainage channels are not well maintained in all areas of the plant. According to the Owner and Operator of the plant, the terrain has problems absorbing high amounts of rainwater.

Figure 102: Drainage system

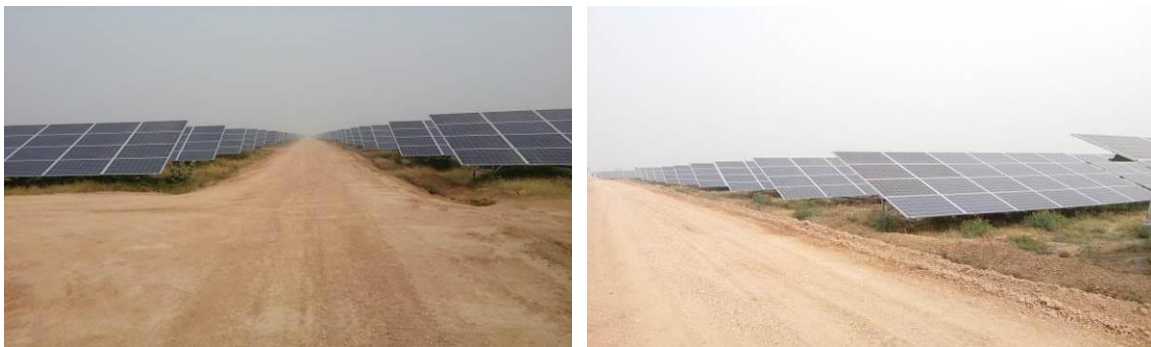
Figure 103: Internal roads

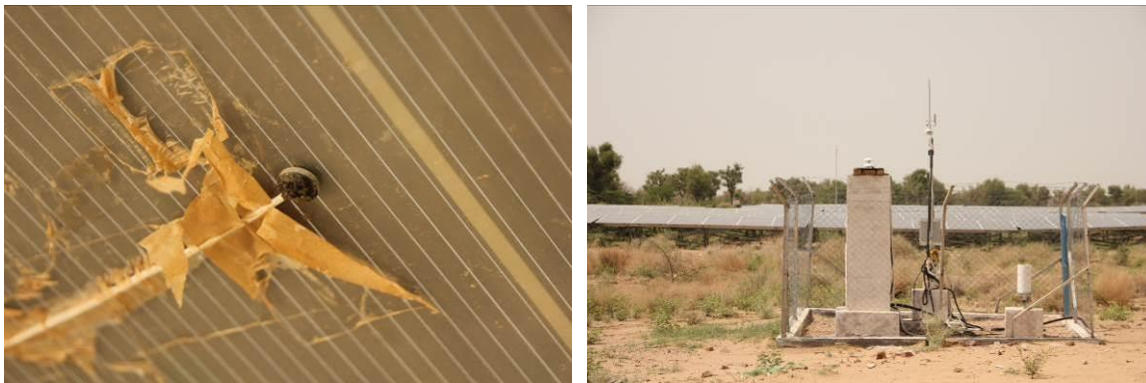
PI Berlin had access to the readings of the irradiation and temperature data of the installed sensors. The values are consistent.²⁴ According to the Owner, the sensors are calibrated each 24 months. No calibration certificates were provided to PI Berlin

Figure 104: (left) Module temperature sensor; (right) Weather station

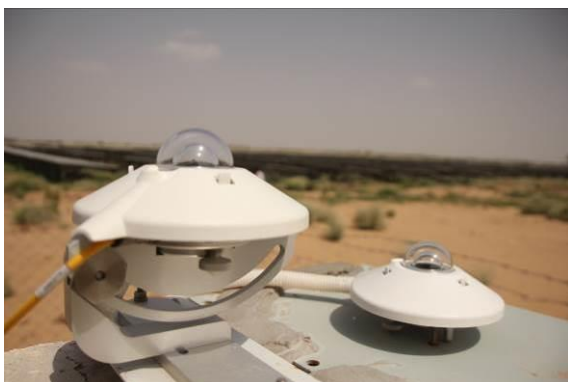
The weather station of each 20MW block is constituted by a pyranometer on the tilted plane (POA), a pyranometer on the horizontal surface (GHI), a module temperature sensor, a cell temperature and an anemometer. One value is recorded each 10min. In some weather stations the GHI sensor is missing. No redundancy was considered. Due to the fact that both pyranometers are installed close to each other and one is higher than the other, a reduction of the diffuse light absorption in the lower pyranometer can't be excluded.

Figure 105: Pyranometers on the horizontal and tilted surface

5.1	Installation failures detected	Due to the fact that both pyranometers (GHI and POA) are installed close to each other and one is higher than the other, a reduction of the diffuse light absorption in the lower pyranometer can't be excluded. Thus, the accuracy of the readings could be affected.

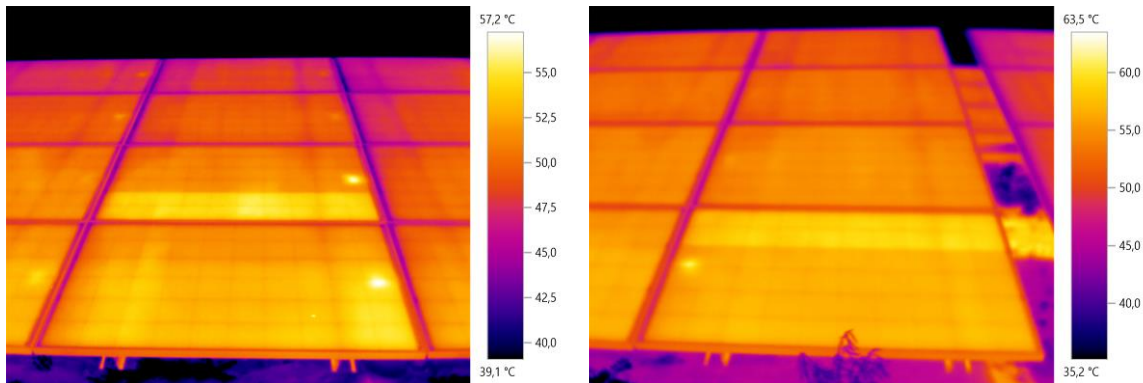
The infrared inspection didn't show major problems besides some sporadic hot spots and inactive cell strings both in the crystalline modules.

Figure 108: PV modules affected by inactive cell strings
