Pilot Study on Quality Aspects of PV Power Plants in India

Conducted in the framework of the Indo-German cooperation project
“Strengthening Quality Infrastructure for the Solar Industry”

by PI Photovoltaik-Institut Berlin AG

First published: September 2017

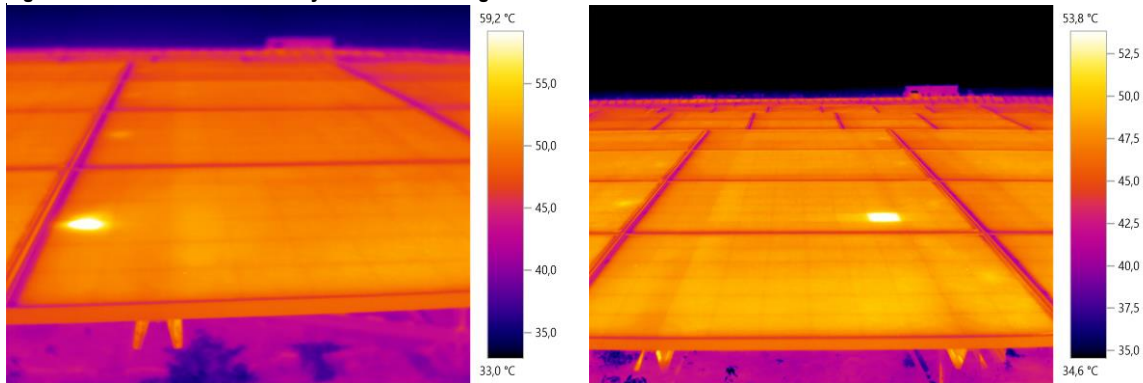
The infrared inspection didn't show major problems besides some sporadic hot spots and inactive cell strings both in the crystalline modules.

Figure 109: PV modules affected by hot spots

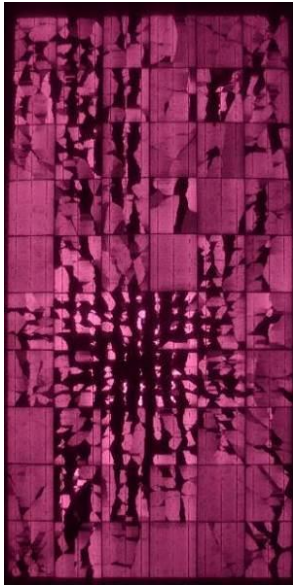
The electroluminescence analysis on a selected amount of crystalline PV modules confirmed the presence of cell cracks. The same analysis conducted on the thin film modules showed a high shunt sensitivity caused by shading.

Sr.Nr.: confidential
Figure 110: Broken PV module

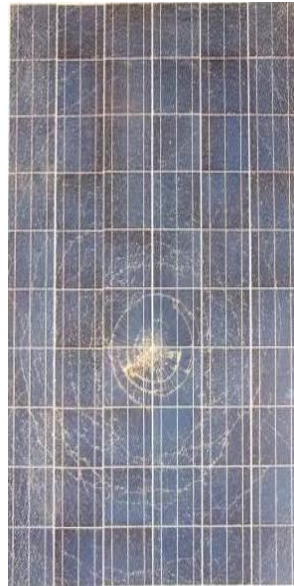
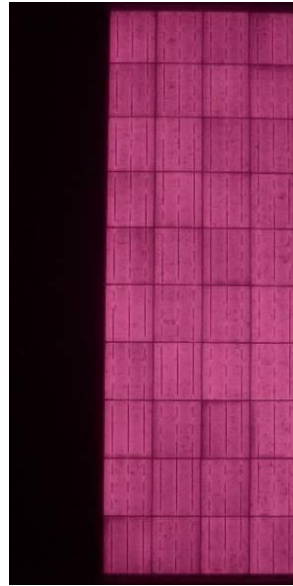
Sr.Nr.: confidential
Figure 111: PV modules affected by inactive cell strings

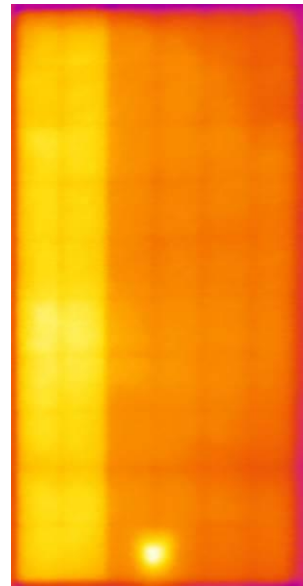
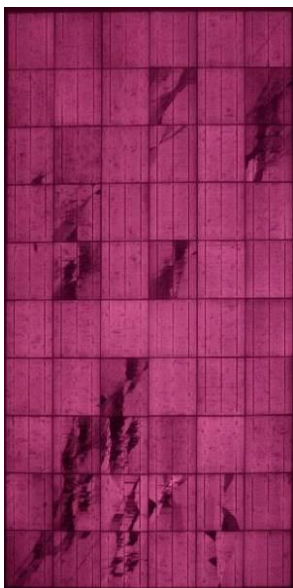
Sr.Nr.: confidential
Figure 112: PV modules affected by cell cracks evidenced by snail trails

6.1	Presence of module and cell cracks due to bad module handling	The snail trails detected on site are an evidence of the presence of cell cracks which can be confirmed with infrared and electroluminescence technology. These cracks show the typical pattern of damages caused by bad module handling during the construction phase. Cracks may lead to performance losses as they develop further, and to hot spots when parts of the cells are isolated by the cracks. The strong winds registered onsite may contribute to a faster development of the cracks due to the dynamic loads associated to them.

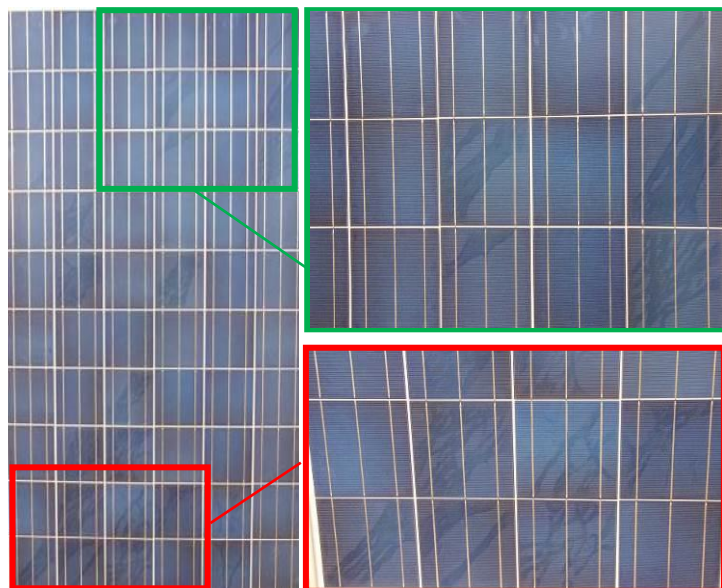
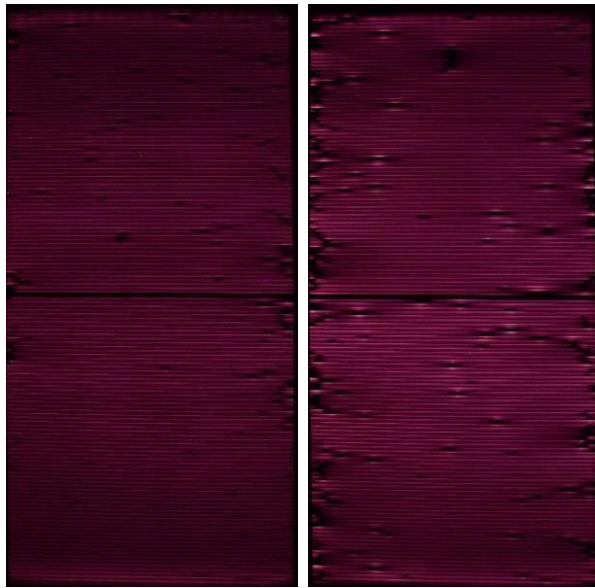
Sr.Nr.: confidential Sr.Nr.: confidential
Figure 113: (left) (before shading); (right) after shading

6.3	Presence of shunts	The thin film modules have a high sensitivity towards shading, which leads to the development of shunts as soon as the module cells are shaded. The shunts reduce the active surface of the cells. Thus, the shading of the cells should be avoided in any case, which is difficult to fulfill during cleaning or replacement actions.

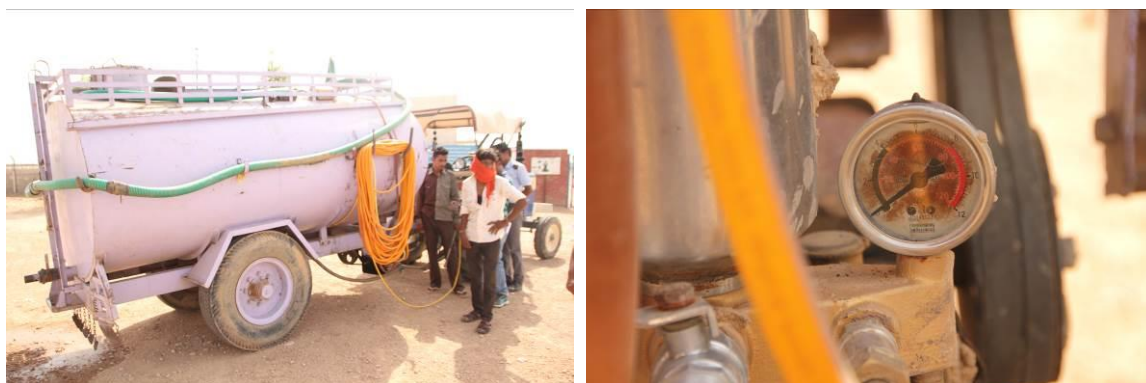
According to the Owner and Operator, the module cleaning is performed 2 times a month using cotton wipers and underground water. The applied water pressure is 5kg/cm².

Figure 114: Module cleaning system

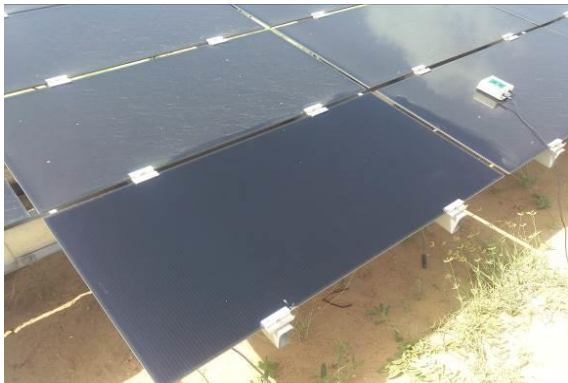
Figure 116: Module cleaned

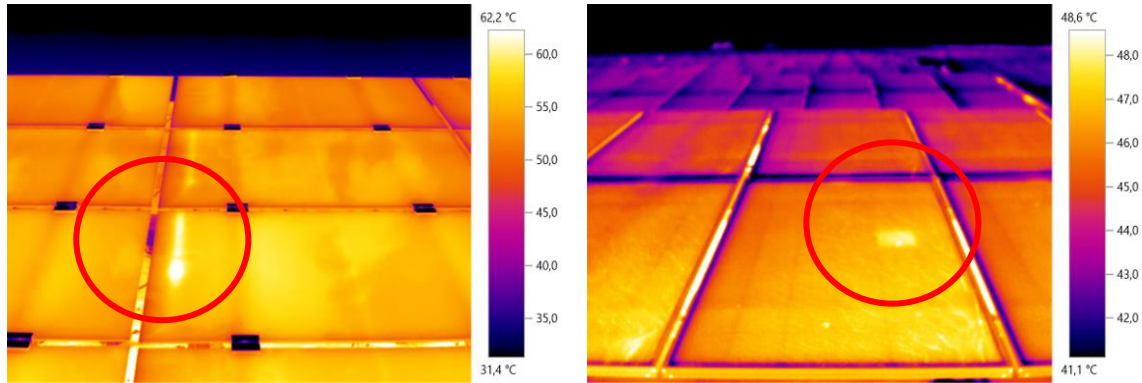
the thin film modules compared to the c-Si technology. According to the infrared analysis conducted by PI Berlin onsite, the soiling accumulation on the module surface leads to soiling induced hotspots as shown in the pictures below.

Figure 117: Soiling induced hot spots

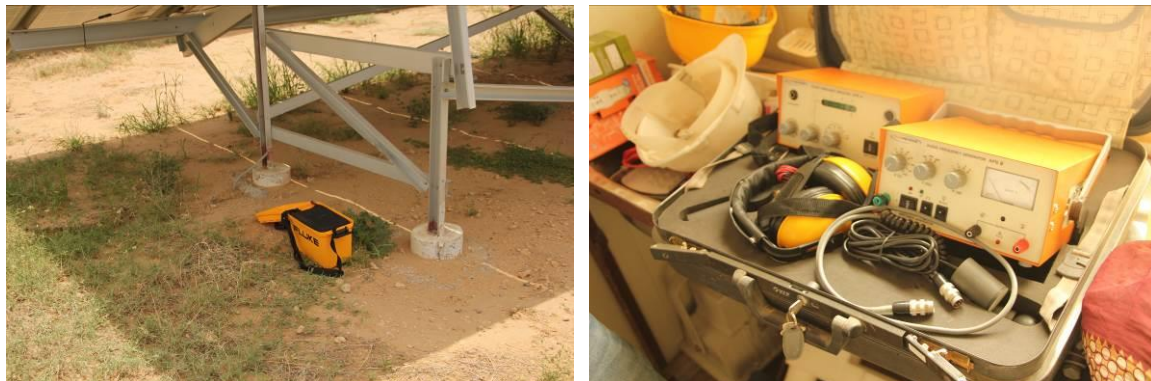
The O&M team uses current clamps, multimeters, IR camera and insulation measurement devices among others. No PV specific tools and devices are used onsite except the infrared camera.

Figure 118: Tools used during the O&M activities

7.3	No PV specific devices used onsite	Devices and tools used in the PV industry such as IV curve tracers, electroluminescence devices and infrared cameras help detecting and evaluating failures easily. The regular use of these devices is necessary during O&M for detecting and monitoring defects and degradation phenomena such as hot spots, cracks or PID.

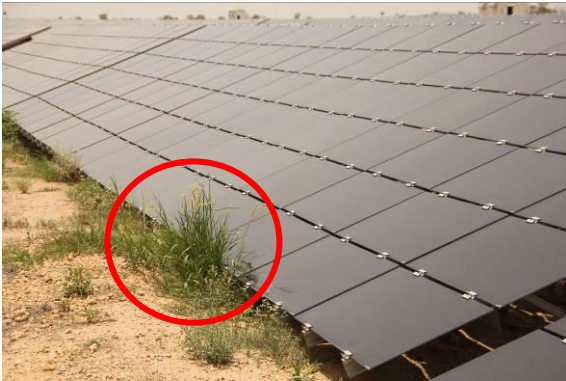
The preventive maintenance is very comprehensive and includes several checklists and forms for all system components such as DC cables, connectors, modules, switchyard, inverters, combiner boxes, LV DC module, HV and MV transformers, grounding system, UPS and weather station. A selection of corrective maintenance documents were shown to PI Berlin onsite. Every action taken by the O&M team is documented. Some sporadic shading due to vegetation was detected. 2 vegetation cuts are conducted each year.

Figure 119: Vegetation growth

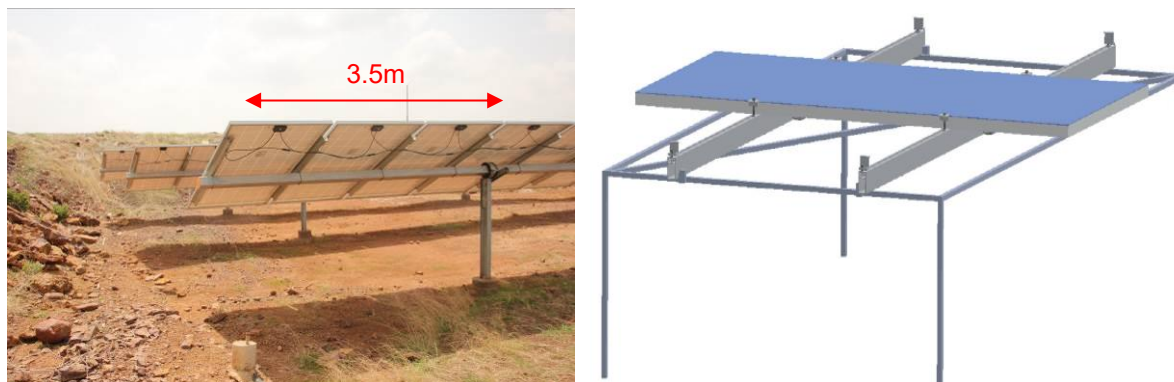
No static calculations were shared with PI Berlin, hence the structural integrity of the mounting structure couldn't be proven. However, a few deviations from the installation manual were detected. On the one hand the cantilever arm at the end of the tracker unit is 3.5m long which exceeds the dimensions specified in the installation manual. This length is the result of conducting the anchorage of each tracker unit to the ground with only 6 foundation piles instead of 8 as prescribed in the manual. Additionally, the modules are fixed to the tracker using only one crossbeam, while the installation manual recommends two.

Figure 121: (left) Real length of the cantilever; (right) Module fixation using two crossbeams according to the installation manual

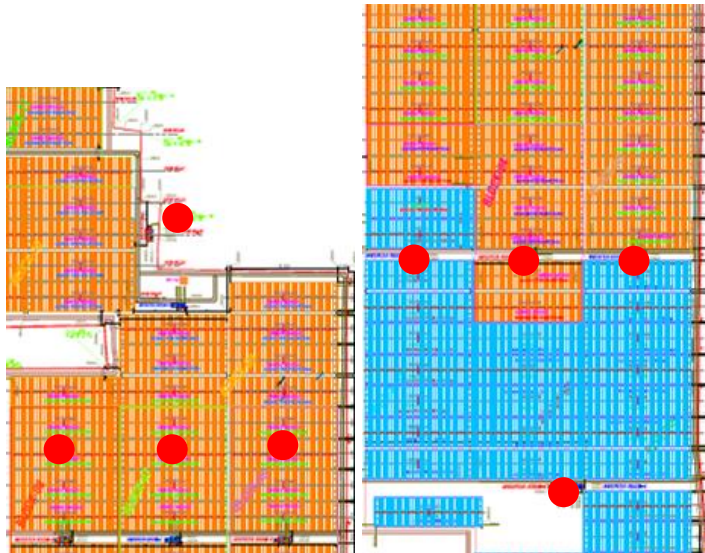
The location of the PCUs containing the inverters, transformers and MV switchgear was not selected considering voltage drop minimization. The cable runs are long enough to exceed 3% of voltage drop between some combiner boxes and the corresponding inverter²⁹. Additionally, the resulting voltage difference between combiner boxes located close and other located far away from the inverter may lead to a voltage mismatch on inverter level. The following screenshot of one of the reviewed drawings³⁰ shows with red dots the location of the inverters and how long the cable runs are on the DC side.

Figure 122: Location of the inverters

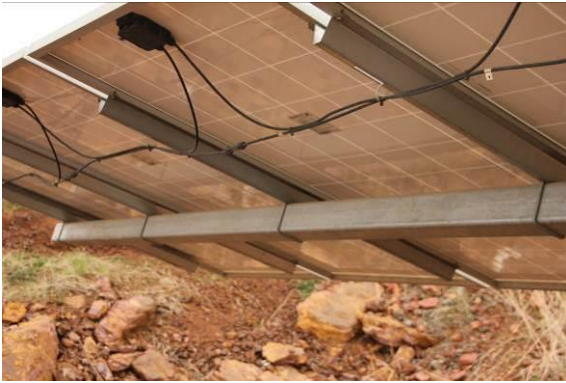
Figure 123: Fixation of the modules to the tracker

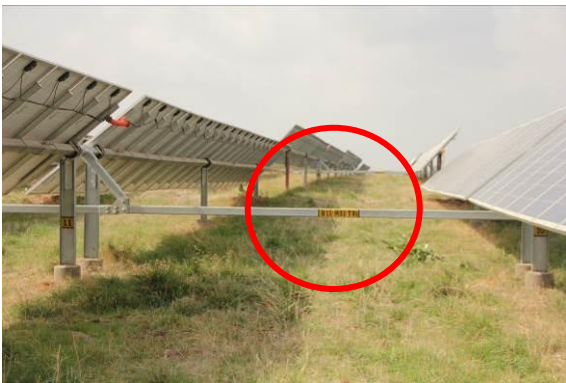
- ii. Labelling of rows: The labelling of the mounting structure was conducted in the entire PV plant. Besides, the labels are durable for the entire lifetime of the project.

Figure 124: Labelling of the trackers

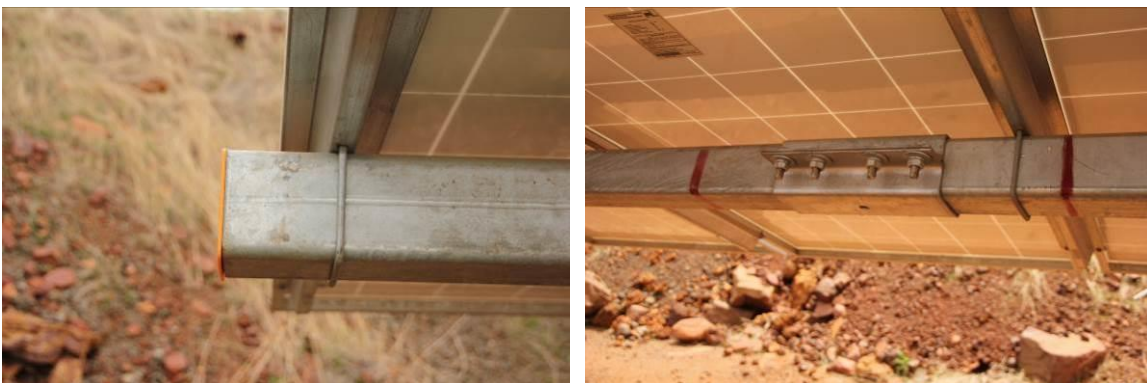
- iii. Rust on the mounting structure surface: The mounting structure doesn't show signs of rust.

Figure 125: Good surface status of the tracker structure

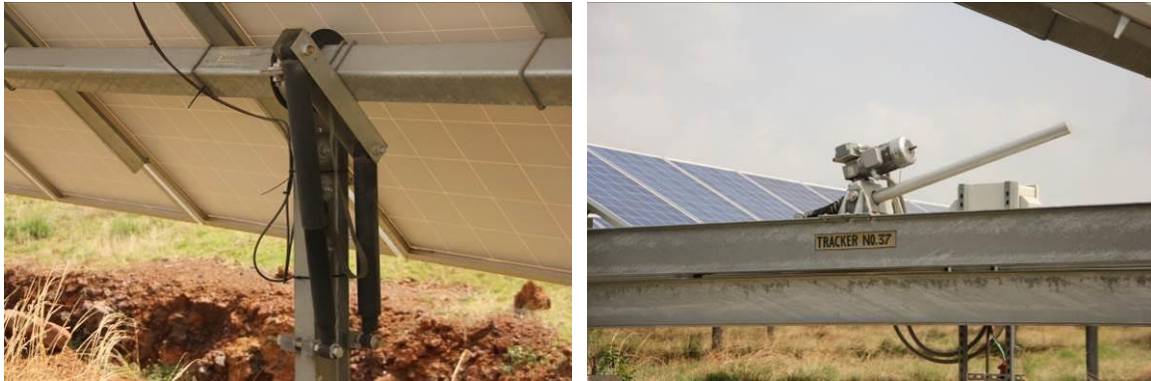
- iv. Status of the motors and dampers: Both elements are in a good shape and no not show signs of deterioration.

Figure 126: (left) Dampers of the tracking system; (right) Motor of the tracking system

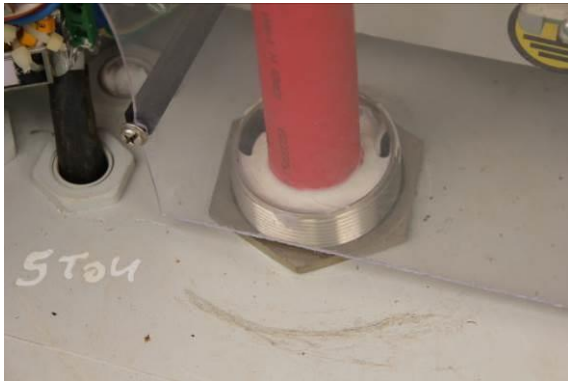
- i. Sealing of the cable glands: The cable glands are properly sealed in all combiner boxes

Figure 127: Sealing of the cable glands inside the DC combiner boxes

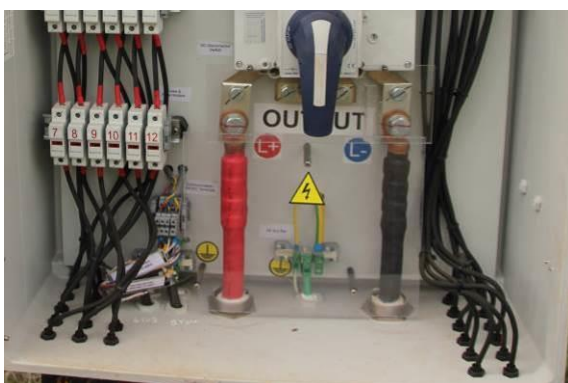
- ii. Cleanliness of the combiner box: The combiner boxes are clean inside.

Figure 128: Clean DC combiner box

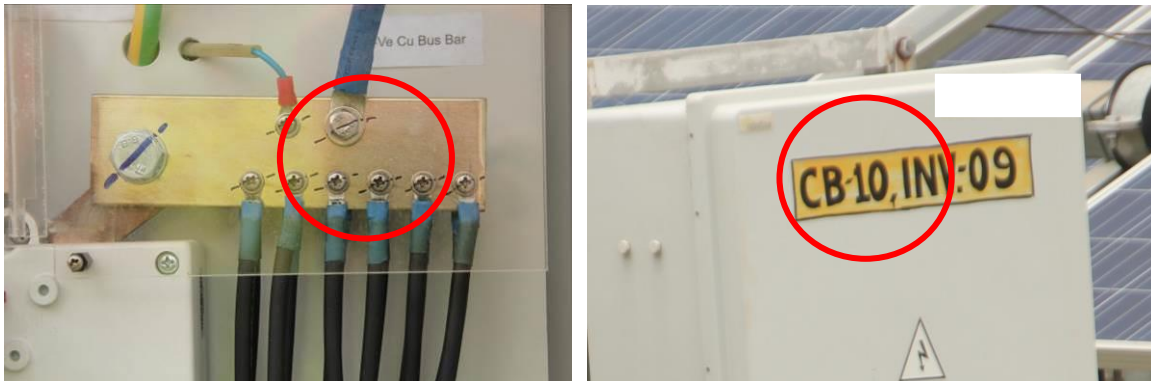
- iii. Labelling of the combiner box: The DC combiner boxes are clearly labelled. The tags are starting to bleach. The torques are marked in the screws of all electrical connections.

Figure 129: (left) Torque marking; (right) Bleaching of the combiner box labels

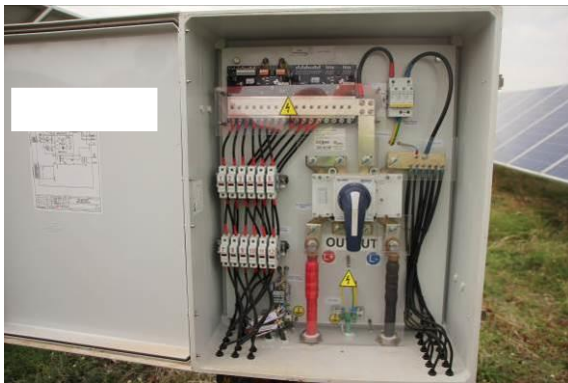
- iv. Protection: Overvoltage protection and DC main switch is included inside the DC combiner boxes. Only the positive pole is protected with 30A fuses.

Figure 130: View of the DC combiner box

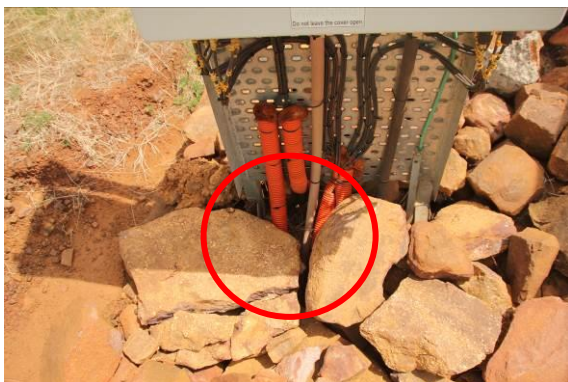
- i. Cable damage: The cables do not show damages caused by external agents. However, some cables are in contact with rocks and stones, thus, an erosion of the cable shield can't be excluded.

Figure 131: Cable ducts covered with stones

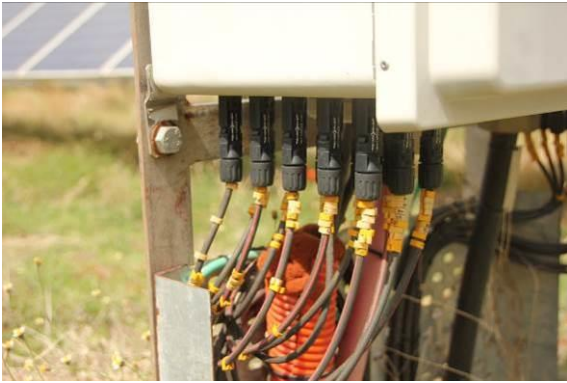
- ii. Labelling of cables: Both the strings cables entering the combiner box and the main DC cables connecting the combiner box with the inverter, are properly labelled. In both cases the used tags seem to be durable for the whole lifetime of the project.

Figure 132: Labelling of the string cables

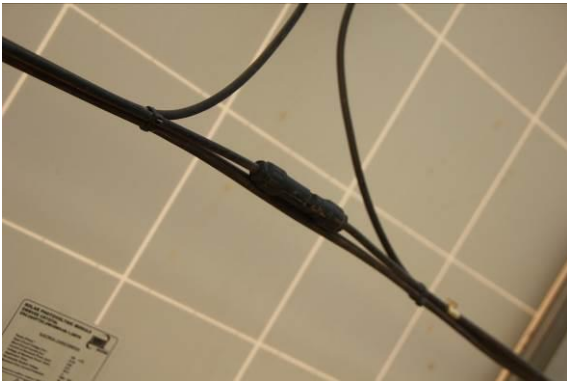
- iii. Connectors: The connectors are in general in a good shape.

Figure 133: MC4 connectors

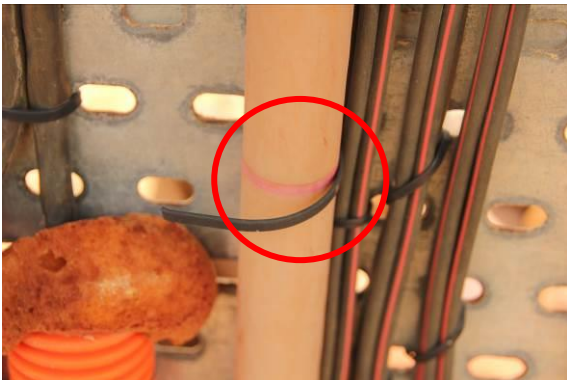
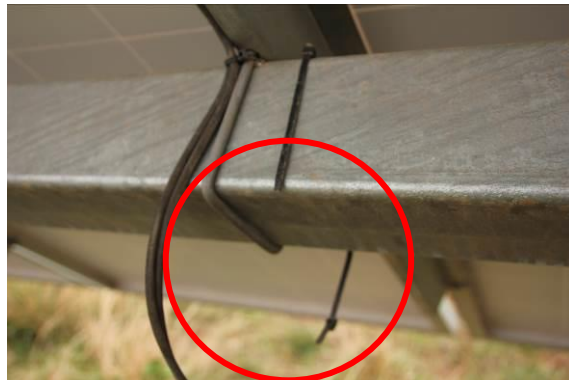
- iv. Cable fixation: The cables ties used for the cable fixation are not suitable for outdoor exposure and start falling apart.

Figure 134: Fixation of the string cables

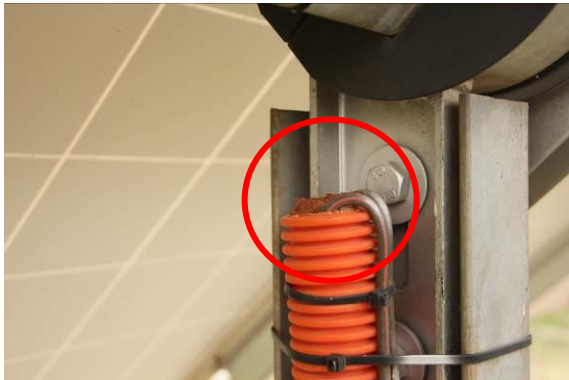
- vii. Sealing of tubes: The tubes conducting the DC cables to the inverter are sealed. However, the used foam doesn't seem to be durable.

Figure 136: Sealing of the cable ducts

3.1.4	No sealing of pipes	Sealing the pipes and tubes helps protecting the cables from water and dirt accumulation as well as from mechanical damage caused by small animals. The proper sealing of the tubes is not ensured in the midterm since the used foam is starting to degrade.

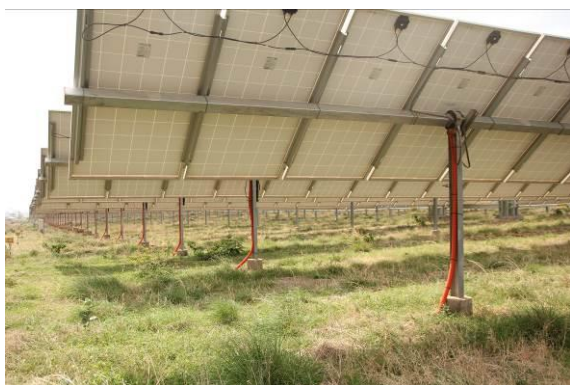
- viii. Cable pipes: The tubes where the cables are routed do not show degradation due to outdoor exposure.

Figure 137: Cable pipes used for the string cable routing

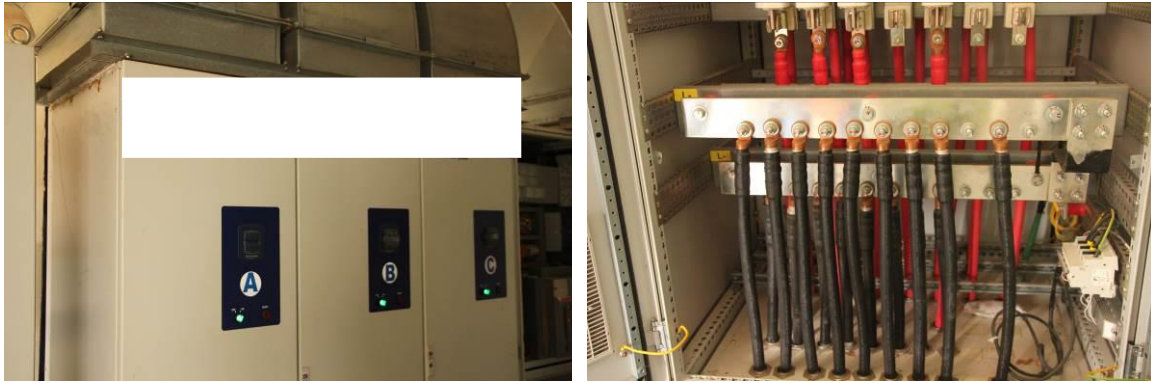
The inverter is based on 7 modular units building a master-slave concept. It has an overvoltage protection on the AC side as well as a DC switch. The PCU is clean, no significant amount of dust has been detected. The inverter has a default ventilation system. The inverter room does not have a thermostat that regulates the temperature inside the housing. A forced ventilation system was installed inside the PCUs. The inverter filters and air inlets are clean.

Figure 138: Central inverter

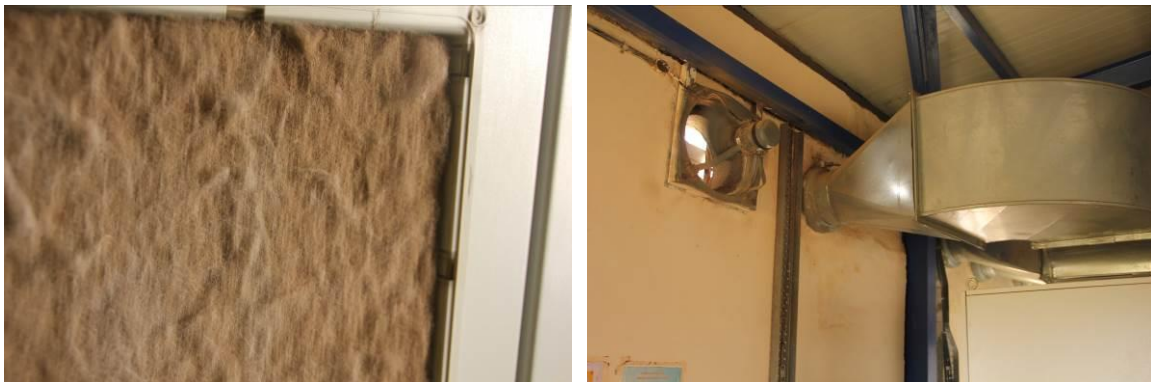
Figure 139: (left) Filters of the inverter room; (right) Ventilation system inside the inverter room

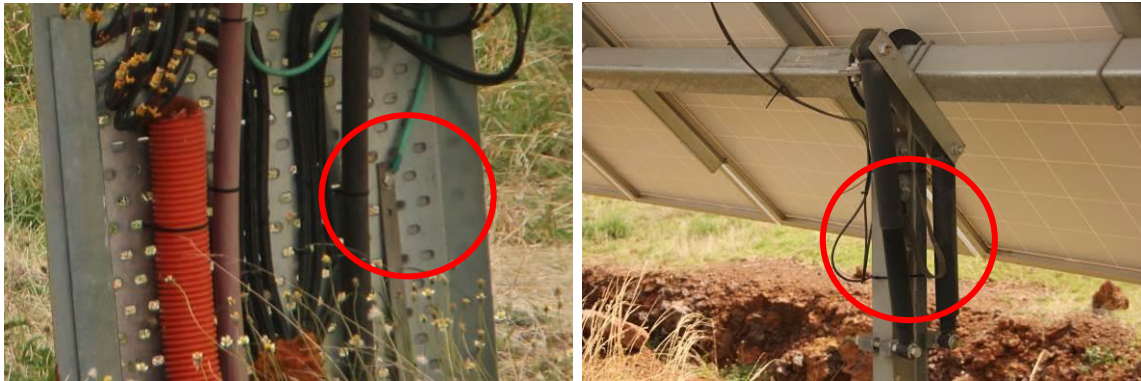
The equipotential bonding system connects all conductive parts of the PV plant as the tracker, module frames or housings. The equipotential bonding conductor is not properly buried and does not comply with the requirement that specifies a minimum depth of 60cm. No signs of rust or corrosion were observed. The negative pole of the generator is grounded with a GFDI kit in order to avoid the development of PID.

Figure 141: Equipotential bonding system

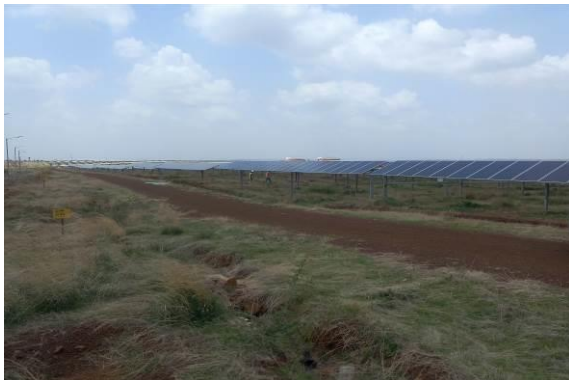
The status of the internal roads is good. A drainage system was implemented on site. The drainage channels aren't kept clean. According to the Owner and Operator of the plant, the terrain has problems to absorb high amounts of rainwater during heavy rainfalls registered on site.

Figure 142: Drainage system

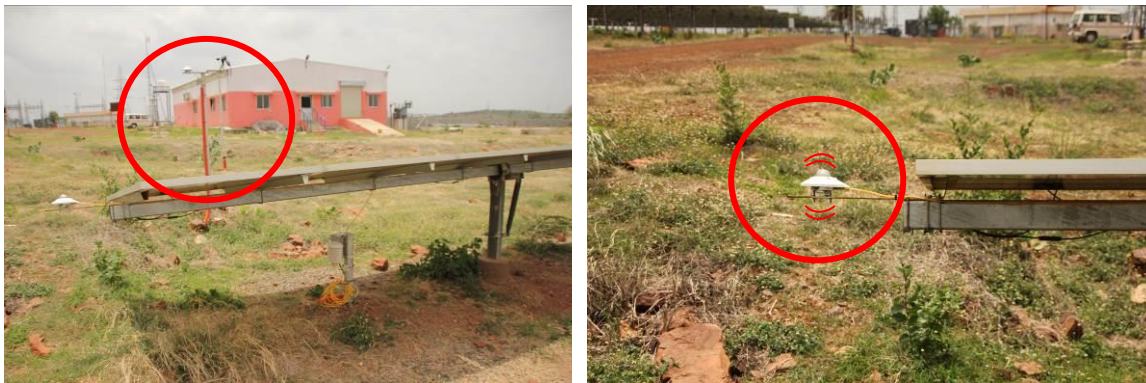
The 3 weather stations installed onsite are constituted by a pyranometer on the tilted plane, a pyranometer on the horizontal surface (GHI), a module temperature sensor, a cell temperature and an anemometer. The metal arm fixing the pyranometer to the mounting structure is too long leading to an oscillation of the sensor when the wind blows. One value is recorded each minute. According to the Owner, the sensors are calibrated each 2 years. The calibration certificates were provided to PI Berlin. The readings of the irradiation and temperature sensors show gaps due to communication problems due to the weak internet connection onsite.

Figure 143: (left) Weather station; (right) Pyranometer

5.1	Installation failures detected	The excessively long arm that supports the pyranometer oscillates with the wind. Thus, the accuracy of the registered data can be affected.

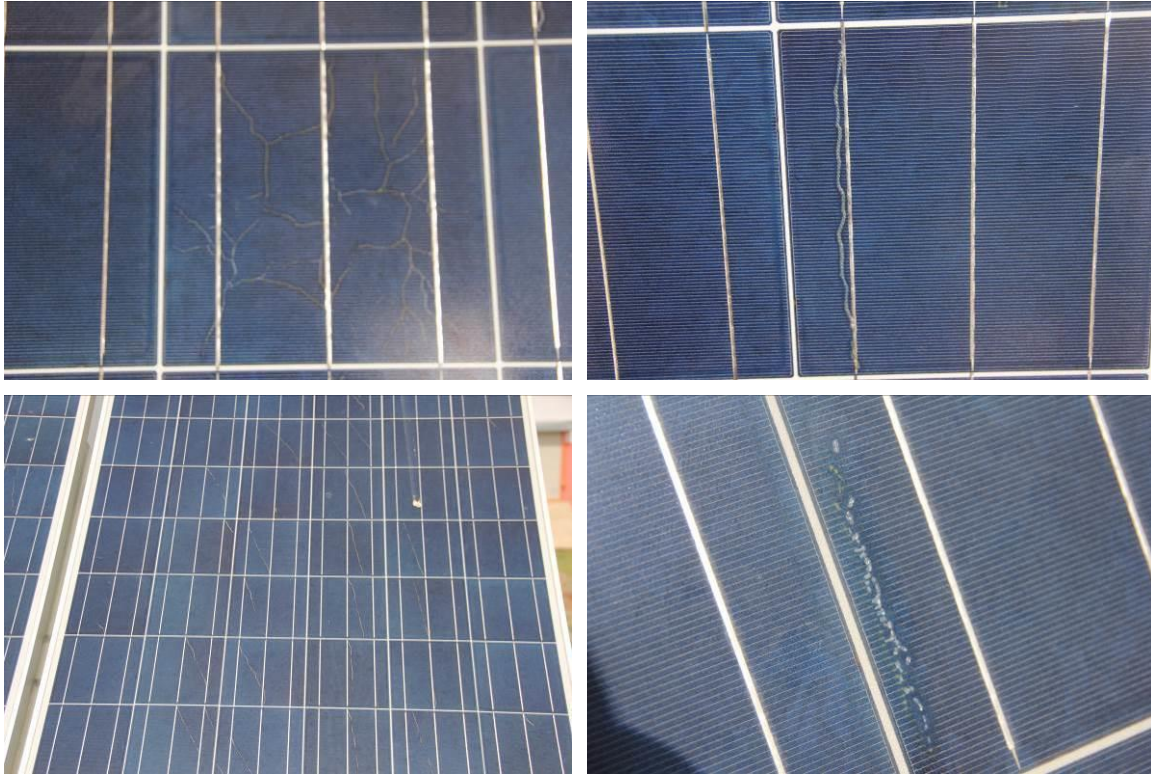
The visual inspection on the modules showed clear signs of snail trails and shunts [23].

Figure 144: PV modules showing snail trails

6.3	Presence of module and cell cracks due to bad module handling	The snail trails detected on site are an evidence of cell cracks which were confirmed with infrared and electroluminescence technology by PI Berlin. These cracks show the typical pattern of damages caused by bad module handling during the construction phase. Cracks may lead to performance losses as they develop further, and to hot spots when parts of the cells are isolated by the cracks.

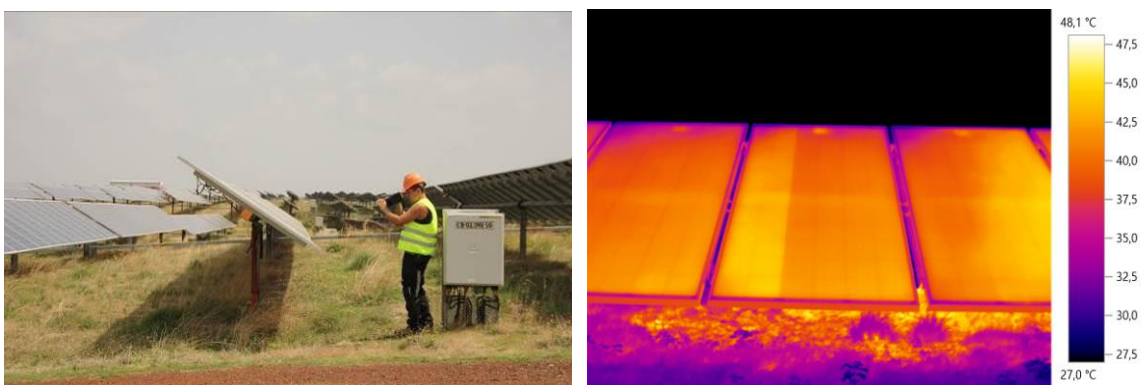
The infrared inspection didn't show major problems besides some sporadic hot spots and inactive cell strings both in the crystalline modules.

Figure 147: (left) Infrared inspection on site conducted by PI Berlin; (right) PV modules affected by one inactive cell string

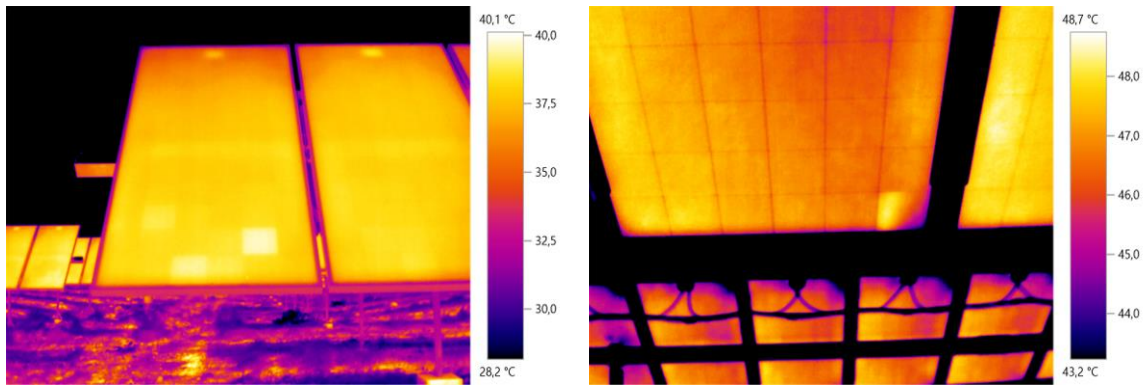
Figure 148: PV modules affected by hot spots

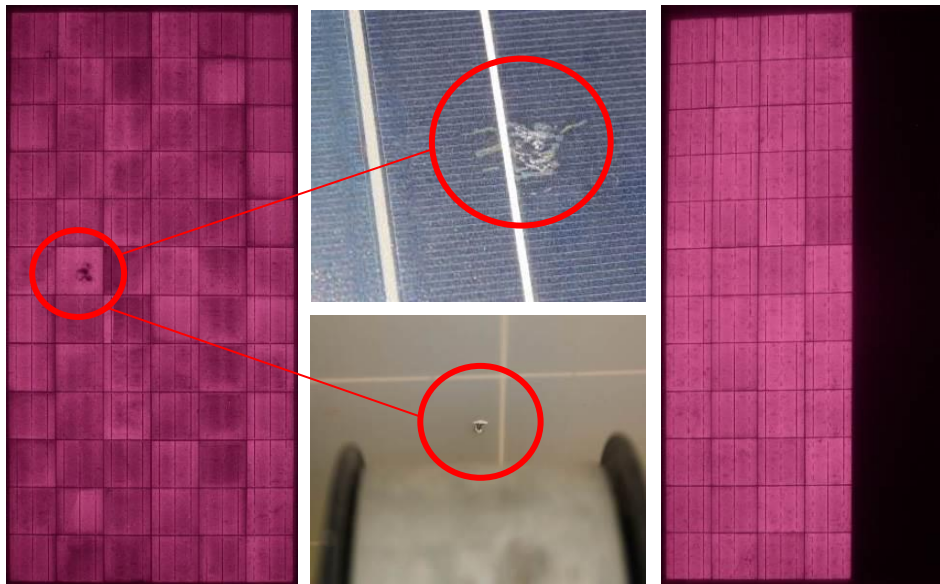
The electroluminescence analysis on a selected amount of crystalline PV modules confirmed the presence of cell cracks caused by improper handling, as well as a cell damage at the spots of the backsheet scratches caused by the bushings.

Figure 149: (left) Cell damages caused by the dampers; (right) PV module affected by one inactive cell string

6.1	Presence of scratched backsheets	Some modules showed scratches in the backsheet, caused by the bushings of the trackers. This failure leads to the loss of the required insulation value of the electrical circuits and to cell cracks combined with corrosion at the location of the scratches. This effect is especially critical in areas with high humidity rates.

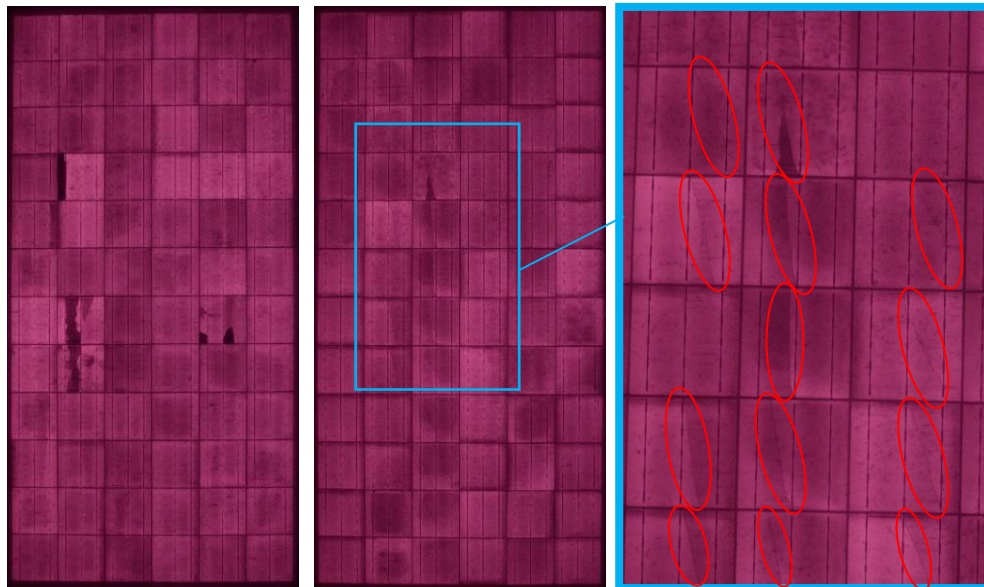
Figure 150: PV module affected by cell cracks

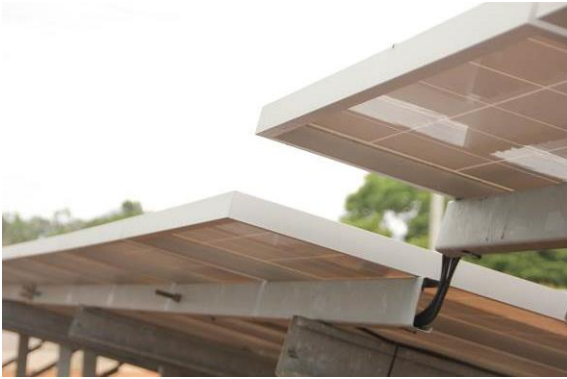
2.2	Not consistent interrow shading simulation.	Due to the considerable height difference between the trackers, an additional mutual shading loss to the already existing E-W interrow shadings can't be excluded. This effect can be reduced by adjusting the foundation height of the trackers during the design phase.

Figure 151: Height differences between the mounting tables in E-W direction

The reason for this height difference is the non-adjustment of the foundation height in order to absorb the terrain slope.

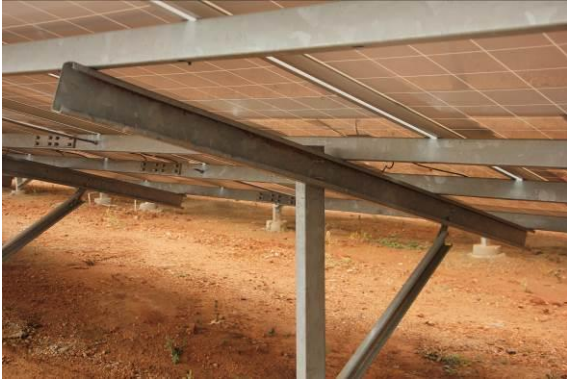
- i. Module fixation: The modules are properly fixed to the cross beams. No misalignment could be observed.

Figure 152: PV modules fixed to the mounting structure

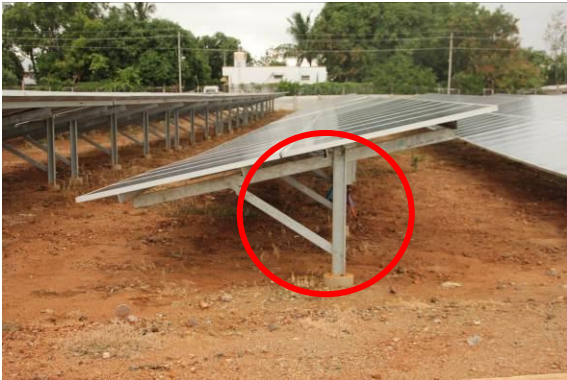
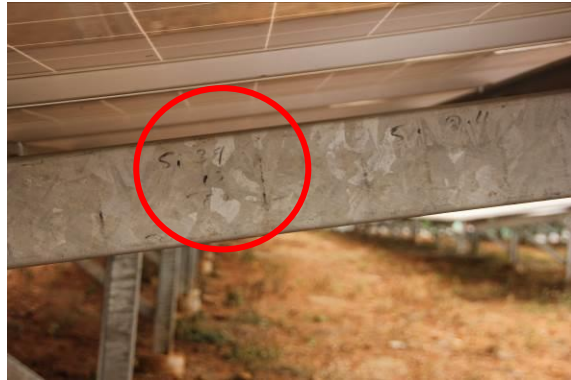
- ii. Labelling of rows: The labelling of the mounting structure hasn't been conducted properly. The used labelling system is not durable and some areas are not labelled at all.

Figure 153: Missing labelling of the module rows

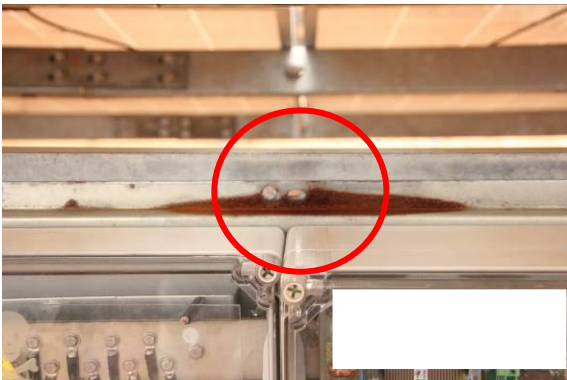
- iii. Rust on the mounting structure surface: The mounting structure shows signs of rust

Figure 154: Presence of rust in the mounting structure

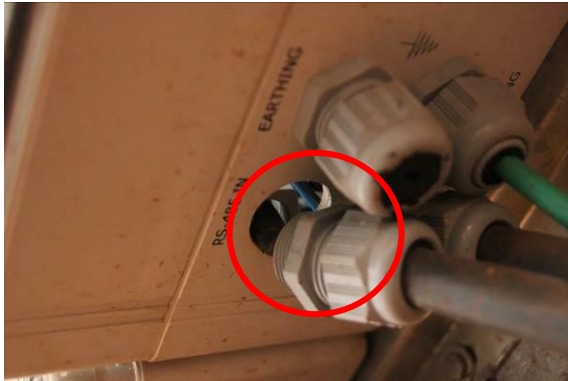
- i. Sealing of the cable glands: Some cable glands in the DC combiner boxes are open.

Figure 155: Open cable glands in the DC combiner box

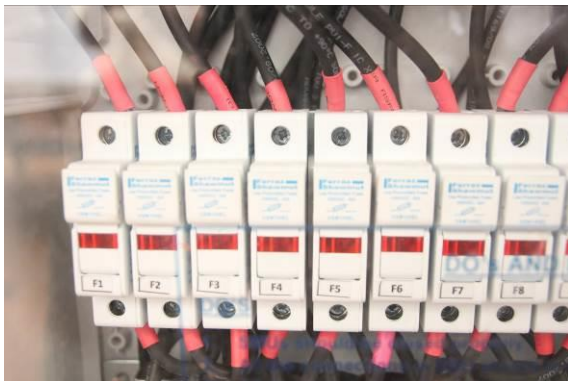
- ii. Cleanliness of the combiner box: The dust accumulation inside the combiner boxes is not significant.

Figure 156: Clean DC combiner box

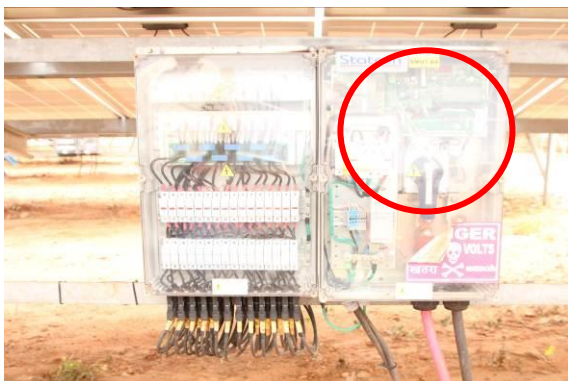
- iii. Labelling of the combiner box: The DC combiner boxes are labelled. Some of the tags attached to the housing are starting to lose adherence.

Figure 157: Missing labelling of the DC combiner box

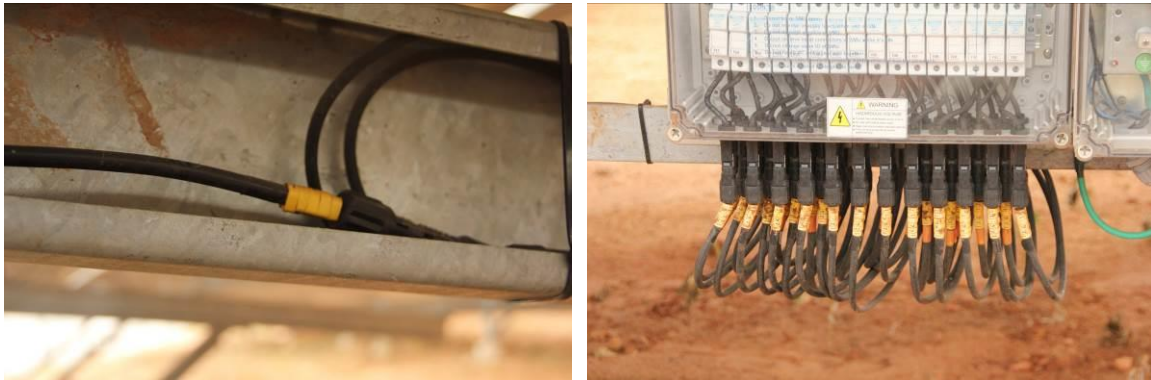
- ii. Labelling of cables: Both the strings cables entering the combiner box and the main DC cables connecting the combiner box with the inverter are properly labelled. In both cases the used tags seem to be durable for the whole lifetime of the project.

Figure 159: Labelling of the string cables

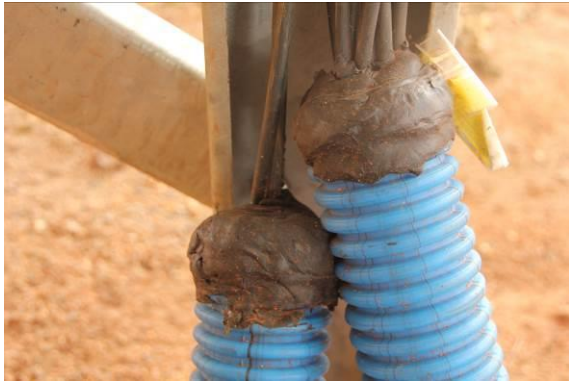
- vi. Cable pipes and sealing: The tubes conducting the DC cables to the inverter are sealed with durable foam. The tubes where the cables are routed do not show degradation due to outdoor exposure.

Figure 161: Sealed cable tubes

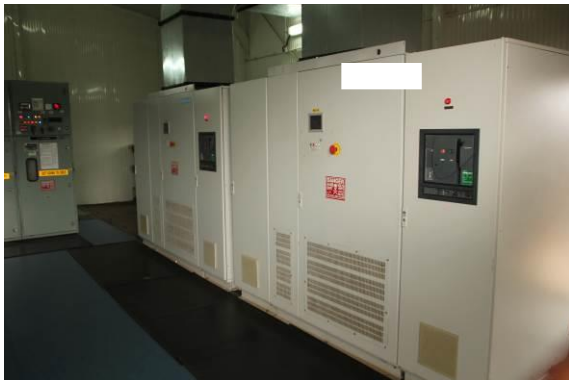
The inverter has an overvoltage protection on the AC side as well as a DC switch. The PCU is clean, no significant amount of dust has been detected. The inverter has a default ventilation system. The inverter room does not have a thermostat that regulates the temperature inside the housing. A forced ventilation system was installed inside the PCUs. The inverter filters and air inlets are clean.

Figure 162: View of the central inverter

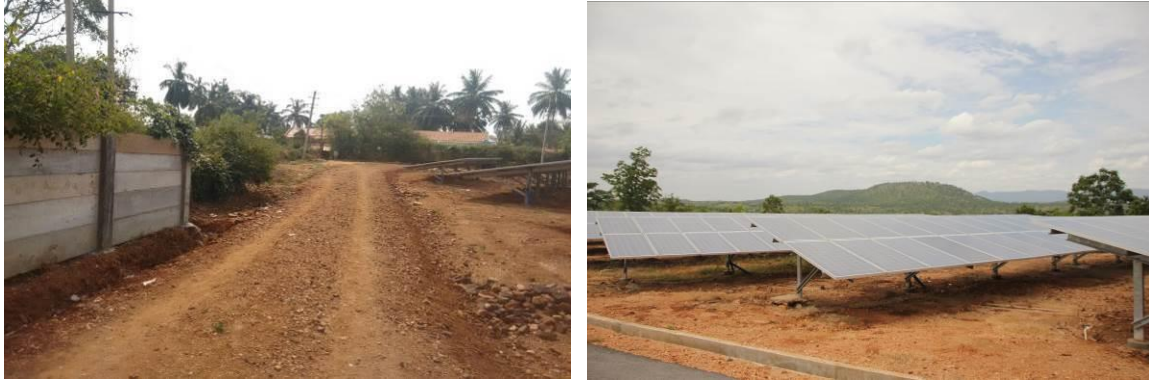
The status of the internal roads is very good. The drainage system is clean and well maintained. According to the EPC, the costs associated to the civil work represent 3% of the total CAPEX due to the levelling, grading and removing of stones and trees.

Figure 164: (left) Internal roads; (right) Drainage system

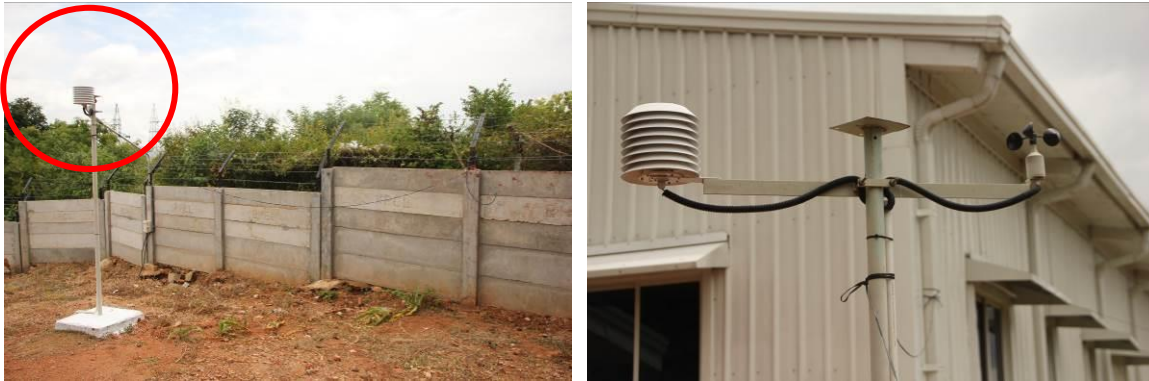
The weather stations installed onsite is constituted by a pyranometer on the horizontal surface, an ambient temperature sensor and an anemometer. Both the irradiation on the plane of the array (POA) and the cell temperature are not measured. The file “*measurement of irradiation ambient temp & gen.xlsx*” shows consistent values of the ambient temperature and wind velocity. The recorded GHI data of the first two years lead to PR values of 124% for the first year and 96% for the second year which are non-realistic values. The communication cable is in a very bad shape and the reliability is not ensured. According to the Owner, the sensors are calibrated each 2 years. The calibration certificates were not provided to PI Berlin.

Figure 165: (left) Weather station; (right) Ambient temperature sensor and anemometer

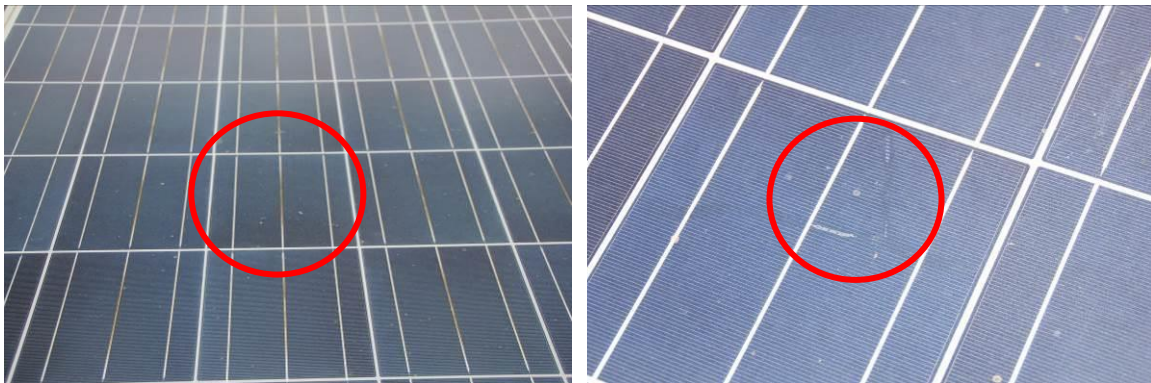
Figure 169: (left) Browning along the busbars; (right) Signs of snail trails

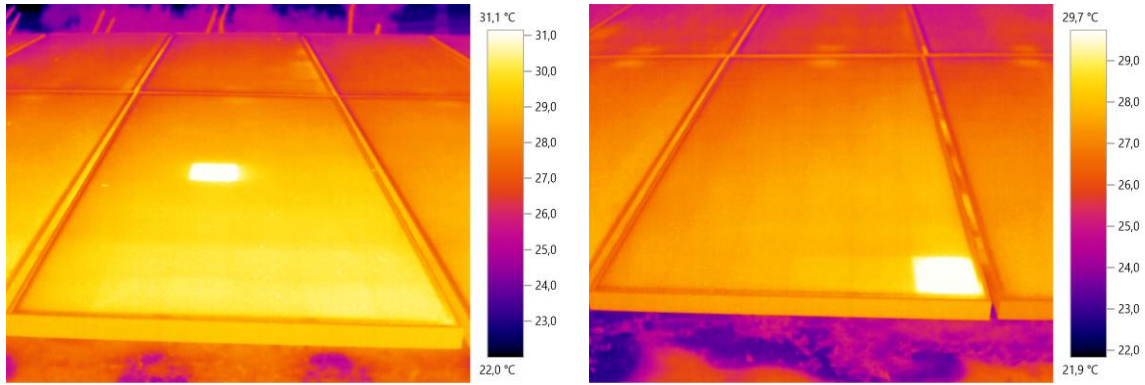
The infrared inspection showed clear evidences of hot spots along the ribbon, cell hotspots and PID. Other minor effects such as inactive cell strings or cell mismatch were also visible.

Figure 170: PV modules affected by hot spots

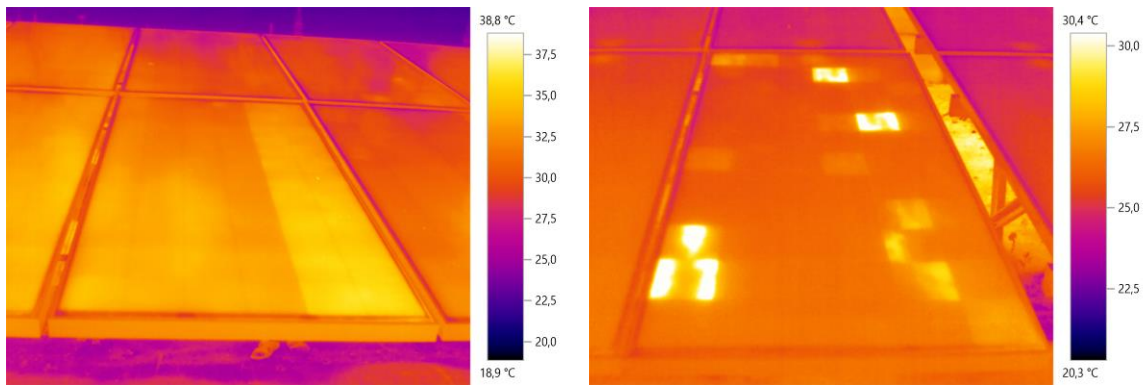
Figure 171: (left) PV module with one inactive cell string; (right) PV module affected by bad soldering
