Pilot Study on Quality Aspects of PV Power Plants in India

Conducted in the framework of the Indo-German cooperation project
“Strengthening Quality Infrastructure for the Solar Industry”

by PI Photovoltaik-Institut Berlin AG

First published: September 2017

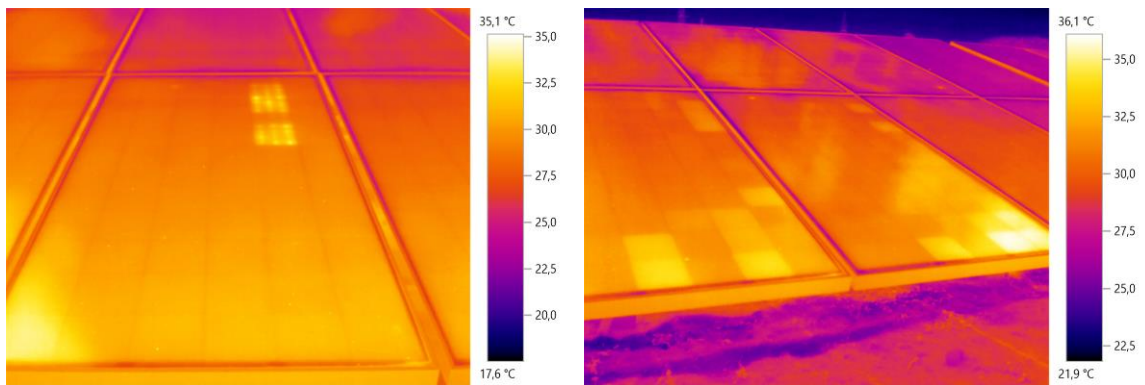
Figure 172: (left) PV module affected by bad soldering; (right) PV module affected by PID

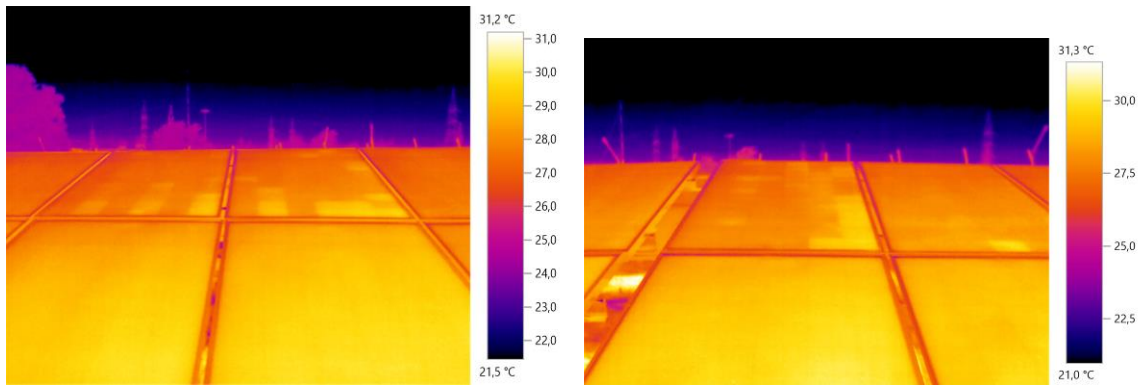
The infrared inspection showed clear evidences of hot spots along the ribbon, cell hotspots and PID. Other minor effects such as inactive cell strings or cell mismatch were also visible.

Figure 173: PV modules affected by PID

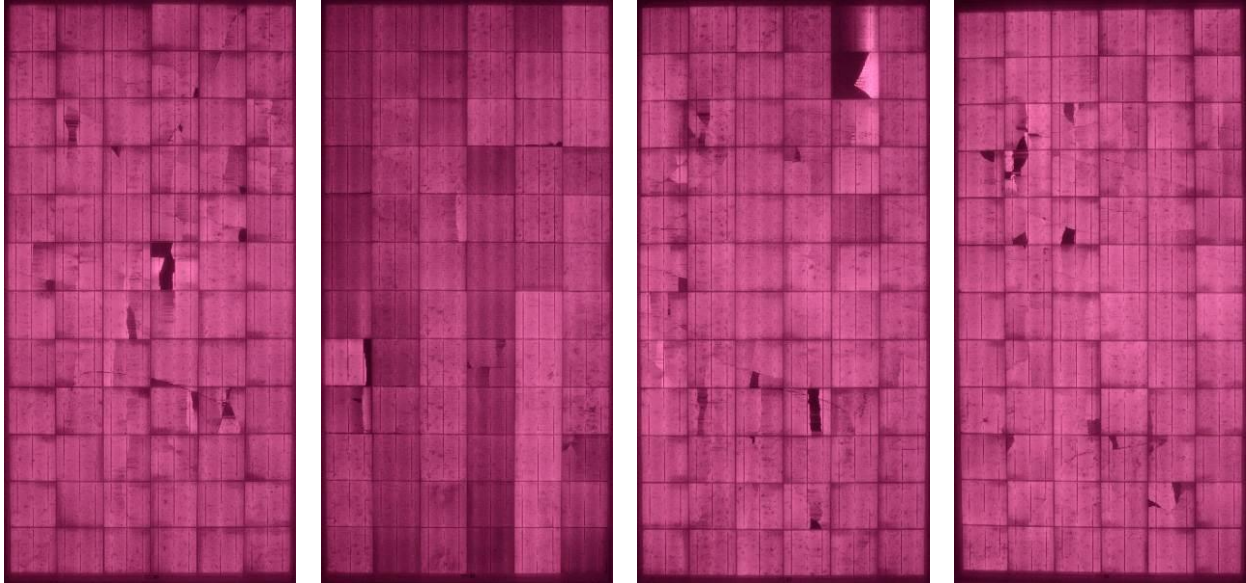
The electroluminescence analysis on a selected amount of crystalline PV modules confirmed the presence of PID and cell cracks caused by improper module handling.

Figure 174: PV modules affected by cracks

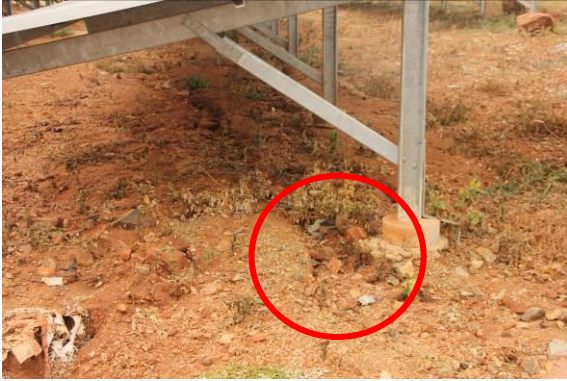
The most relevant environmental phenomena reported onsite are: rainfalls and erosion. The O&M plan does not include specific action to mitigate the effects of the erosion.

Figure 176: Signs of erosion

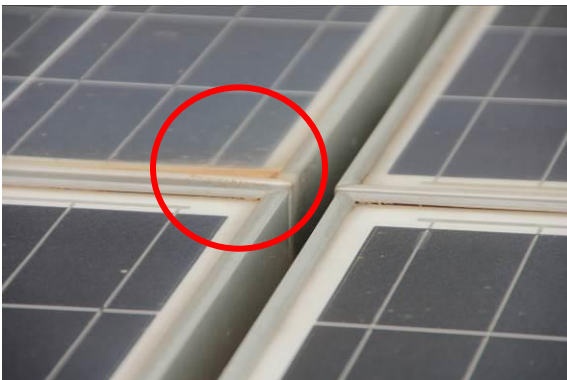
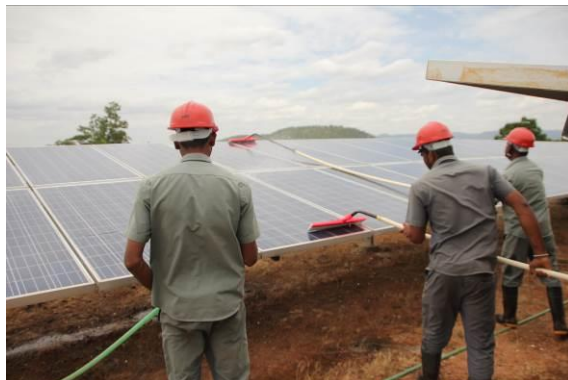
The soiling losses are not measured onsite. According to the Owner and Operator, the module cleaning is performed 3 times a month using cotton wipers and underground water. The resulting soiling losses derived from the established cleaning frequency were not calculated by the Operator. The impact of the selected cleaning methodology on the module warranty was not analysed either. According to the Operator, the module cleaning is performed after the inverters shut down.

Figure 177: (left) Soil accumulation; (right) Module cleaning team

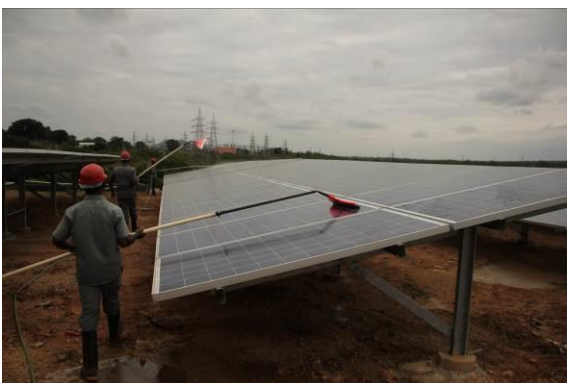
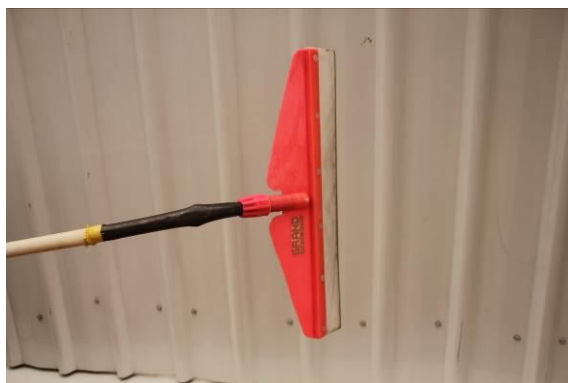
Figure 178: (left) Module cleaning team; (right) Module cleaning device
