HOW MICRO HYDRO POWER SYSTEMS IMPLEMENTED DURING ENDEV I ARE PERFORMING

EVALUATION OF A MONITORING SURVEY OF 20 MHP
SYSTEMS.

November 2010

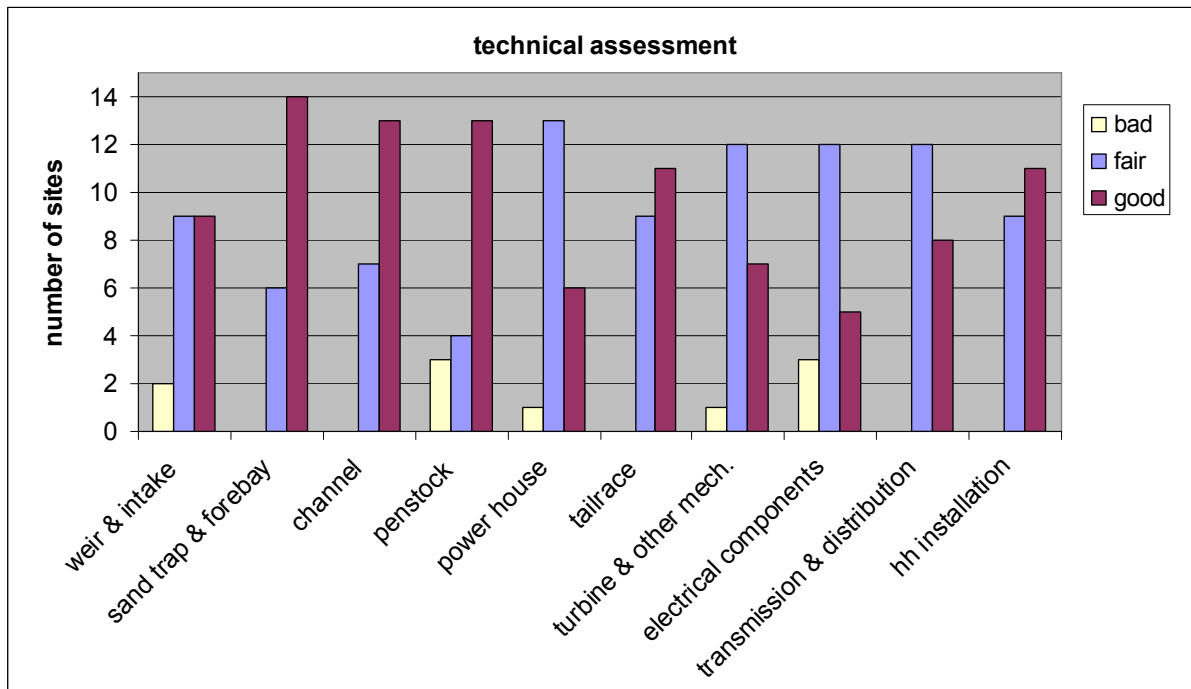
Figure 1: overview on the results of the technical assessment

The following diagram gives an overview on the **scores (in good / fair / bad condition)** awarded by the surveying hydropower specialists. E.g. weir and intake are considered to be in a good or fair condition for 9 sites respectively, and for the remaining 2 sites the score “bad” was given (in Minanga the gabion weir was destroyed by a flood, see photos 1 and 2 below; and the intake in Kampung non Limo has neither gate nor spillway).

The “bad” scores for penstocks were given in cases where corrosion (see photo 3 below) or even leakages were visible or where the strength of the thrust block was not sufficient. The “bad” score for “turbine & other mechanical equipment” was given for the turbine in Wonorejo, which can not be closed anymore (problem with guide vane, see photo 4 below).

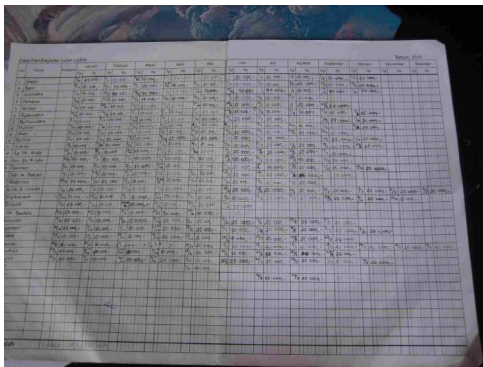
<p>Photo 25: tariff payments registered in blue booklet, Lambah Saiyo, Oct 10</p>	<p>Photo 26: book keeping documents from Pante Puang, Oct 10</p>

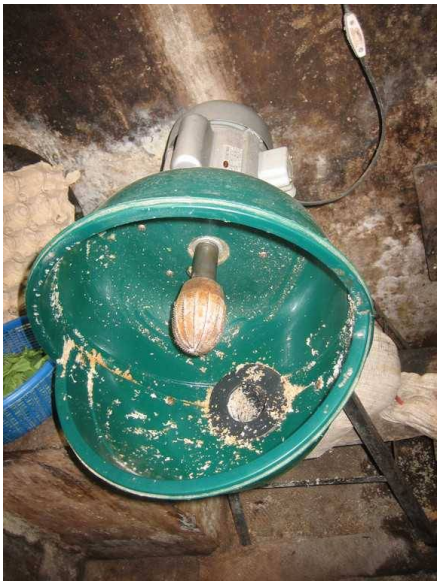
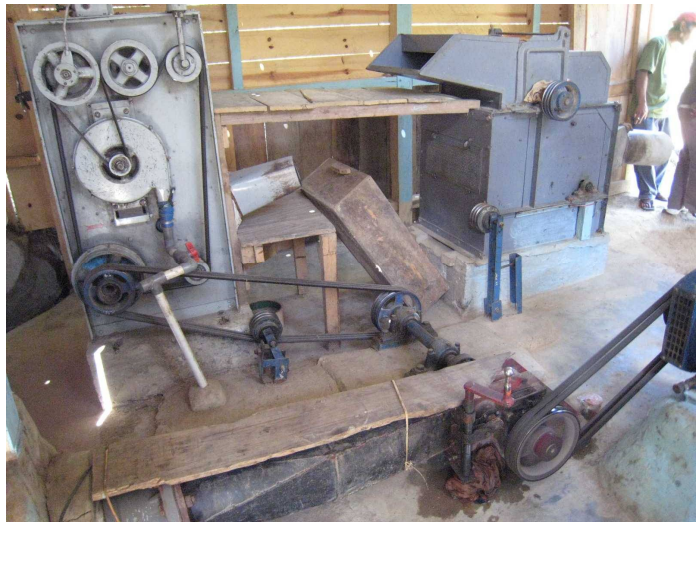
Coconut rasping in Muara Air, Oct 10	Directly driven rice huller (left) and thresher (right) in Lisuan Ada Tandiallo, Oct 10
